Canoa Hills Golf Course Club House
*Determination of the Basement's
 ambient concentrations of Volatile
 Organic Compounds*

Results Summary

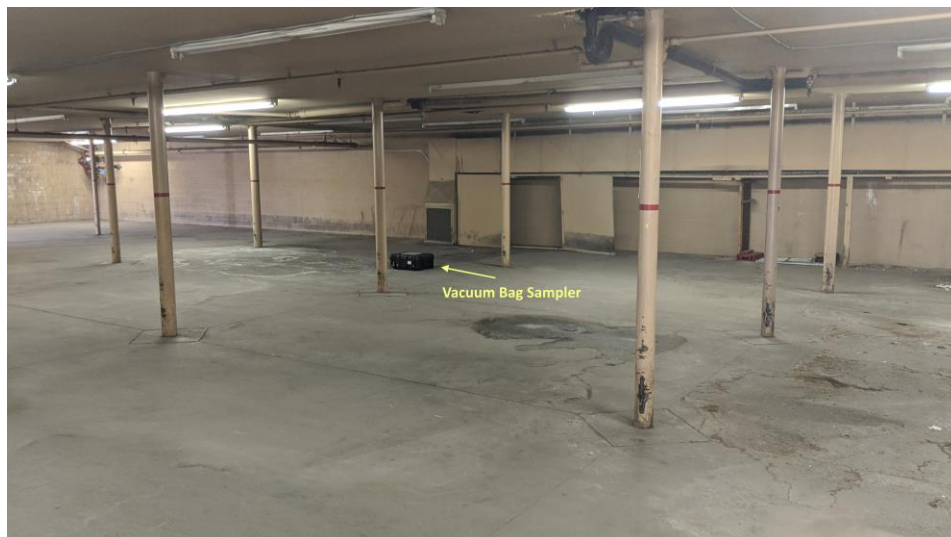
Photo 2: Basement

At 2:00 PM, on August 19th, Dennis Froehlich (Froehlich Environmental PLLC) initiated sample collection from the basement air at an ambient temperature of 93 F, without ventilation (building is has been out of service for an extended period), and without sensible smells or odors (Photo 2).

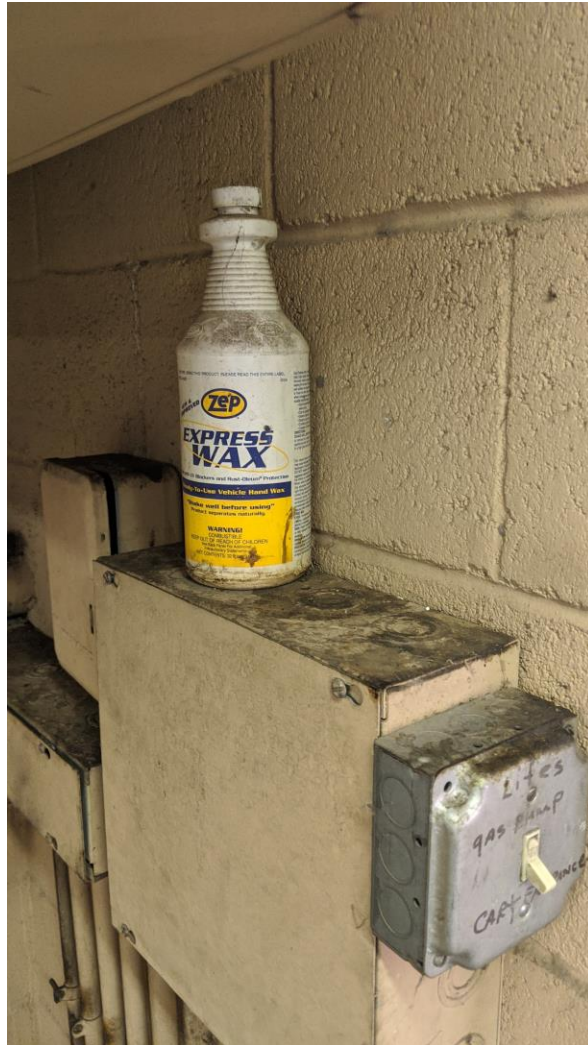
Photo 3: ZEP Express Wax

A bottle of ZEP Express WAX was on a wall box in the southeast corner of the basement (Photo 2). Per the manufacturer's product literature³ and excerpts from the product Safety Data Sheet⁴, this bottle is a VOC permeation source of the product through the plastic bottle and considered a contributing source of the trace VOC measured.

- 1) two VOCs, alpha-Pinene and d-Limonene, do not have permissible exposure limits as they are used in foods, scents, and perfumes (and car wax).
- 2) the magnitude of the reported concentration in excess of the method reporting limit (MRL) is less than 80% of the MRL, i.e. less than the first unit of precision (MRL – zero).
- 3) the reported concentration value is less than the sum the MRL, sampling error, and outside air concentration – and therefore at such low concentrations, represent a compound’s presence rather than precise concentration.
- 4) contributing sources of the measurable VOCs in the basement air, may include diffusion from the basement surfaces, VOCs permeated (diffused) through the plastic ZEP EXPRESS WAX bottle, and the background contribution from outside air.

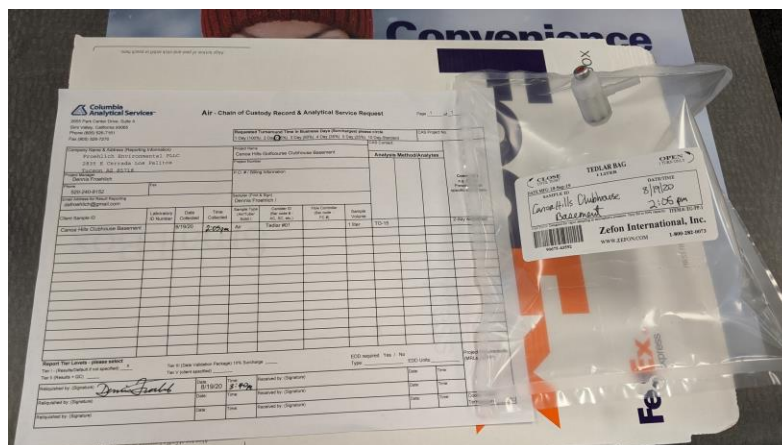
The basement air sample was collected into a new 1-liter Tedlar sample bag employing a vacuum bag sampler per the standard sampling procedure, and then sent via FedEx overnight to Columbia Analytical in Simi Valley California (Photo 4).
