Reserve Study Transmittal Letter

Re: Green Valley Recreation Inc; Update w/ Site Visit Review

RESERVE STUDY

Update w/ Site Visit Review

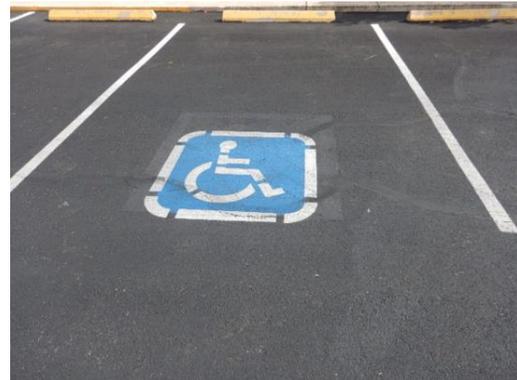
south parking lot and maintenance yard- 14,965 sf
north parking lot- 12,797 sf

2021- \$2,642 was expended for both North and South lots. Per client, Contractor did the North lot at no charge, was missed in their proposal.
2020- \$1,100 was expended to seal coat approximately 3,519 sf of lot surface, remainder of the lots were asphalt overlay, per client 6/16/2020. Balance of sealcoat assumed to be performed in 2021.
2019- Per client 7/22/2019, reduce remaining life from 2022 to 2020 and increase estimate from \$0.15/sf to \$0.20/sf.
2017- \$4,000 was expended for a follow-up seal coat from 2016.
2016- The north and south parking lots are in need of sealing and restriping.

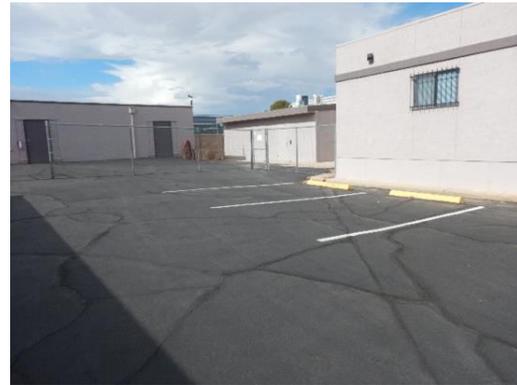
2016- There is alligator type cracking and moderate linear cracking throughout the paved surfaces.

300 - Asphalt: Overlay w/ Interlayer	Useful Life 25	Remaining Life 23	
14,965 sf South Parking & Maintenance	Quantity 14,965	Unit of Measure Square Feet	
	Cost /SqFt \$2.10		
	% Included 100.00%	Total Cost/Study \$31,427	
Summary	Replacement Year 2045	Future Cost \$55,456

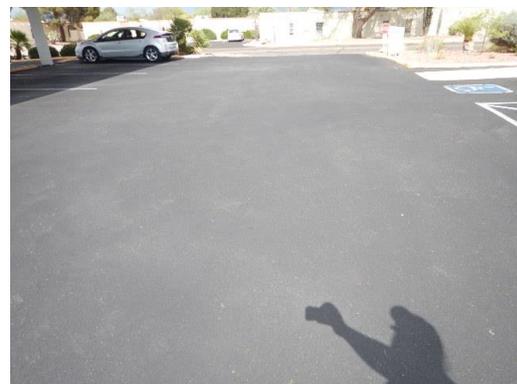
This is to apply a geotextile interlayer to the existing asphalt surface and overlay with a minimum of 1.5" of new hot mix asphalt. Generally this includes edge grinding and utility box extensions.

2020- \$19,506 was expended.

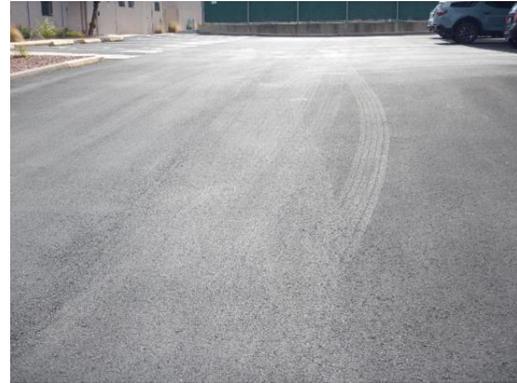
This is to apply a geotextile interlayer to the existing asphalt surface and overlay with a minimum of 1.5" of new hot mix asphalt. Generally this includes edge grinding and utility box extensions.

2020- \$16,764 was expended.

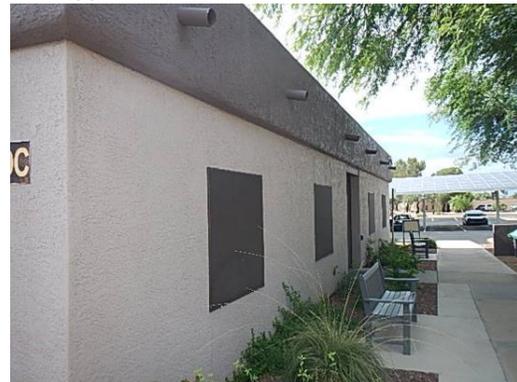
100 - Stucco	Useful Life 10	Remaining Life 6	
9,085 sf Building Exterior & Wall Surfaces	Quantity 9,085	Unit of Measure Square Feet	
	Cost /SqFt \$1.40		
	% Included 100.00%	Total Cost/Study \$12,719	
Summary	Replacement Year 2028	Future Cost \$14,750

2019- Paint appears in good condition, no issues noted.

2016- The paint is faded, peeling and rust stained around the scuppers.

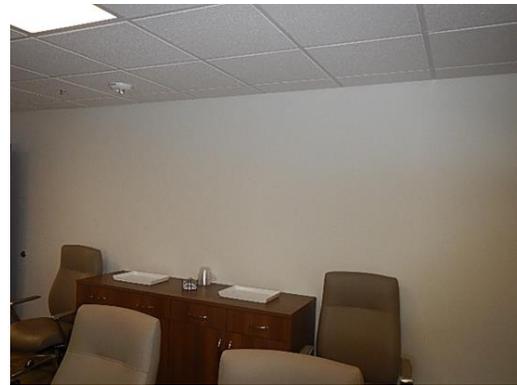
2016- Building was undergoing renovation during the reserve site visit, so this component assumes that painting was performed in conjunction with renovation.

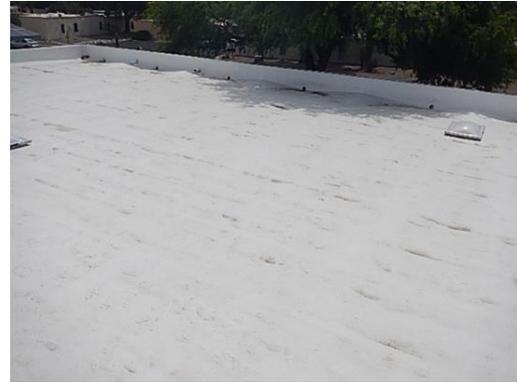
This is to replace the low slope single-ply vinyl roofing system. All roofs should be regularly inspected and repaired as indicated to ensure maximum life.

2021- Per client 6/1/2021, move remaining life from 2024 to 2023. Budget \$80,500 per TREMCO
 2018/19- Per client, roof re-coated. Remaining life extended by BRG to 2024.

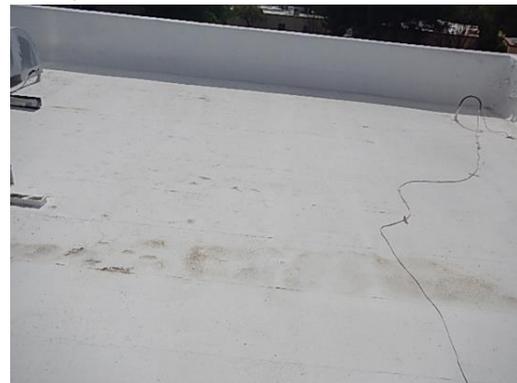
930 - Coating	Useful Life 5	Remaining Life 1	
7,900 sf Low Slope Roof Recoating	Quantity 7,900	Unit of Measure Square Feet	
	Cost /SqFt \$0.960		
	% Included 100.00%	Total Cost/Study \$7,584	
Summary	Replacement Year 2023	Future Cost \$7,774

This to prepare the roof and apply a coating to extend the roof's serviceable life by protecting against ponding water and ultraviolet rays.

2019- Per client 6/14/2019, \$6,750 expended for coating with 5 year life in 2018.

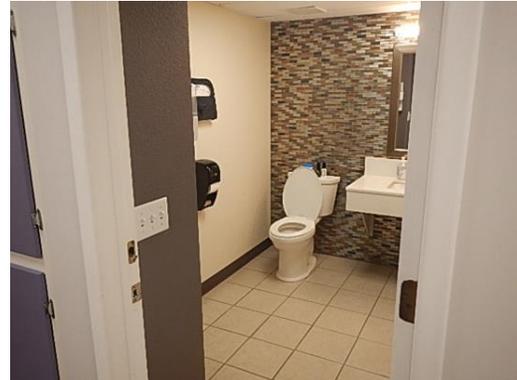
Women's similar to men's with: no urinal, and 2 toilet stalls.

2022- Men's restroom appear in excellent condition.
 2019- Increased estimate from \$4,000 to \$15,000 per restroom.
 2016- Remodeled.

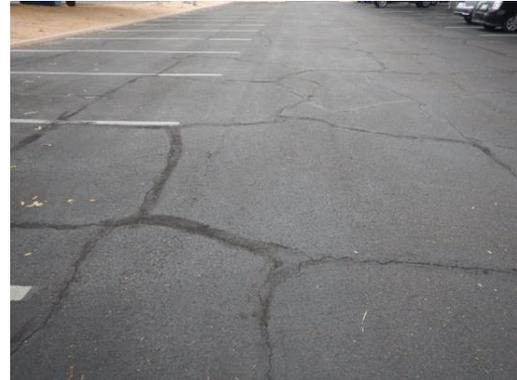
loading dock driveway- 7,155 sf
 north parking lot- 23,812 sf
 south parking lot- 12,576 sf

2022- Paved surfaces near tennis courts in need of sealing.
 2020- \$7,402 was expended.
 2019- Per client 7/22/2019, reduce remaining life from 2022 to 2020 and increase estimate from \$0.15/sf to \$0.20/sf.
 2017- \$17,985 total was expended to seal, crack seal and stripe the west, north and south areas.

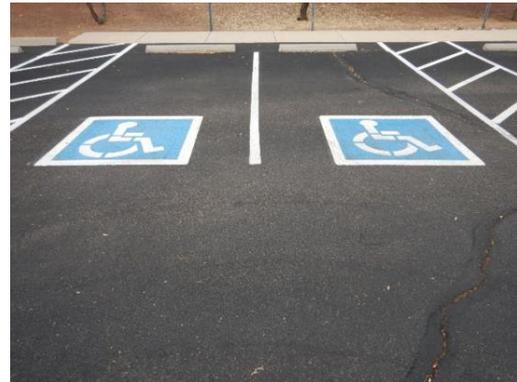
2017- \$17,985 total was expended to seal, crack seal and stripe the west, north and south areas.

2016- The west parking lot is in need of sealing and crack fill. The striping is in fair condition.

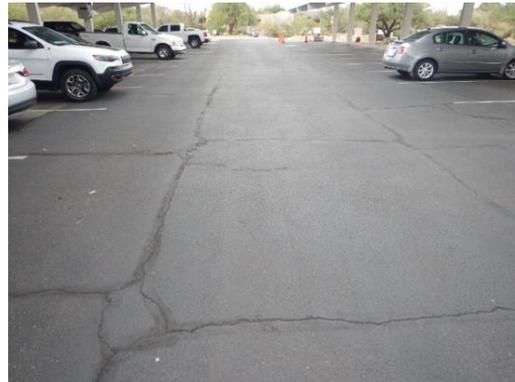
loading dock driveway- 7,155 sf
 north parking lot- 23,812 sf
 south parking lot- 12,576 sf

2022- Loading dock driveway exhibits large cracks.

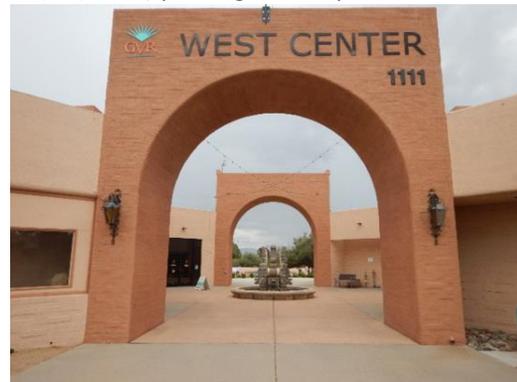
106 - Stucco	Useful Life 10	Remaining Life 8	
53,060 sf Building Exterior & Wall Surfaces	Quantity 53,060	Unit of Measure Square Feet	
	Cost /SqFt \$1.40		
	% Included 100.00%	Total Cost/Study \$74,284	
Summary	Replacement Year 2030	Future Cost \$90,508

This is to prepare, power wash, sand, scrape, caulk and paint the stucco surfaces with a premium paint.

2022- Stucco painting appears in good condition.
 2020- \$60,050 was expended.
 2019- Peel, fade and efflorescence were observed. Per client 6/14/2019, painting is anticipated in 2020.

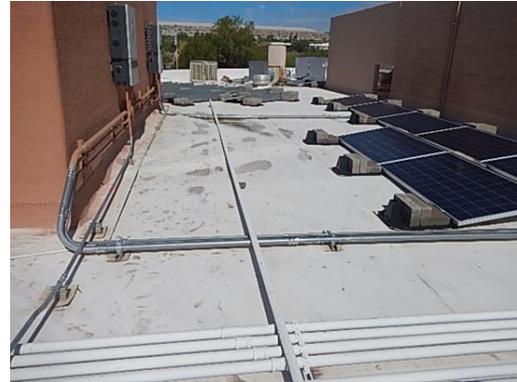
This is to replace the low slope single-ply vinyl roofing system. All roofs should be regularly inspected and repaired as indicated to ensure maximum life.

2019- During the reserve study site visit, solar installation was in progress, and the roof had just been recoated. Per client 6/14/2019, extend remaining life from 2019 to 2029.

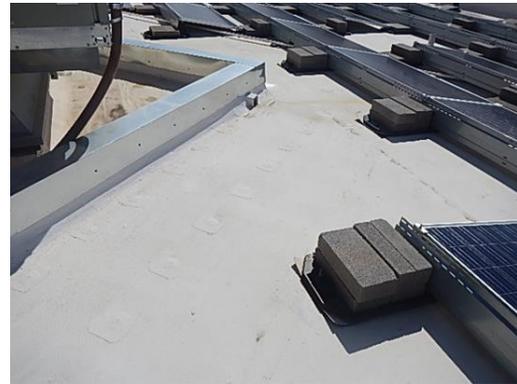
2021- \$1,589 was expended for roof coating shuffleboard and locker room building.

2019- During the reserve study site visit, solar installation was in progress. \$37,525 was expended to recoat with Uniflex Coolmax41 per client 6/14/2019.

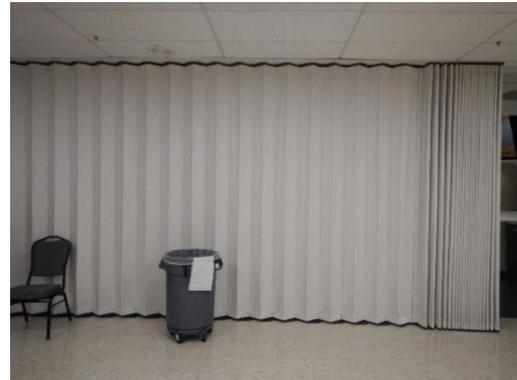
This is to repair and replace the operable wall/partition.

Modernfold
 10' x 32'

2021- \$18,369 was expended.
 2019- Some damage was observed.

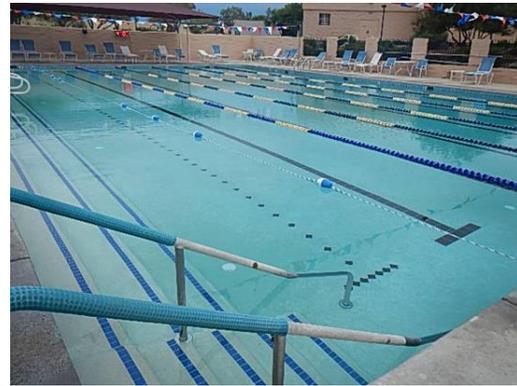
100 - Resurface	Useful Life 12	Remaining Life 3	
250 lf Pool	Quantity 250	Unit of Measure	Linear Feet
	Cost /l.f. \$188		
	% Included 100.00%	Total Cost/Study	\$47,000
Summary	Replacement Year 2025	Future Cost	\$50,614

- 6- tile race lanes with targets
- 1- tile walk lane

2021- Remaining life, per client is revised to 2025.

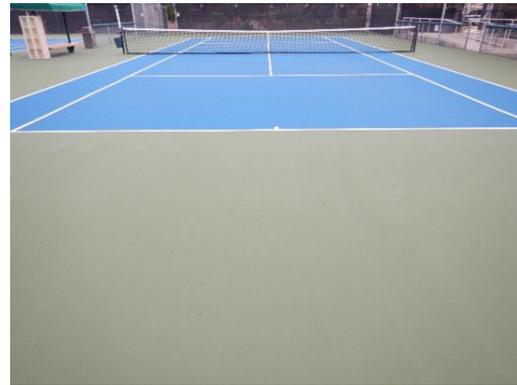
2019- Court surfaces, nets and posts appear in excellent condition. No cracking noted. Per client 7/22/2019, these courts are post-tensioned concrete that do not require resurface.

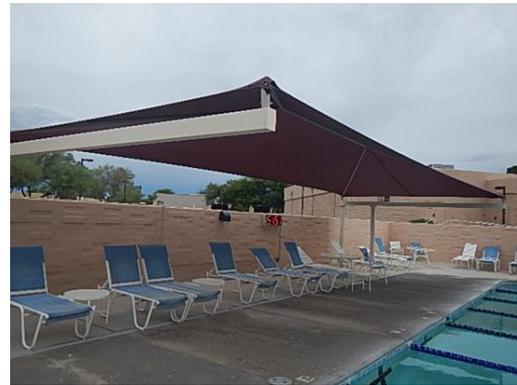
2019- The canvas portions of the shade structures appear to have been replaced in approximately 2018.
 2006- Structure installed.

844 - Shade Structure	Useful Life 15	Remaining Life 10
1,955 sf [3] Tennis Court Shade Canopies	Quantity 1,955	Unit of Measure Square Feet
	Cost /SqFt \$23.00	
	% Included 100.00%	Total Cost/Study \$44,965
Summary	Replacement Year 2032	Future Cost \$57,559

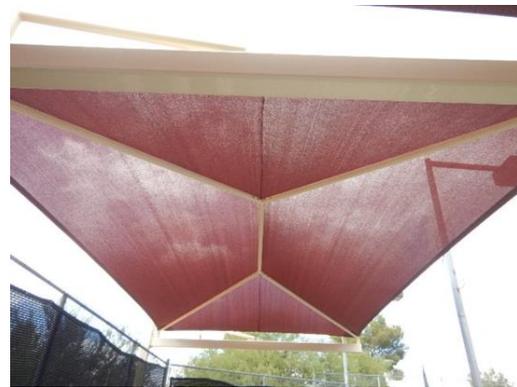
This is to replace the canvas canopy shade structures.

- 1- south tennis courts at east side ramada- 455 sf
- 1- west side north tennis courts- 900 sf
- 1- east side north tennis courts- 600 sf

2019- The canvas portions of the shade structures appear to have been replaced in approximately 2017. Per client 6/14/2019, one structure was added in May 2019.
 2008- Structures installed.

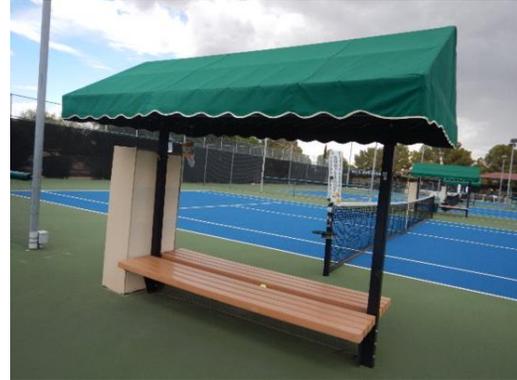
846 - Shade Structure	Useful Life 15	Remaining Life 10
4 Tennis Court Bench Shades (25%)	Quantity 4	Unit of Measure Items
	Cost /Itm \$2,000	Qty * \$/Itm \$8,000
	% Included 25.00%	Total Cost/Study \$2,000
Summary	Replacement Year 2032	Future Cost \$2,560

This is to replace the shade structure with new similar model.

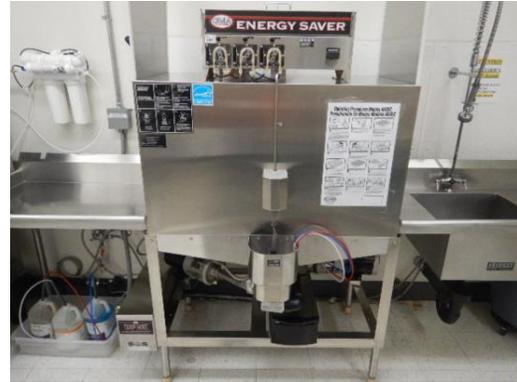
324 - Dishwasher, Commercial	Useful Life 12	Remaining Life 0
Commercial Dishwasher- 2022	Quantity 1	Unit of Measure Items
	Cost /Itm \$10,000	
	% Included 100.00%	Total Cost/Study \$10,000
Summary	Replacement Year 2022	Future Cost \$10,000

This is to replace the commercial grade dishwasher.

1- CMA commercial dishwasher Model #- B-2, Serial # 276399

2022- \$10,000 anticipated.

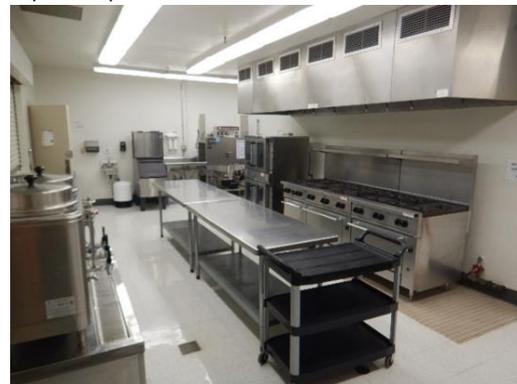
700 - Miscellaneous	Useful Life 5	Remaining Life 2
30 Kitchen Appliances (33%)	Quantity 30	Unit of Measure Items
	Cost /Itm \$3,500	Qty * \$/Itm \$105,000
	% Included 33.33%	Total Cost/Study \$35,000
Summary	Replacement Year 2024	Future Cost \$36,772

This is to periodically repair or replace miscellaneous appliances.

- 1- Stainless steel handwash sink
- 1- GE microwave
- 1- Duke Heritage HB5HFM 5-well buffet table
- 1- Grindmaster Cecilware Corp CL100n Triple coffee
- 1- Bunn Coffee
- 1- Southbend CGS/28SC double stack convection oven
- 1- Wood block cutting table
- 1- Triple SS sink
- 1- SS sink
- 1- Arctic Air single door commercial refer, MN R22CW8, SN WA13500890
- 1- Arctic Air single door commercial refer, MN R22CW10, SN WA31000648
- 1- Arctic Air single door commercial freezer
- 1- Arctic Air double door refer
- 1- Manitowoc ice maker MN SY0324A, SN 110980166, mfg 12/2010, bin MN B320, SN 11968608
- 1- Stainless Hood
- 1- ANSUL R-102 wet chemical fire suppression system
- 1- Josam JA3 grease interceptor
- 1- Speed Queen commercial stacked heavy duty washer/dryer (dressing room)
- 2- Carter Hoffmann FH-80 banquet carts
- 4- SS tables
- 3- Tables
- 1- Coffee Server

- 2022- \$10,000 expended for dishwasher replacement.
- 2021- \$11,808 was expended to replace dishwasher and ice machine at Tennis Ramada.
- 2018- 2 Wolf pieces were replaced by 2 Vulcan units and are provided for within another component.
- 2016- Southbend CGS/28SC double stack convection oven replaced prior oven.

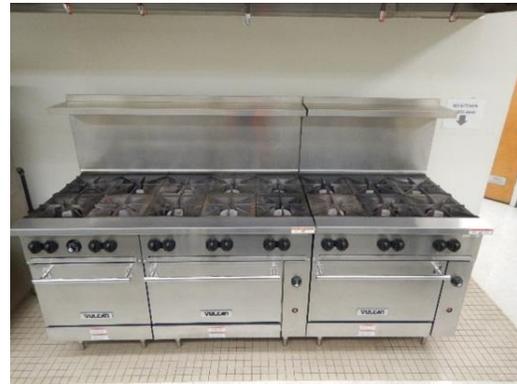
702 - Stove	Useful Life 20	Remaining Life 16
2 Vulcan 10-Burner & 6-Burner	Quantity 2	Unit of Measure Items
	Cost /Itm \$3,600	
	% Included 100.00%	Total Cost/Study \$7,200
Summary	Replacement Year 2038	Future Cost \$10,688

This is to replace the kitchen stoves.

- 1- Vulcan 10-burner
- 1- Vulcan 6-burner

2018- \$6,478 total was expended to replace 2 prior Wolf units.

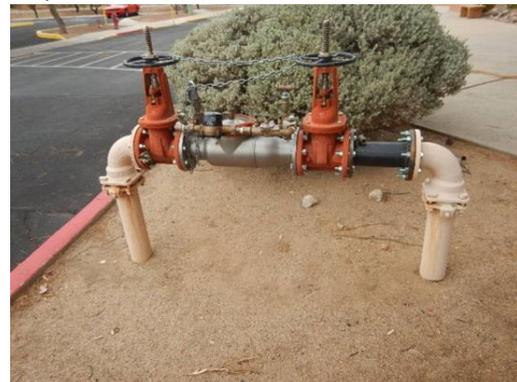
158 - Backflow Valves	Useful Life 12	Remaining Life 11
4" Backflow	Quantity 1	Unit of Measure Items
	Cost /Itm \$5,850	
	% Included 100.00%	Total Cost/Study \$5,850
Summary	Replacement Year 2033	Future Cost \$7,676

This is to replace the backflow prevention valve.

2021- \$5,631 was expended.

2020- \$7,031, 12 year life, and 2021 remaining life estimates per client 6/15/2020.

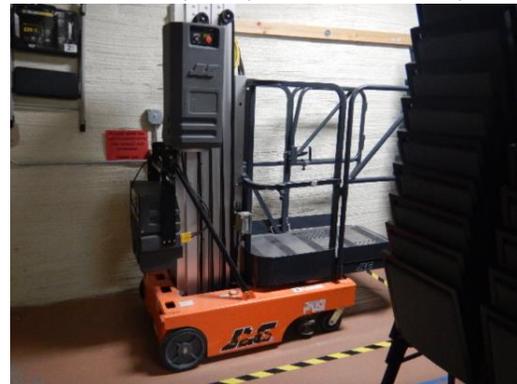
240 - Maintenance Equipment	Useful Life 20	Remaining Life 4	
2 Portable Lifts	Quantity 2	Unit of Measure	Items
	Cost /Itm \$11,800		
	% Included 100.00%	Total Cost/Study	\$23,600
Summary	Replacement Year 2026	Future Cost	\$26,050

This is to repair and replace the portable man-lifts.

JLG manlift, MN SCR121097B1, SN 11292160
 Genie Industries 15' easy up lift, MN EU-15, SN 2785-354

2019- Per client, the UpRight manlift (MN 068001-001M, SN 20642) was damaged beyond repair.
 2016- These units appear to have different ages. Unit replacement will likely be spread over several years.

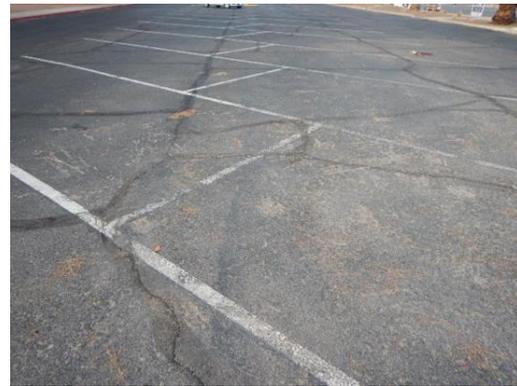
2021- Quantity increased by 8,000 sf due to the north driveway is GVR responsibility.
 2019- The surface is due for seal coat. \$8,400 was expended per client 6/14/2019.
 2014- West and north lots overlaid.
 2006- South lot reconstructed.

212 - Asphalt: Ongoing Repairs	Useful Life 5	Remaining Life 2	
87,662 sf Parking Lot & N Driveway (2%)	Quantity 87,662	Unit of Measure Square Feet	
	Cost /SqFt \$3.85	Qty * \$/SqFt \$337,499	
	% Included 2.00%	Total Cost/Study \$6,750	
Summary	Replacement Year 2024	Future Cost \$7,092

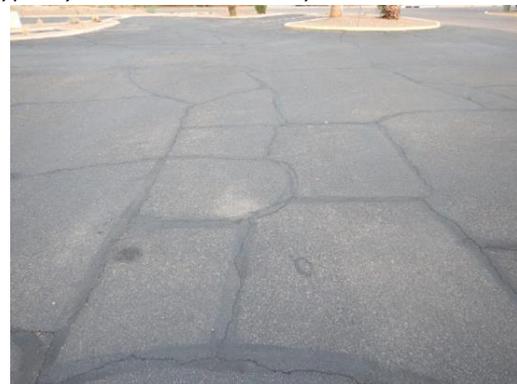
This is for miscellaneous repairs including crackfill, skin patching and minor dig out & fill. Cracks 1/4" or wider should be filled when observed.

2022- Per client 6/22/2022, \$45,000 is anticipated by September. The south lot exhibits large unsealed cracks.
 2021- Quantity increased by 8,000 sf due to the north driveway is GVR responsibility. Per client 6/30/2021, \$19,665 is anticipated to repair and apply micro surface (type II) to the north driveway in 2022.

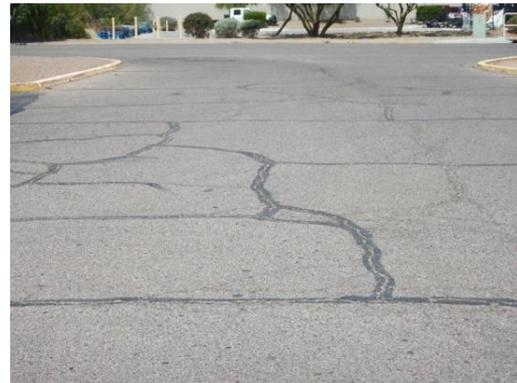
312 - Asphalt: Overlay w/ Interlayer 27,900 sf South Parking Lot	Useful Life 25 Quantity 27,900 Cost /SqFt \$2.10 % Included 100.00%	Remaining Life 9 Unit of Measure Square Feet Total Cost/Study \$58,590	
Summary	Replacement Year 2031	Future Cost \$73,171

This is to apply a paving fabric interlayer to the existing asphalt surface and overlay with a minimum of 1.5" of new hot mix asphalt. Generally this includes edge grinding and utility box extensions.

2022- Large unsealed cracks exhibited.
 2006- Parking lot reconstructed.

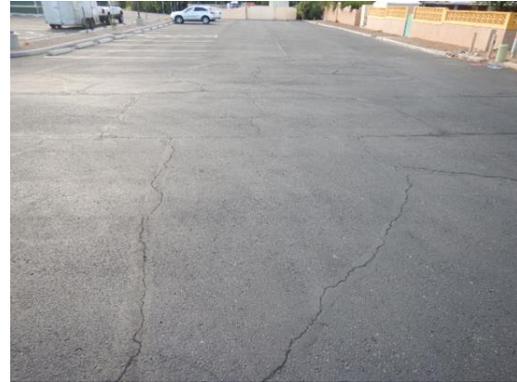
316 - Asphalt: Overlay w/ Interlayer	Useful Life 25	Remaining Life 17
56,762 sf West & North Parking Lots & N Driveway	Quantity 56,762	Unit of Measure Square Feet
	Cost /SqFt \$2.10	
	% Included 100.00%	Total Cost/Study \$119,200
Summary	Replacement Year 2039	Future Cost \$181,377

This is to apply a paving fabric interlayer to the existing asphalt surface and overlay with a minimum of 1.5" of new hot mix asphalt. Generally this includes edge grinding and utility box extensions.

2021- Quantity increased by 8,000 sf due to the north driveway is GVR responsibility.
 2014- West and north lots overlaid.

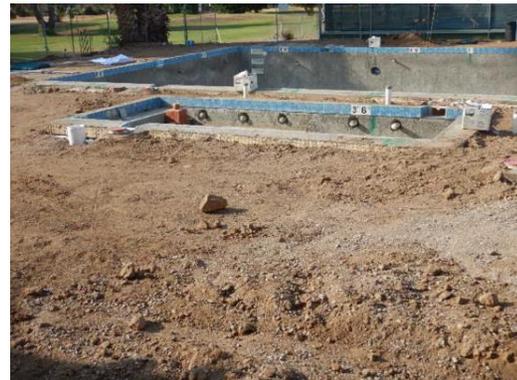
406 - Pool Deck	Useful Life 2	Remaining Life 0
5,661 sf Pool/Spa Area Concrete Repair (4%)	Quantity 5,661	Unit of Measure Square Feet
	Cost /SqFt \$23.20	Qty * \$/SqFt \$131,310
	% Included 4.12%	Total Cost/Study \$5,408
Summary	Replacement Year 2022	Future Cost \$5,408

This is to periodically repair and replace concrete pool deck, deck drains and deck mastic to remove abrupt elevation shifts and to maintain functionality. Since concrete pool deck useful life typically exceeds the scope of the 30-year study, this component provides for repair only and not full replacement. However, as the deck ages and undergoes multiple repairs and patches, this component may revert from occasional partial repairs to full replacement. Deck acrylic lace coating replacement is provided for within another component.

2022- \$5,408 was expended. Not yet installed as of the reserve study site visit.
 2020- \$2,574 was expended.
 2019- Uneven deck drains were observed (marked with orange safety cones). \$5,022 total was expended for partial area repair and recoat per client 6/14/2019. Per client 8/5/2019, reduce useful life from 5 to 2 years.

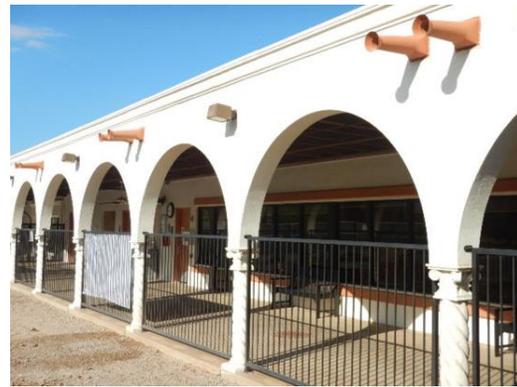
2022- South end of building exhibits cracks above door/windows.
 2019- Per client 6/14/2019, \$16,869 was expended to paint in 2018.
 2009- Painting completed.

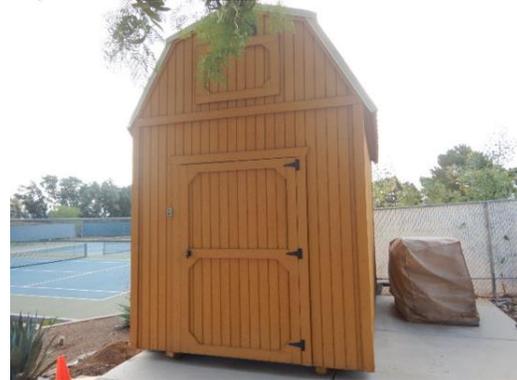
896 - Shed	Useful Life 20	Remaining Life 15	
Pool Equipment Area Shed	Quantity 1	Unit of Measure	Items
	Cost /Itm \$5,000		
	% Included 100.00%	Total Cost/Study	\$5,000
Summary	Replacement Year 2037	Future Cost	\$7,241

This is to replace the 8' x 12', wood sided, metal roofed shed by the pool equipment.

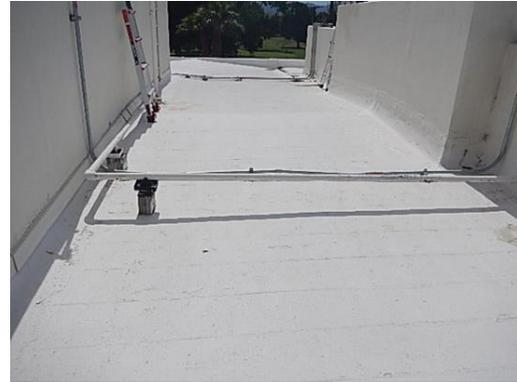
312 - Low Slope: Vinyl 207 Squares- Building Roof (50%)	Useful Life 20 Quantity 207 Cost /Sqrs \$710 % Included 50.00%	Remaining Life 2 Unit of Measure Squares Qty * \$/Sqrs \$146,970 Total Cost/Study \$73,485 Replacement Year 2024	Future Cost \$77,205
Summary

This is to replace the low slope single-ply vinyl roofing system. All roofs should be regularly inspected and repaired as indicated to ensure maximum life.

2019- At the time of the reserve study site visit, solar panel had been installed and roof recoating completed. BRG extended the remaining life of this component to 2024.

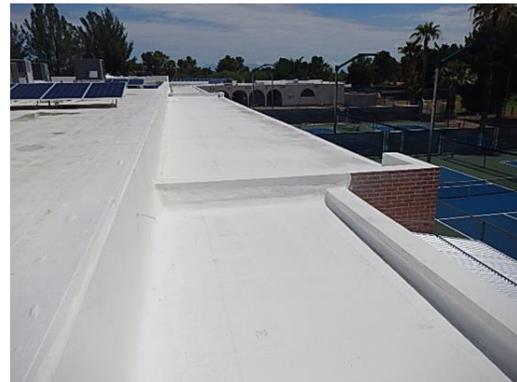
356 - Low Slope: Vinyl 207 Squares- Building Roof (50%)	Useful Life 20 Quantity 207 Cost /Sqrs \$710 % Included 50.00%	Remaining Life 7 Unit of Measure Squares Qty * \$/Sqrs \$146,970 Total Cost/Study \$73,485 Replacement Year 2029	Future Cost \$87,351
Summary

This is to replace approximately half of the low slope single-ply vinyl roofing system. All roofs should be regularly inspected and repaired as indicated to ensure maximum life.

2019- At the time of the reserve study site visit, solar panel had been installed and roof recoating completed. BRG extended the remaining life of this component to 2029.

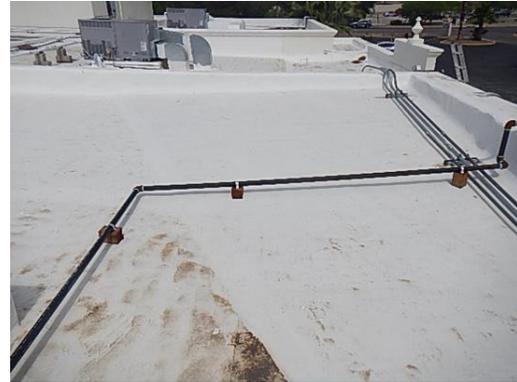
938 - Coating	Useful Life 5	Remaining Life 2
20,700 sf Low Slope Roof Recoating	Quantity 20,700	Unit of Measure Square Feet
	Cost /SqFt \$0.590	
	% Included 100.00%	Total Cost/Study \$12,213
Summary	Replacement Year 2024	Future Cost \$12,831

This to prepare the roof and apply a coating to extend the roof's serviceable life by protecting against ponding water and ultraviolet rays.

2019- At the time of the reserve study site visit, solar system had been installed and roof recoating completed. \$11,056 was expended per client 6/14/2019.

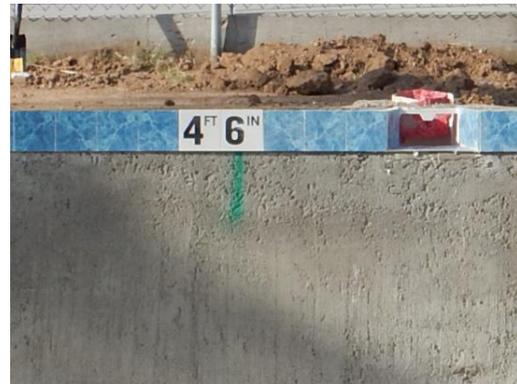
106 - Resurface	Useful Life 12	Remaining Life 0
165 lf Pool	Quantity 165	Unit of Measure Linear Feet
	Cost /l.f. \$135	
	% Included 100.00%	Total Cost/Study \$22,247
Summary	Replacement Year 2022	Future Cost \$22,247

This is to resurface the pool including start-up costs.

2022- \$22,247 expended. Not yet plastered as of the reserve study site visit.
 2021- Per client 6/1/2021, work was not completed in 2020, now anticipated in 2022 with re-construction. See related structural component for the work scheduled in 2022.
 2020- \$21,704 was expended.
 2019- Stains, patches and minor spall were observed.

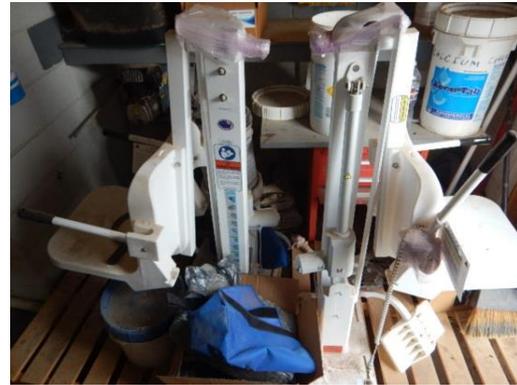
This is to periodically replace the pool and spa equipment. Since not all equipment will fail simultaneously, this component provides for one half replacement every five years.

- 1- Clear Comfort advanced oxidation system
- Assorted- chemical system probes, fittings, chem pumps, injectors, etc.
- Assorted- pipes, fittings, controls, lights, drain covers, hand rails, etc.

- 2022- \$20,769 is anticipated.
- 2021- Per client 6/1/2021, work was not completed in 2020, now anticipated in 2022.
- 2020- \$20,262 was expended.
- 2019- \$371 was expended per client 6/14/2019.
- 2018- \$5,020 expended for pool/spa Aquasol systems & chlorine pumps.

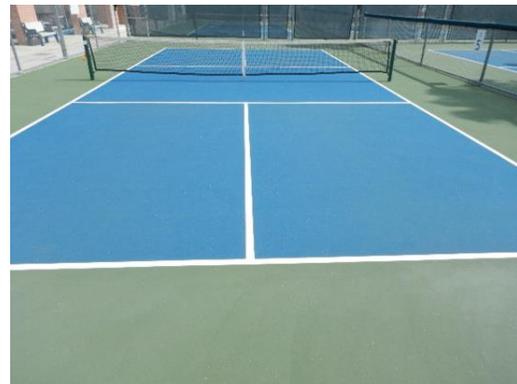
- 8 courts at 2,275 sf/court
- 1- south court 2018
- 3- middle courts 2000-2006
- 4- north courts 2015

2021- \$19,400 was expended.
 2020- Per client 8/5/2020, reduce estimate from \$4,500 to \$1,613 per court.
 2019- \$14,858 was expended per client 6/14/2019. Per client 7/22/2019, anticipate \$4,500/court every two years.
 2017- \$5,199 total was expended.

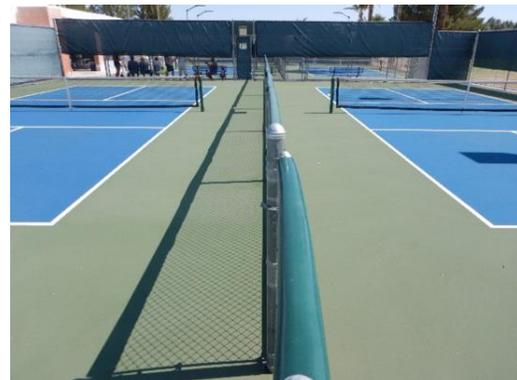
104 - Chain Link: 4'	Useful Life 25	Remaining Life 22	
270 lf Pickleball Court Divider Fences	Quantity 270	Unit of Measure Linear Feet	
	Cost /l.f. \$22.00		
	% Included 100.00%	Total Cost/Study \$5,940	
Summary	Replacement Year 2044	Future Cost \$10,226

This is to replace the 4' chain link fencing and gates.

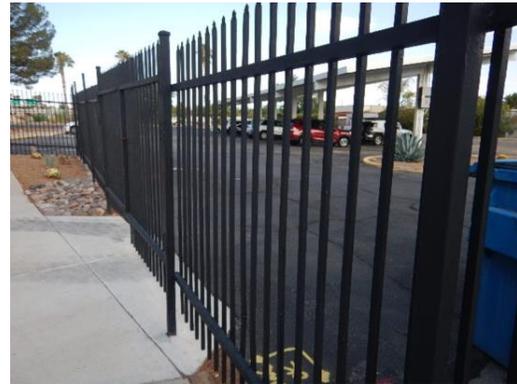
200 - Wrought Iron: 5'	Useful Life 30	Remaining Life 4
415 lf Pool Perimeter Fence	Quantity 415	Unit of Measure Linear Feet
	Cost /l.f. \$40.00	
	% Included 100.00%	Total Cost/Study \$16,600
Summary	Replacement Year 2026	Future Cost \$18,323

This is to replace the 5' wrought iron fencing and gates. With aggressive paint maintenance, this component's life may be extended. Painting is provided for within another component.

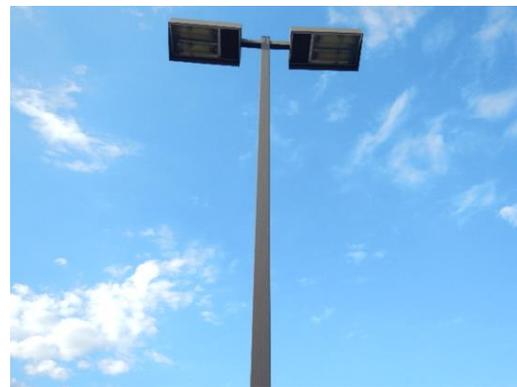
604 - Sports Field / Court	Useful Life 10	Remaining Life 7	
8 Pickleball Court Lights	Quantity 8	Unit of Measure	Items
	Cost /Itm \$3,400		
	% Included 100.00%	Total Cost/Study	\$27,200
Summary	Replacement Year 2029	Future Cost	\$32,332

This is to replace the pickleball court lights.

2019- \$24,800 was expended to install lights with a 10 year life per client 6/14/2019.

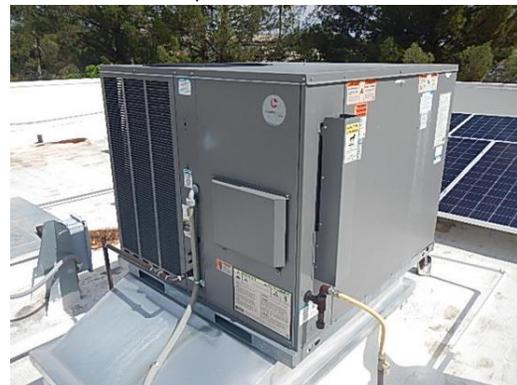
326 - HVAC	Useful Life 15	Remaining Life 2
Rooftop Carrier Unit #3- 2009	Quantity 1	Unit of Measure Items
	Cost /Itm \$20,200	
	% Included 100.00%	Total Cost/Study \$20,200
Summary	Replacement Year 2024	Future Cost \$21,223

Unit 3- Auditorium- Carrier- 10T

2016- client provided spreadsheet lists 48HJE008-6 as the model number for this unit. Unit sticker lists 48HJD012571.

This is to replace the Carrier HVAC system. It is possible that sub-components of this system can be replaced or rebuilt to extend its life.

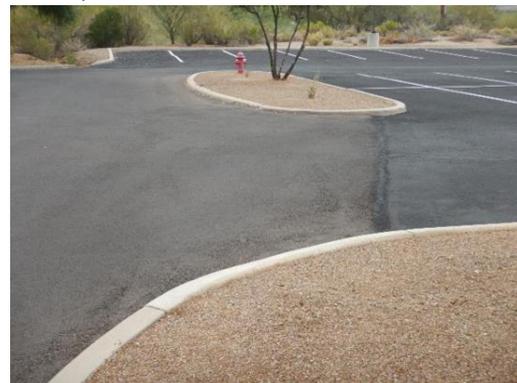
216 - Asphalt: Ongoing Repairs	Useful Life 5	Remaining Life 4	
70,468 sf Parking Lot (3%)	Quantity 70,468	Unit of Measure Square Feet	
	Cost /SqFt \$3.85	Qty * \$/SqFt \$271,302	
	% Included 2.50%	Total Cost/Study \$6,783	
Summary	Replacement Year 2026	Future Cost \$7,487

2021- \$7,720 expended to seal coat East and South lots only, approximately 48,452 sf.
 2019- North parking lot exhibits moderate linear cracking.
 2017- Remaining life extended due to seal work done in 2017.

This is for miscellaneous repairs including crackfill, skin patching and minor dig out & fill. Cracks 1/4" or wider should be filled when observed.

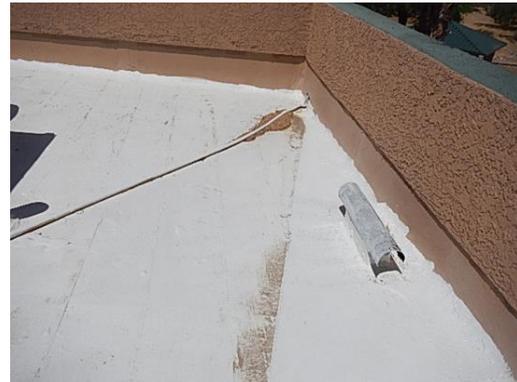
942 - Coating 19,800 sf Low Slope Roof Recoating	Useful Life 5 Remaining Life 2 Quantity 19,800 Unit of Measure Square Feet Cost /SqFt \$1.08 % Included 100.00% Total Cost/Study \$21,384 Replacement Year 2024 Future Cost \$22,467
Summary

2019- \$6,672 was expended to coat part of the roof prior to solar installation per client 6/14/2019.

This to prepare the roof and apply a coating to extend the roof's serviceable life by protecting against ponding water and ultraviolet rays.

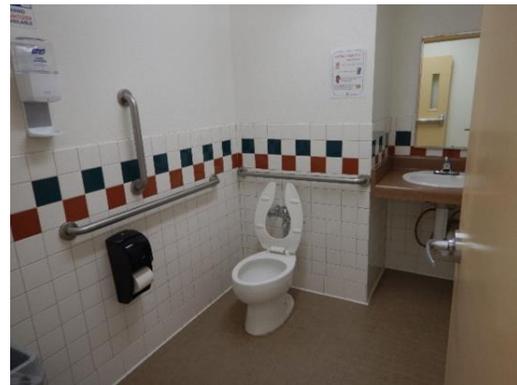
318 - Restrooms	Useful Life 20	Remaining Life 17
2 Racquetball Court Restrooms	Quantity 2	Unit of Measure Room
	Cost /Rm \$7,200	
	% Included 100.00%	Total Cost/Study \$14,400
Summary	Replacement Year 2039	Future Cost \$21,911

2019- These restrooms appear dated and worn. \$13,192 was expended per client 6/14/2019.

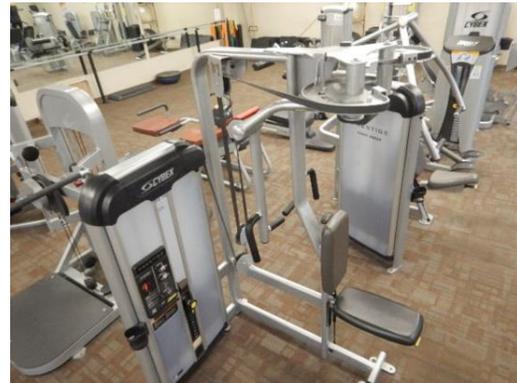
310 - Exercise: Strength Equipment	Useful Life 8	Remaining Life 1
23 Fitness Center Strength Machines (50%)	Quantity 23	Unit of Measure Items
	Cost /Itm \$4,704	Qty * \$/Itm \$108,189
	% Included 50.00%	Total Cost/Study \$54,094
Summary	Replacement Year 2023	Future Cost \$55,447

This is to periodically replace strength equipment on a percentage basis. Cardio equipment is provided for within other components.

- 1- MuscleD classic
- 1- Cybex leg press
- 1- Cybex let curl
- 1- Cybex leg extension
- 1- Cybex fly rear deltoid
- 1- Cybex chest press
- 1- Cybex back extension
- 1- Paramount lat pull down
- 1- Paramount multi hip
- 1- Precor stretch trainer
- 1- Technogym low row
- 1- Technogym hip abductor
- 1- Technogym hip adductor
- 1- Technogym chin dip
- 1- Technogym posterior flexibility
- 1- Technogym anterior flexibility
- 1- Hoist mid row
- 1- Hoist seat swivel
- 1- Radiant multi station
- 1- Hoist dumbbell rack
- 3- benches

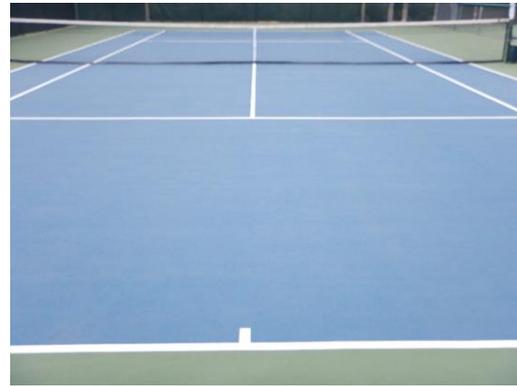
120 - Reseal	Useful Life 4	Remaining Life 2	
14,000 sf [2] Tennis Courts	Quantity 14,000	Unit of Measure	Square Feet
	Cost /SqFt \$0.710		
	% Included 100.00%	Total Cost/Study	\$9,940
Summary	Replacement Year 2024	Future Cost	\$10,443

This is to prepare the courts, repair cracks with acrylic crack patch, paint with epoxy coating mixed with silica sand, and restripe. These courts are post-tensioned concrete and don't require overlay.

2022- Courts appear in good condition, BRG extended remaining life to 2024.
 2019- Per client 6/14/2019, post-tensioned concrete courts were installed in 2018. 4-year useful life and \$4,700/court estimate per client 7/22/2019 estimate.

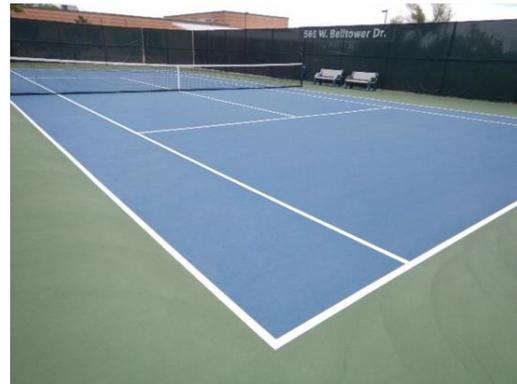
520 - Resurface	Useful Life 21	Remaining Life 17	
14,000 sf [2] Tennis Courts	Quantity 14,000	Unit of Measure	Square Feet
	Cost /SqFt \$3.20		
	% Included 100.00%	Total Cost/Study	\$44,800
Summary	Replacement Year 2039	Future Cost	\$68,168

This is to resurface the tennis courts utilizing an overlay, color coat and striping.

2019- Per client 6/14/2019, overlaid w/ post-tensioned concrete in 2018 per client 6/14/2019.
 2018- \$36,387 was expended for scope of work.

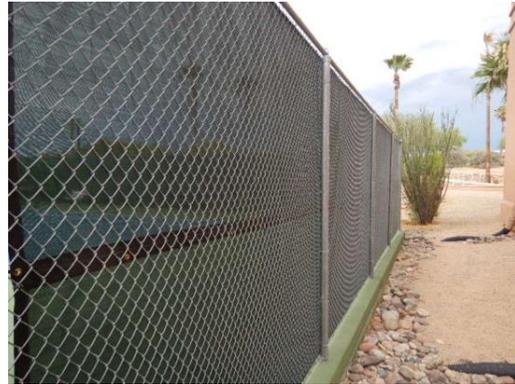
140 - Chain Link: 10'	Useful Life 30	Remaining Life 12	
600 lf Tennis Court Fence	Quantity 600	Unit of Measure Linear Feet	
	Cost /l.f. \$42.00		
	% Included 100.00%	Total Cost/Study \$25,200	
Summary	Replacement Year 2034	Future Cost \$33,891

This is to replace the 10' chain link fencing.

10' perimeter fence- 540 lf
 4' interior fence- 60 lf
 4- gates

2022- Fencing and gates appear in fair condition, BRG extended remaining life to 2034.

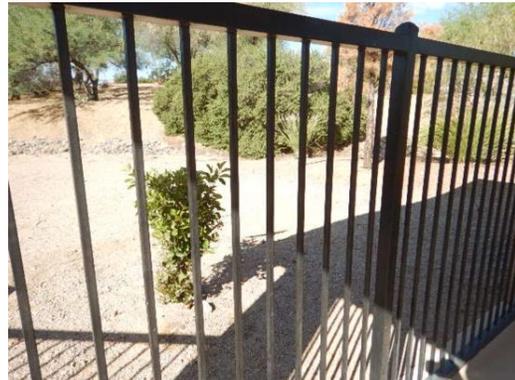
210 - Wrought Iron: 5'	Useful Life 30	Remaining Life 5	
315 lf Pool Area Fencing	Quantity 315	Unit of Measure Linear Feet	
	Cost /l.f. \$40.00		
	% Included 100.00%	Total Cost/Study \$12,600	
Summary	Replacement Year 2027	Future Cost \$14,256

This is to replace the 5' wrought iron fencing. With aggressive paint maintenance, this component's life may be extended. Painting is provided for within another component.

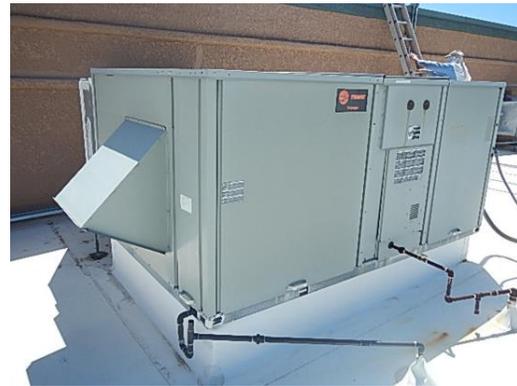
212 - HVAC	Useful Life 15	Remaining Life 2	
11 Rooftop Trane Units- 2008	Quantity 11	Unit of Measure	Items
	Cost /Itm \$14,907		
	% Included 100.00%	Total Cost/Study	\$163,977
Summary	Replacement Year 2024	Future Cost	\$172,278

This is to replace the Trane HVAC systems. It is possible that sub-components of these systems can be replaced or rebuilt to extend their life.

- Unit 1- Acacia- Trane- 3.5T
- Unit 2- Cypress- Trane- 3.5T
- Unit 3- Lobby- Trane- 3.5T
- Unit 4- Cottonwood- Trane 4.5T
- Unit 5- Iron Wood- Trane- 5T
- Unit 6- Kitchen- Trane- 5T
- Unit 7- Bathrooms- Trane- 2.5T
- Unit 8- Ocotillo- Trane- 12.5T
- Unit 9- Agave- Trane 10T
- Unit 10- Juniper- Trane- 12.5T
- Unit 11- Fitness- Trane- 10T

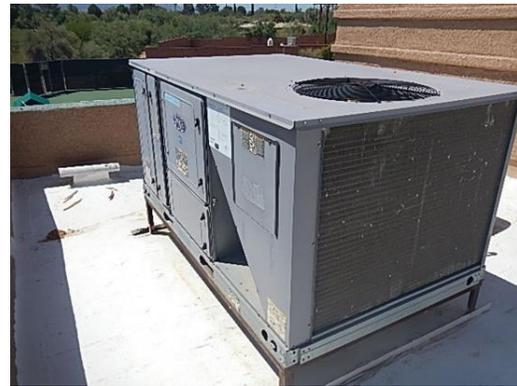
292 - HVAC	Useful Life 15	Remaining Life 3	
4 Rooftop Carrier Units- 2010	Quantity 4	Unit of Measure	Items
	Cost /Itm \$13,467		
	% Included 100.00%	Total Cost/Study	\$53,868
Summary	Replacement Year 2025	Future Cost	\$58,010

This is to replace the Carrier HVAC systems. It is possible that sub-components of these systems can be replaced or rebuilt to extend their life.

- Unit 12- Fitness- Carrier- 6T
- Unit 13- Lobby- Carrier- 3T
- Unit 14- Locker Room- Carrier- 5T
- Unit 15- Racquetball Courts 1 & 2- Carrier- 5T

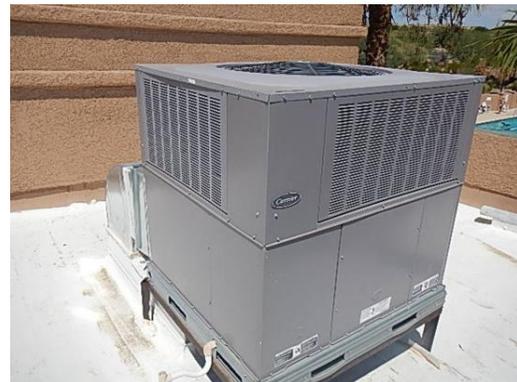
328 - HVAC	Useful Life 15	Remaining Life 7	
Rooftop Carrier Unit #16- 2014	Quantity 1	Unit of Measure	Items
	Cost /Itm \$11,200		
	% Included 100.00%	Total Cost/Study	\$11,200
Summary	Replacement Year 2029	Future Cost	\$13,313

This is to replace the Carrier HVAC system. It is possible that sub-components of this system can be replaced or rebuilt to extend its life.

- Unit 16- Racquetball Lobby, men's & women's restrooms- Carrier- 4T

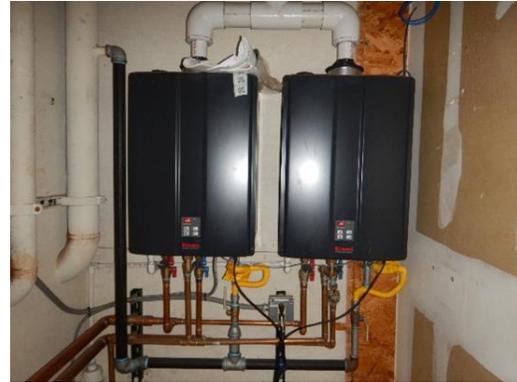
612 - Water Heater	Useful Life 12	Remaining Life 11	
2 Rennai Tankless Heaters	Quantity 2	Unit of Measure	Items
	Cost /Itm \$5,795		
	% Included 100.00%	Total Cost/Study	\$11,590
Summary	Replacement Year 2033	Future Cost	\$15,207

This is to replace the tankless water heater including discarded unit disposal.

2021- \$11,144 expended to replace solar water heater w/ 2 Rennai tankless heaters.

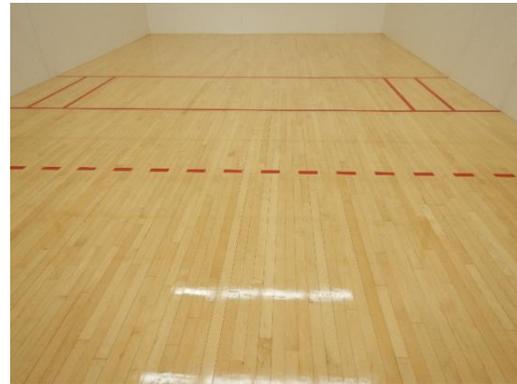
700 - Hardwood Floors	Useful Life 25	Remaining Life 7	
1,600 sf [2] Racquetball Courts- Replace	Quantity 1,600	Unit of Measure Square Feet	
	Cost /SqFt \$16.48		
	% Included 100.00%	Total Cost/Study \$26,368	
Summary	Replacement Year 2029	Future Cost \$31,343

2022- Well maintained appearance continues.

2019- The hardwood floors appear in well maintained condition. Good buff and finish.

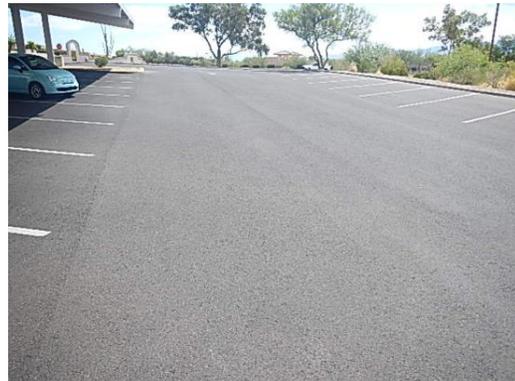
120 - Asphalt: Sealing	Useful Life 5	Remaining Life 2	
104,016 sf Drives & Parking	Quantity 104,016	Unit of Measure	Square Feet
	Cost /SqFt \$0.250		
	% Included 100.00%	Total Cost/Study	\$26,004
Summary	Replacement Year 2024	Future Cost	\$27,320

This is to prepare the surface, apply a single coat asphalt emulsion product and restripe to match the existing layout. If a second coat is desired the cost is generally 10% to 20% higher.

2019- The parking lot west of the complex appears recently sealed, crack filled and striped. The south parking lot appears dull and gray. \$12,450 was expended per client 6/14/2019.

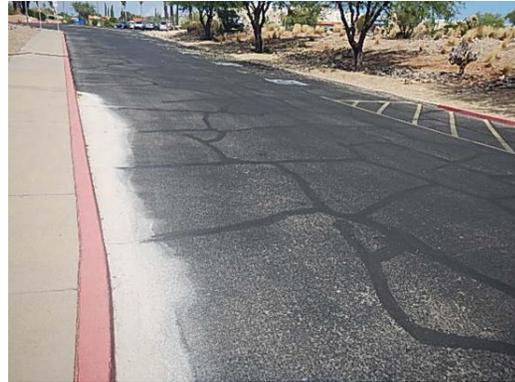
220 - Asphalt: Ongoing Repairs 104,016 sf Drives & Parking (3%)	Useful Life 5 Remaining Life 2 Quantity 104,016 Cost /SqFt \$3.85 % Included 2.50%	Unit of Measure Square Feet Qty * \$/SqFt \$400,462 Total Cost/Study \$10,012 Future Cost \$10,518
Summary	Replacement Year 2024

This is for miscellaneous repairs including crackfill, skin patching and minor dig out & fill. Cracks 1/4" or wider should be filled when observed.

2019- The parking lot west of the complex appears recently sealed, crack filled and striped. The south parking lot appears dull and gray. Per client 7/22/2019, extend remaining life from 2020 to 2024.

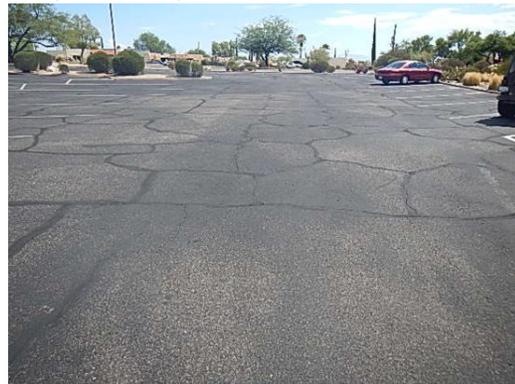
328 - Asphalt: Overlay w/ Interlayer 71,286 sf Upper Parking Area & Drive	Useful Life 25 Remaining Life 7 Quantity 71,286 Cost /SqFt \$2.10 % Included 100.00%	Unit of Measure Square Feet Total Cost/Study \$149,701 Future Cost \$177,947
Summary	Replacement Year 2029

This is to apply a paving fabric interlayer to the existing asphalt surface and overlay with a minimum of 1.5" of new hot mix asphalt. Generally this includes edge grinding and utility box extensions.

2022- The upper parking area & drive appear older than 2014. Association input will help further define this component. BRG separated upper & lower parking areas into separate components.

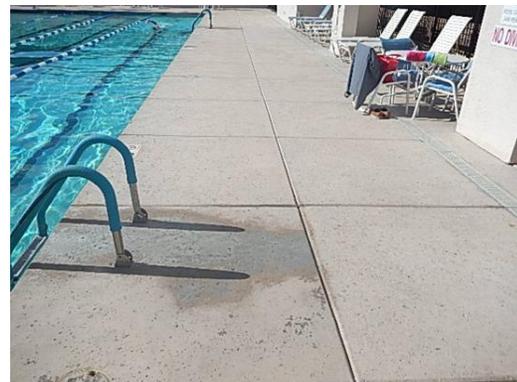
414 - Pool Deck 5,981 sf Pool/Spa Area Concrete Repair (7.5%)	Useful Life 5 Remaining Life 4 Quantity 5,981 Unit of Measure Square Feet Cost /SqFt \$23.50 Qty * \$/SqFt \$140,554 % Included 7.50% Total Cost/Study \$10,542 Replacement Year 2026 Future Cost \$11,636
Summary

This is to periodically repair and replace concrete pool deck, deck drains and deck mastic to remove abrupt elevation shifts and to maintain functionality. Since concrete pool deck useful life typically exceeds the scope of the 30-year study, this component provides for repair only and not full replacement. However, as the deck ages and undergoes multiple repairs and patches, this component may revert from occasional partial repairs to full replacement. Deck acrylic lace coating replacement is provided for within another component.

2022- \$4,000 was expended. Move remaining life from 2022 to 2023.

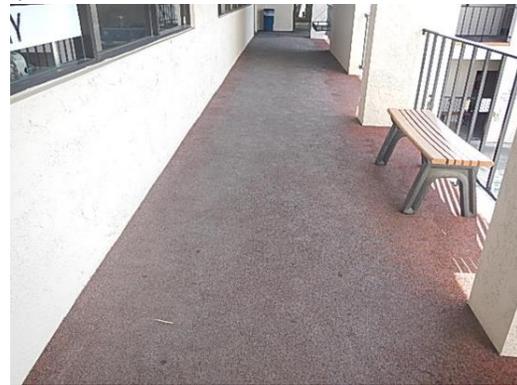
200 - Resurface	Useful Life 18	Remaining Life 1	
1,778 sf Second Floor Deck	Quantity 1,778	Unit of Measure	Square Feet
	Cost /SqFt \$16.39		
	% Included 100.00%	Total Cost/Study	\$29,141
Summary	Replacement Year 2023	Future Cost	\$29,870

This is to resurface the 2nd floor deck.

2021- Per client 6/1/2021, move remaining life from 2021 to 2023, per Facility Director.
 2019- Per client 6/14/2019, current estimate is \$15/sf and extend remaining life from 2019 to 2021.
 2017- 18 year useful life and 2019 remaining life estimates per client.

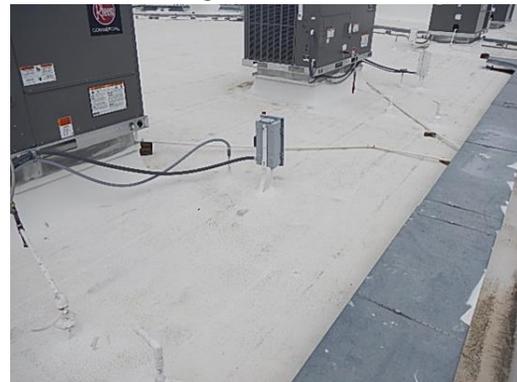
324 - Low Slope: Vinyl	Useful Life 20	Remaining Life 2	
137 Squares- Roof Replacement	Quantity 137	Unit of Measure	Squares
	Cost /Sqrs \$710		
	% Included 100.00%	Total Cost/Study	\$97,270
Summary	Replacement Year 2024	Future Cost	\$102,194

This is to replace the low slope single-ply vinyl roofing system. All roofs should be regularly inspected and repaired as indicated to ensure maximum life.

2021- Per client 6/30/2021, \$5,860 was expended for repairs.
 2019- Water filled blister on roof noted. Client reports roof leaks over the stage.

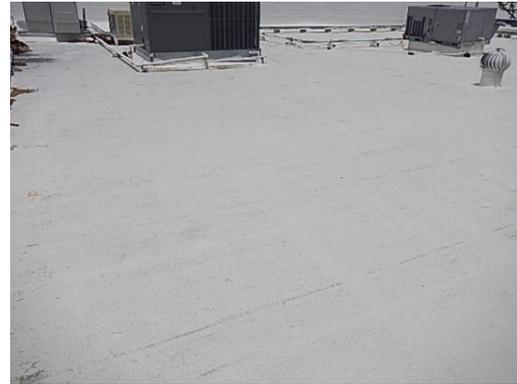
946 - Coating	Useful Life 5	Remaining Life 0
13,700 sf Low Slope Roof Recoating	Quantity 13,700	Unit of Measure Square Feet
	Cost /SqFt \$1.07	
	% Included 100.00%	Total Cost/Study \$14,659
Summary	Replacement Year 2022	Future Cost \$14,659

2019- Per client 6/14/2019, MSC building given 5 year life, so all coating components were adjusted to 5 year useful life.

2017- Client advised the recoat was done in 2016 and also the life should be extended from 5 to 10 years.

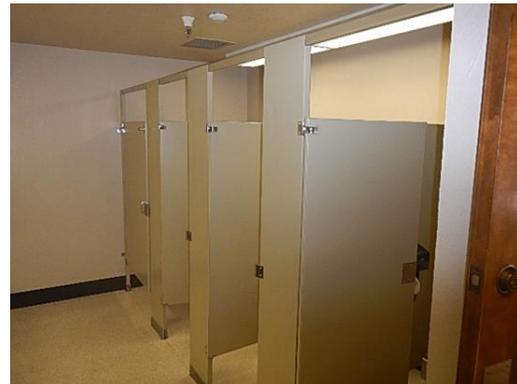
324 - Restrooms	Useful Life 20	Remaining Life 2
2 Auditorium Lobby Restrooms	Quantity 2	Unit of Measure Room
	Cost /Rm \$16,390	
	% Included 100.00%	Total Cost/Study \$32,780
Summary	Replacement Year 2024	Future Cost \$34,439

This is to rehab and redecorate the restrooms including items such as partitions, fixtures, lighting, tile, etc. Client input will further define this component.

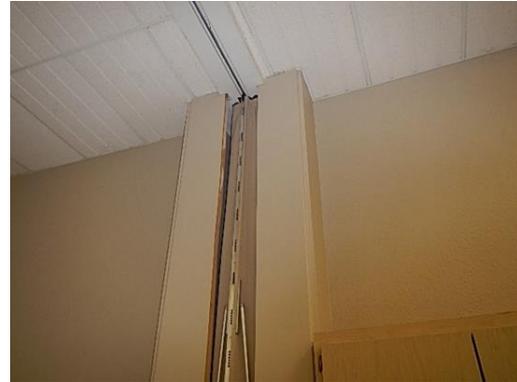
570 - Operable Wall/Partition	Useful Life 21	Remaining Life 12	
770 sf [4] Room Dividers	Quantity 770	Unit of Measure	Square Feet
	Cost /SqFt \$47.07		
	% Included 100.00%	Total Cost/Study	\$36,244
Summary	Replacement Year 2034	Future Cost	\$48,744

This is to repair and replace the operable walls/partitions.

- 1- 18' x 14' dining area divider
- 1- 12' x 14' kitchen/auditorium divider
- 2- 12.5' x 14' dining/auditorium dividers (pair)

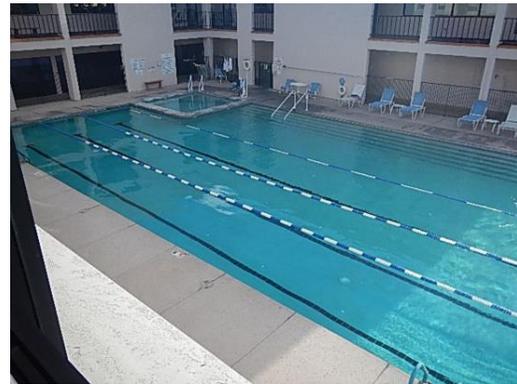
118 - Resurface	Useful Life 12	Remaining Life 16
260 lf Pool	Quantity 260	Unit of Measure Linear Feet
	Cost /l.f. \$188	
	% Included 100.00%	Total Cost/Study \$48,880
Summary	Replacement Year 2038	Future Cost \$72,563

This is to resurface the pool including start-up costs.

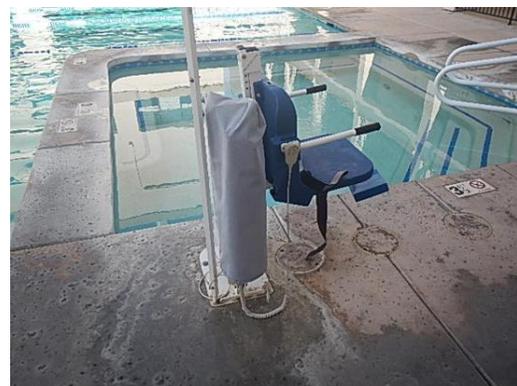
404 - ADA Chair Lift	Useful Life 10	Remaining Life 5
2 Pool & Spa Chair Lifts	Quantity 2	Unit of Measure Items
	Cost /itm \$6,720	
	% Included 100.00%	Total Cost/Study \$13,440
Summary	Replacement Year 2027	Future Cost \$15,206

This is to replace the spa & pool's ADA compliant chair lift.
