Reserve Study Transmittal Letter

Re: Green Valley Recreation Inc; Update w/ Site Visit Review

RESERVE STUDY

Update w/ Site Visit Review

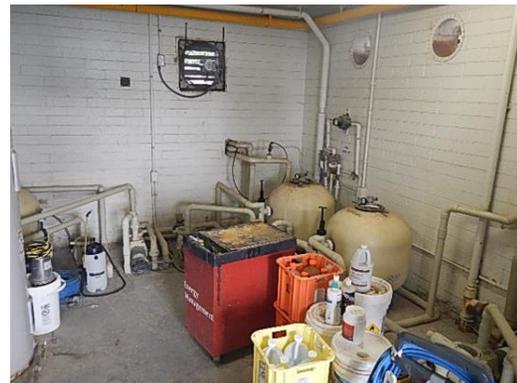
742 - Equipment: Replacement	Useful Life 5	Remaining Life 0	
Pool & Spa Equipment (50%)	Quantity 1	Unit of Measure Lump Sum	
	Cost /LS \$56,036	Qty * \$/LS \$56,036	
	% Included 50.00%	Total Cost/Study \$28,018	
Summary	Replacement Year 2022	Future Cost \$28,018

This is to periodically replace the pool and spa equipment. Since not all equipment will fail simultaneously, this component provides for one half replacement every five years.

- 1- pool filter #1, Pentair Triton II Commercial
- 1- pool filter #2, Pentair Triton II Commercial
- 1- pool filter #3, Pentair Triton II Commercial
- 1- spa filter, Pentair Triton II Commercial
- 4- Pentair IntelliFlo Variable Speed pumps
- 2- additional spa pumps
- 1- Pool Vacuum
- 1- pool heater #1, Raypak Professional
- 1- pool heater #2, Raypak Professional
- 1- pool heater #3, Raypak Professional
- 1- pool heater #4, Raypak Professional
- 1- spa heater, Raypak Professional
- 1- pool Aquasol chemical controller
- 1- spa Aquasol chemical controller
- 1- Clear Comfort advanced oxidation system
- Assorted- chemical system probes, fittings, chem pumps, injectors, etc.
- Assorted- pipes, fittings, controls, lights, drain covers, hand rails, etc.

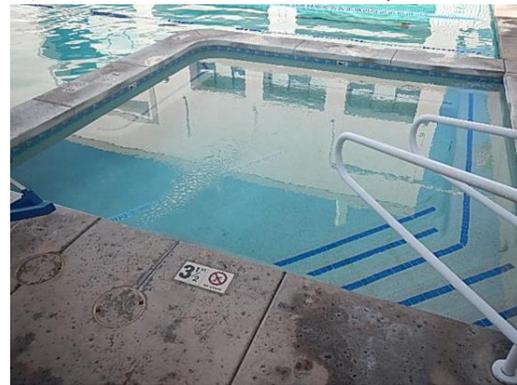
122 - Resurface	Useful Life 8	Remaining Life 0	
Spa	Quantity 1	Unit of Measure Items	
	Cost /Itm \$10,000		
	% Included 100.00%	Total Cost/Study \$10,000	
Summary	Replacement Year 2022	Future Cost \$10,000

2022- \$10,000 total is anticipated. \$9,090 was expended by May and \$910 is anticipated for work currently in progress.

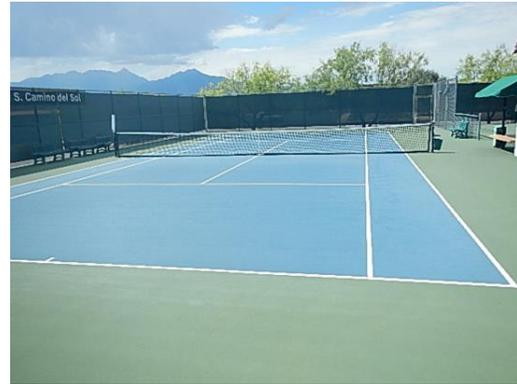
130 - Reseal	Useful Life 4	Remaining Life 1
28,800 sf [4] Tennis Courts	Quantity 28,800	Unit of Measure Square Feet
	Cost /SqFt \$0.710	
	% Included 100.00%	Total Cost/Study \$20,448
Summary	Replacement Year 2023	Future Cost \$20,959

This is to prepare the courts, repair cracks with acrylic crack patch, paint with epoxy coating mixed with silica sand, and restripe. These courts are post-tensioned concrete and don't require overlay.

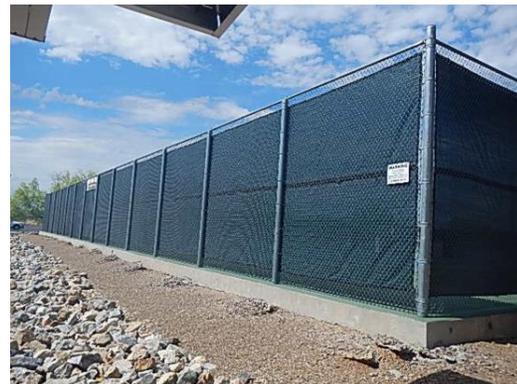
150 - Chain Link: 10'	Useful Life 30	Remaining Life 9
960 lf Tennis Court Fence	Quantity 960	Unit of Measure Linear Feet
	Cost /l.f. \$42.00	
	% Included 100.00%	Total Cost/Study \$40,320
Summary	Replacement Year 2031	Future Cost \$50,354

This is to replace the 10' chain link fencing.

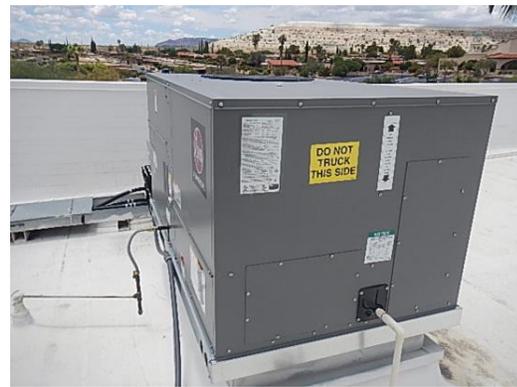
216 - HVAC	Useful Life 15	Remaining Life 0	
4 Rooftop Rheem Units- 2022	Quantity 4	Unit of Measure Items	
	Cost /Itm \$10,539		
	% Included 100.00%	Total Cost/Study \$42,157	
Summary	Replacement Year 2022	Future Cost \$42,157

This is to replace the Rheem HVAC systems. It is possible that sub-components of these systems can be replaced or rebuilt to extend their life.

- Unit 1- Auditorium- Rheem- 5T
- Unit 2- Auditorium- Rheem- 5T
- Unit 3- Auditorium- Rheem- 5T
- Unit 4- Auditorium- Rheem- 5T

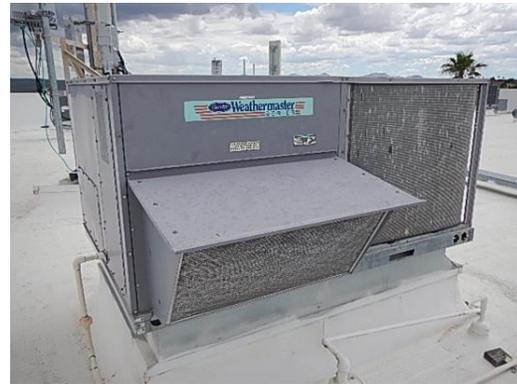
332 - HVAC	Useful Life 15	Remaining Life 2	
3 Rooftop Carrier Units- 2009	Quantity 3	Unit of Measure	Items
	Cost /Itm \$13,112		
	% Included 100.00%	Total Cost/Study	\$39,335
Summary	Replacement Year 2024	Future Cost	\$41,327

This is to replace the Carrier HVAC systems. It is possible that sub-components of these systems can be replaced or rebuilt to extend their life.

- Unit 6- Lobby- Carrier- 4T
- Unit 7- Room A- Carrier- 7.5T
- Unit 9- Locker Room- Carrier- 4T

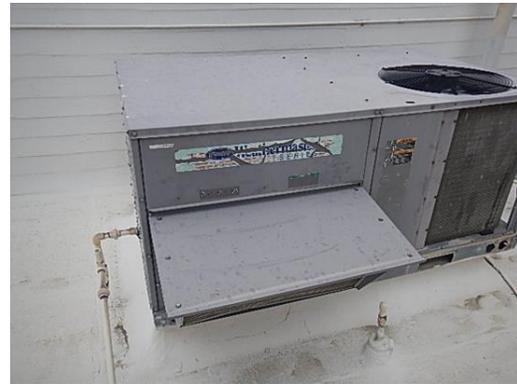
388 - HVAC	Useful Life 15	Remaining Life 6	
3 Rooftop Carrier Units- 2013	Quantity 3	Unit of Measure	Items
	Cost /Itm \$13,440		
	% Included 100.00%	Total Cost/Study	\$40,319
Summary	Replacement Year 2028	Future Cost	\$46,757

This is to replace the Carrier HVAC systems. It is possible that sub-components of these systems can be replaced or rebuilt to extend their life.

- Unit 10- Ceramics- Carrier- 5T
- Unit 13- Art Room- Carrier- 5T
- Unit 14- Room C- Carrier- 4T

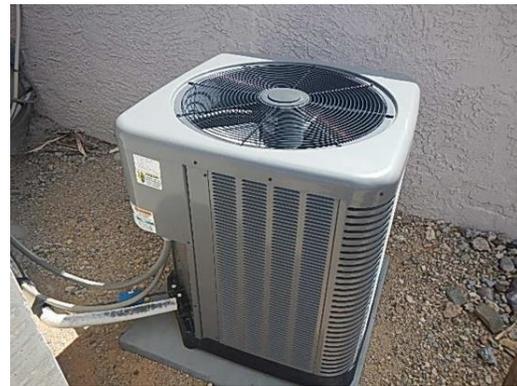
444 - HVAC	Useful Life 15	Remaining Life 12
Ground Level Rheem Unit 17A/B- 2003	Quantity 1	Unit of Measure Items
	Cost /Itm \$5,177	
	% Included 100.00%	Total Cost/Study \$5,177
Summary	Replacement Year 2034	Future Cost \$6,962

Billiards Room- Rheem 3T MN RP1536AJ1NA mfg 12/2018

2019- Per client 6/14/2019, replaced in 2018 for \$4,622 of which half was paid in 2018 and 2019. Unit observed during the 2019 reserve site visit was the old 2003 unit. Per client 7/16/2019, the replacement process began in 2018 and is expected to complete in 2019.

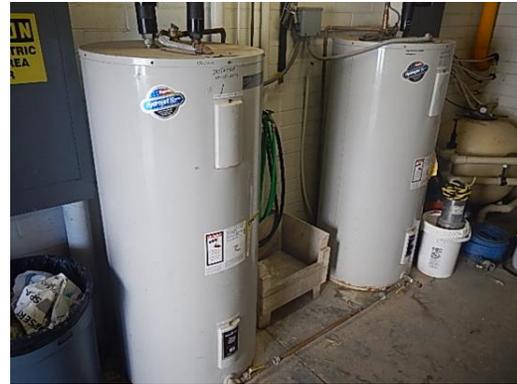
604 - Water Heater	Useful Life 12	Remaining Life 3	
2 Pool Equipment Area Water Heaters	Quantity 2	Unit of Measure	Items
	Cost /Itm \$3,934		
	% Included 100.00%	Total Cost/Study	\$7,867
Summary	Replacement Year 2025	Future Cost	\$8,472

2- Bradford White, 120 Gallon water heaters, dated 3-15-2013.

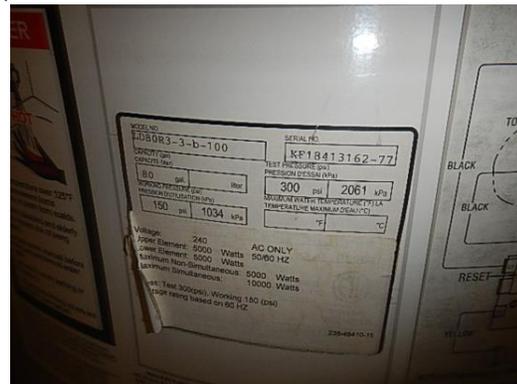
632 - Water Heater	Useful Life 15	Remaining Life 6	
Men's Restroom's Janitor's Closet	Quantity 1	Unit of Measure	Items
	Cost /Itm \$1,800		
	% Included 100.00%	Total Cost/Study	\$1,800
Summary	Replacement Year 2028	Future Cost	\$2,087

Bradford White, 80 gallon, electric, MN LD80R3-3-b-100, SN KF17413162-77, mfg. 2013

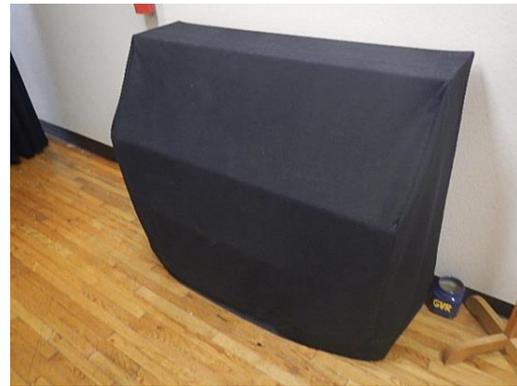
Yamaha upright
 model- T121
 serial #- 6058452

2017- Per client, \$7,500 was expended in 2005.

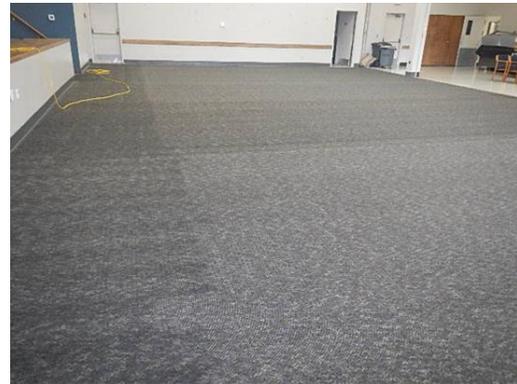
240 - Carpeting	Useful Life 10	Remaining Life 7	
670 Sq. Yds. Clubhouse Carpet	Quantity 670	Unit of Measure	Square Yard
	Cost /SqYd \$51.50		
	% Included 100.00%	Total Cost/Study	\$34,505
Summary	Replacement Year 2029	Future Cost	\$41,016

This is to replace the carpeting.

2019- \$21,672 was expended to replace 670 yards in 2019 with remaining anticipated in 2020 per client 6/14/2019. Per client 7/22/2019, increase estimate from \$21,672 to \$31,537.
 2017- Client advises the auditorium carpet will be replaced in 2019.
 2009- Carpet installed.

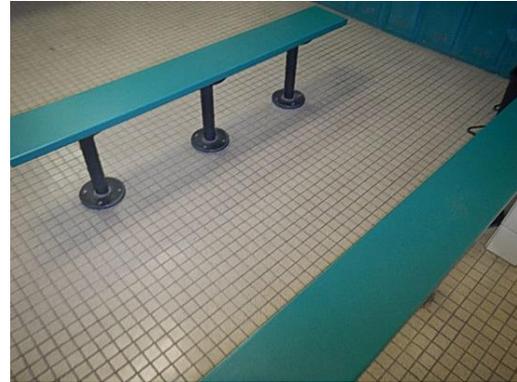
440 - Tile	Useful Life 20	Remaining Life 1	
975 sf Clubhouse Walls & Floors	Quantity 975	Unit of Measure	Square Feet
	Cost /SqFt \$31.02		
	% Included 100.00%	Total Cost/Study	\$30,245
Summary	Replacement Year 2023	Future Cost	\$31,001

This is to replace the wall and floor tile.

2022- Per client, move remaining life from 2022 to 2023.
 2020- Per client 8/6/2020, extend remaining life from 2021 to 2022.
 2019- Per client 6/14/2019, increase estimate from \$12,675 to \$27,675.

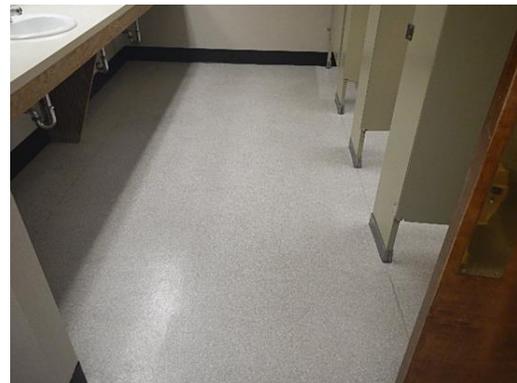
630 - Vinyl	Useful Life 15	Remaining Life 2	
566 Sq. Yds. Clubhouse Vinyl	Quantity 566	Unit of Measure	Square Yard
	Cost /SqYd \$30.60		
	% Included 100.00%	Total Cost/Study	\$17,320
Summary	Replacement Year 2024	Future Cost	\$18,196

This is to replace the vinyl flooring.

2021- Per client 6/1/2021, change quantity from 650 to 566 square yds, remove 83.33 sy of VCT and replaced with carpet, see component 50/25000/244.

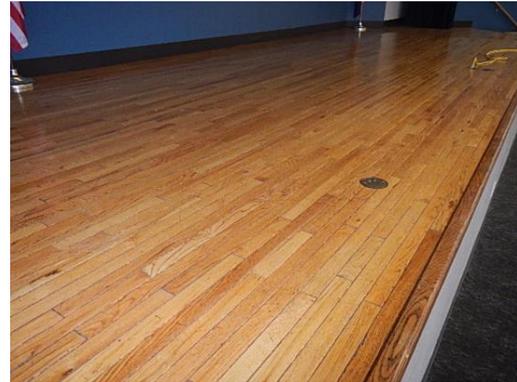
710 - Hardwood Floors	Useful Life 50	Remaining Life 9
500 sf Stage- Replace	Quantity 500	Unit of Measure Square Feet
	Cost /SqFt \$17.65	
	% Included 100.00%	Total Cost/Study \$8,825
Summary	Replacement Year 2031	Future Cost \$11,021

This is to replace the hardwood flooring. Refinishing is provided from operating.

2016- The floor appears in good condition.

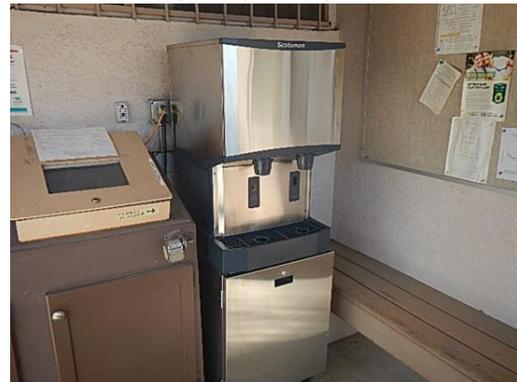
160 - Ice Machine	Useful Life 10	Remaining Life 9
Tennis Courts	Quantity 1	Unit of Measure Items
	Cost /Itm \$6,469	
	% Included 100.00%	Total Cost/Study \$6,469
Summary	Replacement Year 2031	Future Cost \$8,079

Scotsman

2021- \$6,220 was expended for the ice machine. Added as a reserve study component per client direction.

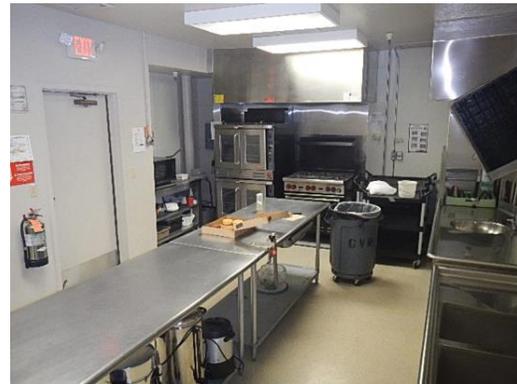
740 - Miscellaneous	Useful Life 5	Remaining Life 3
12 Kitchen Appliances (33%)	Quantity 12	Unit of Measure Items
	Cost /Itm \$4,245	Qty * \$/Itm \$50,939
	% Included 33.33%	Total Cost/Study \$16,980
Summary	Replacement Year 2025	Future Cost \$18,285

This is to repair or replace miscellaneous appliances.

- 1- True reach-in freezer, MN T-19F, SN 7310194, mfg. 2012
- 1- True reach-in refrigerator, MN T-23, SN 7295434, mfg. 2012
- 1- Scotsman ice machine, MN C0530SA-1E, SN 18041320012079, bin, MN B530S, SN 18061320014191, mfg. 2018
- 1- Captive-Aire Systems SS Hood, MN 4230 ND
- 1- Ansul fire suppression system
- 1- Salvajor disposer
- 1- Wolf double stack oven
- 1- Wolf 6-burner range
- 1- stainless dishwash table
- 1- stainless triple sink
- 2- stainless tables

2019- Traulsen freezer and refrigerator units replaced with 2012 True units since 2016 reserve site visit.

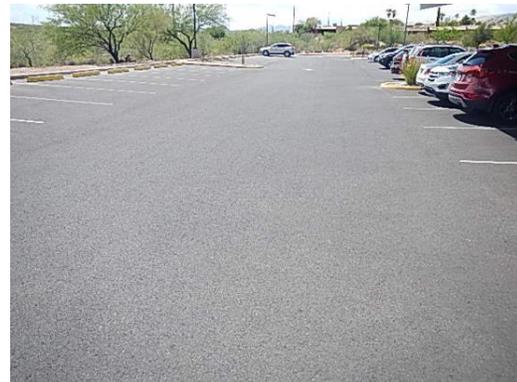
124 - Asphalt: Sealing	Useful Life 5	Remaining Life 4	
67,354 sf Parking Lot	Quantity 67,354	Unit of Measure	Square Feet
	Cost /SqFt \$0.250		
	% Included 100.00%	Total Cost/Study	\$16,839
Summary	Replacement Year 2026	Future Cost	\$18,587

2021- \$125,784 was expended for overlay.

2019- \$10,999 was expended to seal and crackfill per client 6/14/2019.

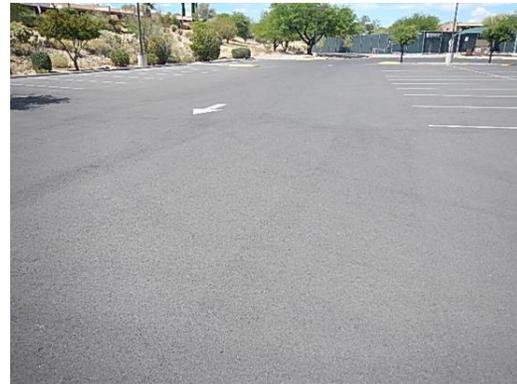
224 - Asphalt: Ongoing Repairs	Useful Life 5	Remaining Life 4	
67,354 sf Parking Lot (4%)	Quantity 67,354	Unit of Measure Square Feet	
	Cost /SqFt \$3.85	Qty * \$/SqFt \$259,313	
	% Included 4.00%	Total Cost/Study \$10,373	
Summary	Replacement Year 2026	Future Cost \$11,449

This is for miscellaneous repairs including crackfill, skin patching and minor dig out & fill. Cracks 1/4" or wider should be filled when observed.

2021- \$125,784 was expended for overlay.
 2018- \$9,135 was expended.
 2017- \$4,400 was expended repairing asphalt near dumpster pad.

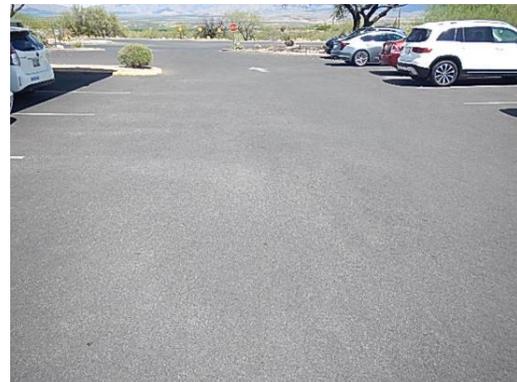
332 - Asphalt: Overlay w/ Interlayer	Useful Life 25	Remaining Life 24	
67,354 sf Parking Lot	Quantity 67,354	Unit of Measure Square Feet	
	Cost /SqFt \$2.10		
	% Included 100.00%	Total Cost/Study \$141,443	
Summary	Replacement Year 2046	Future Cost \$255,832

This is to apply a paving fabric interlayer to the existing asphalt surface and overlay with a minimum of 1.5" of new hot mix asphalt. Generally this includes edge grinding and utility box extensions.

2021- \$125,784 was expended for overlay.
 2019- Sealing and crack fill completed, BRG extended remaining life to 2023.
 2018- Per client, defer from 2018 to 2020.

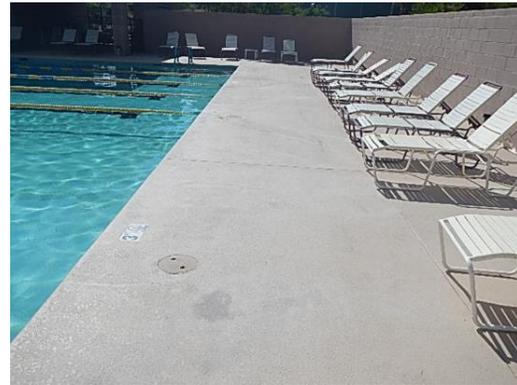
424 - Pool Deck	Useful Life 2	Remaining Life 2	
5,950 sf Pool/Spa Area Concrete Repair (6%)	Quantity 5,950	Unit of Measure Square Feet	
	Cost /SqFt \$23.50	Qty * \$/SqFt \$139,825	
	% Included 6.00%	Total Cost/Study \$8,389	
Summary	Replacement Year 2024	Future Cost \$8,814

This is to periodically repair and replace concrete pool deck, deck drains and deck mastic to remove abrupt elevation shifts and to maintain functionality. Since concrete pool deck useful life typically exceeds the scope of the 30-year study, this component provides for repair only and not full replacement. However, as the deck ages and undergoes multiple repairs and patches, this component may revert from occasional partial repairs to full replacement. Deck acrylic lace coating replacement is provided for within another component.

2021- Per client 6/30/2021, extend remaining life from 2022 to 2024.
 2020- \$20,724 was expended for deck resurface. Per client 8/6/2020, reduce remaining life from 2024 to 2022.
 2017- \$2,073 was expended to repair deck at spa. Per client 7/22/2019, decrease useful life from 5 to 2 years.

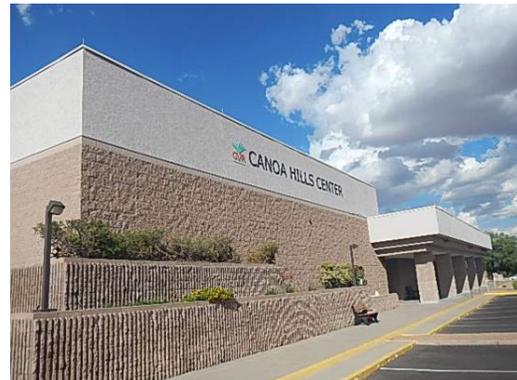
130 - Stucco	Useful Life 10	Remaining Life 8	
10,940 sf Building Exterior	Quantity 10,940	Unit of Measure Square Feet	
	Cost /SqFt \$2.40		
	% Included 100.00%	Total Cost/Study \$26,256	
Summary	Replacement Year 2030	Future Cost \$31,990

This is to prepare, power wash, sand, scrape, caulk and paint the stucco surfaces with a premium paint.

2020- \$24,580 was expended.
 2019- Per client 6/14/2019, decrease remaining life from 2021 to 2020. Per client 7/22/2019, maintain 2018 cost adjusted estimate (\$22,988 in 2018).

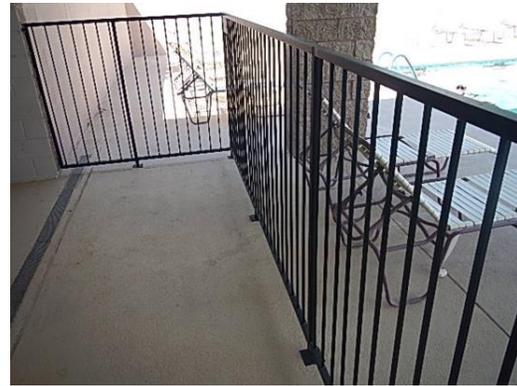
416 - Wrought Iron	Useful Life 4	Remaining Life 2	
160 lf Pool Perimeter Fence	Quantity 160	Unit of Measure Linear Feet	
	Cost /l.f. \$16.66		
	% Included 100.00%	Total Cost/Study \$2,666	
Summary	Replacement Year 2024	Future Cost \$2,801

2020- \$2,500 was expended.

2019- Per client 7/22/2019, anticipate 2020 painting in conjunction with building painting.

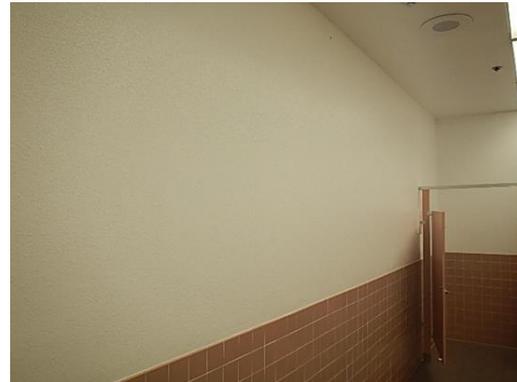
130 - Building	Useful Life 10	Remaining Life 6	
22,750 sf All Interior Spaces	Quantity 22,750	Unit of Measure Square Feet	
	Cost /SqFt \$1.30		
	% Included 100.00%	Total Cost/Study \$29,575	
Summary	Replacement Year 2028	Future Cost \$34,298

2022- \$12,000 is anticipated. Move remaining life from 2022 to 2023.

2021- Per client 6/1/2021, move remaining life from 2021 to 2022, per CEO.

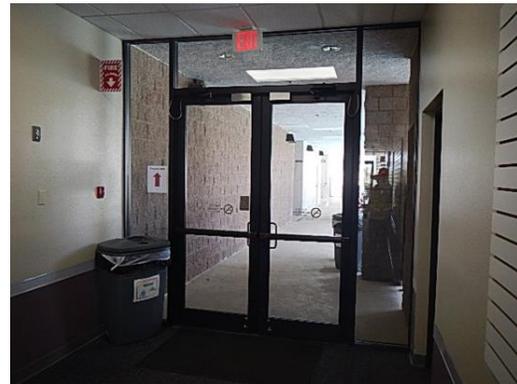
920 - Doors	Useful Life 10	Remaining Life 2	
47 Exterior & Interior Doors (25%)	Quantity 47	Unit of Measure	Items
	Cost /Itm	\$1,750	Qty * \$/Itm \$82,250
	% Included	25.00%	Total Cost/Study \$20,563
Summary	Replacement Year	2024	Future Cost \$21,603

This is to periodically repair, replace and maintain exterior and interior doors including items such as panic exit hardware, automatic door operators, door closers, frames/jambs, posts, locks/latches, etc.

17- exterior
 30- interior

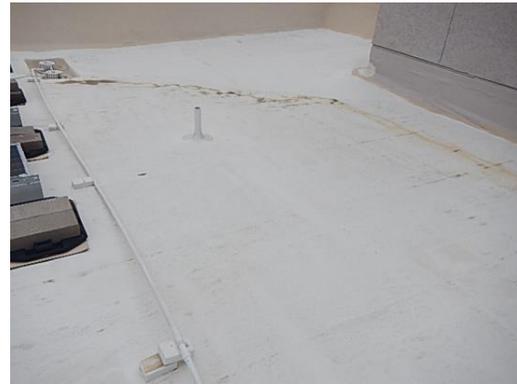
328 - Low Slope: Vinyl 227 Squares- Building Roof	Useful Life 20 Remaining Life 8 Quantity 227 Unit of Measure Squares Cost /Sqrs \$710 % Included 100.00% Total Cost/Study \$161,170 Replacement Year 2030 Future Cost \$196,370
Summary

This is to replace the low slope single-ply vinyl roofing system. All roofs should be regularly inspected and repaired as indicated to ensure maximum life.

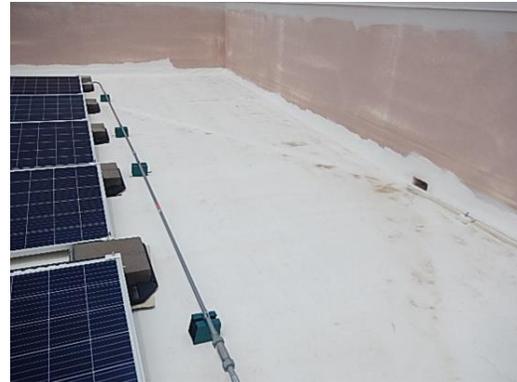
950 - Coating 22,700 sf Low Slope Roof Recoating	Useful Life 5 Remaining Life 4 Quantity 22,700 Unit of Measure Square Feet Cost /SqFt \$0.850 % Included 100.00% Total Cost/Study \$19,295 Replacement Year 2026 Future Cost \$21,298
Summary

This to prepare the roof and apply a coating to extend the roof's serviceable life by protecting against ponding water and ultraviolet rays.

2021- \$18,420 was expended for repairs and coating.
 2019- \$22,450 was expended per client 6/14/2019.

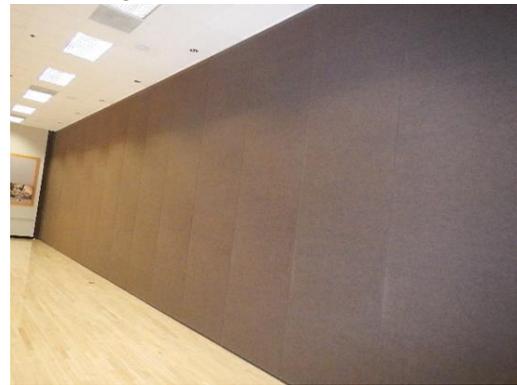
580 - Operable Wall/Partition	Useful Life 25	Remaining Life 17
980 sf Saguaro & Palo Verde Divider	Quantity 980	Unit of Measure Square Feet
	Cost /SqFt \$41.18	
	% Included 100.00%	Total Cost/Study \$40,356
Summary	Replacement Year 2039	Future Cost \$61,407

This is to replace the operable panel wall.

70'x14'

2017- Per client, operable wall installed in 2014 with a 2039 remaining life.

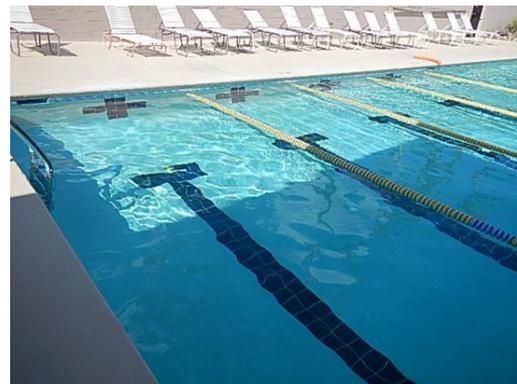
124 - Resurface	Useful Life 12	Remaining Life 2
274 lf Pool	Quantity 274	Unit of Measure Linear Feet
	Cost /l.f. \$188	
	% Included 100.00%	Total Cost/Study \$51,512
Summary	Replacement Year 2024	Future Cost \$54,120

This is to resurface the pool including start-up costs.

2012- Pool resurfaced.

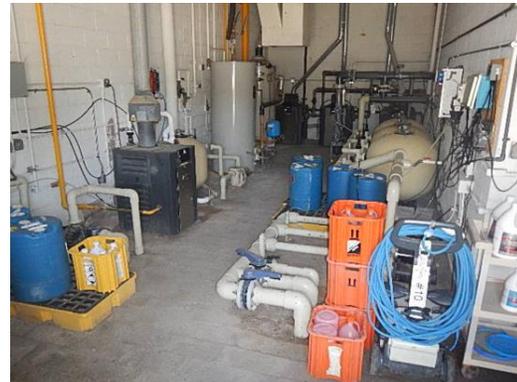
746 - Equipment: Replacement	Useful Life 5	Remaining Life 4	
Pool & Spa Equipment (50%)	Quantity 1	Unit of Measure	Lump Sum
	Cost /LS \$58,357	Qty * \$/LS	\$58,357
	% Included 50.00%	Total Cost/Study	\$29,179
Summary	Replacement Year 2026	Future Cost	\$32,208

This is to periodically replace pool and spa equipment. Since not all equipment will fail simultaneously, this component provides for one half replacement every five years.

2017- \$875 was expended. \$3,400 was expended for pool vacuum original purchase.

2016- \$31,220 total was expended to replace prior Xtherm with 4 Raypak 408 heaters.

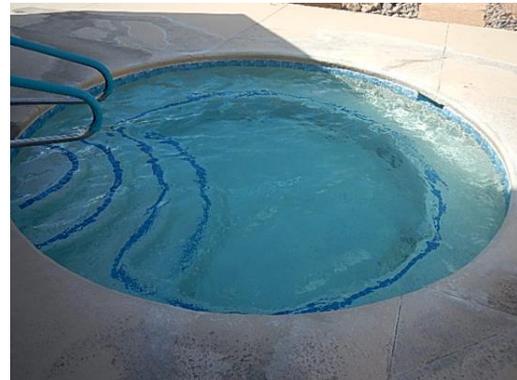
126 - Resurface	Useful Life 8	Remaining Life 4	
Spa	Quantity 1	Unit of Measure	Items
	Cost /itm \$5,764		
	% Included 100.00%	Total Cost/Study	\$5,764
Summary	Replacement Year 2026	Future Cost	\$6,362

This is to resurface the spa including start-up costs.

2019- Per client 7/22/2019, spa resurfaced 6/2018. Per client 8/5/2019, increase useful life from 6 to 8 years.

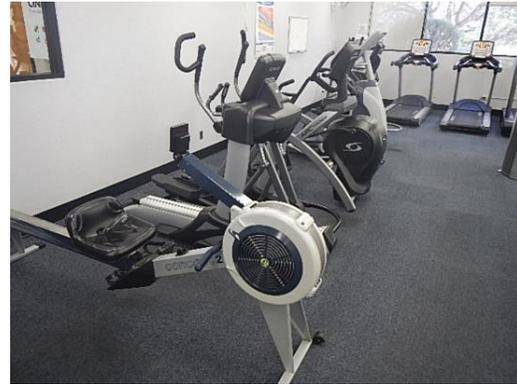
234 - Exercise: Cardio Equipment	Useful Life 3	Remaining Life 1
16 Fitness Center Cardio Machines (25%)	Quantity 16	Unit of Measure Items
	Cost /Itm \$7,005	Qty * \$/Itm \$112,080
	% Included 25.00%	Total Cost/Study \$28,020
Summary	Replacement Year 2023	Future Cost \$28,720

This is to periodically replace the cardio equipment on a percentage basis. Strength equipment is provided for within other components.

2021- \$8,000 was expended to replace 1 Cybex Arc Trainer, per Fitness Supervisor.

2020- \$20,000 was expended to replace one Woodway treadmill, one Cybex Arc Trainer and one TechnoGym rec bike.

2018- \$16,619 was expended, 2 recumbent bikes replaced.

2017- \$25,982 was expended.

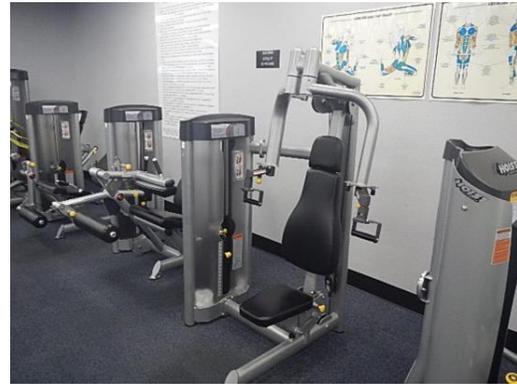
330 - Exercise: Strength Equipment	Useful Life 8	Remaining Life 1	
20 Fitness Center Strength Machines (50%)	Quantity 20	Unit of Measure Items	
	Cost /Itm \$4,707	Qty * \$/Itm \$94,133	
	% Included 50.00%	Total Cost/Study \$47,067	
Summary	Replacement Year 2023	Future Cost \$48,243

This is to periodically replace strength equipment on a percentage basis. Cardio equipment is provided for within other components.

- 1- Cybex arm extension
- 1- True rotary torso
- 1- Paramount pull-up/chin-up
- 1- Paramount lower back extension
- 1- Paramount abdominal
- 1- Paramount lat pull down
- 1- Paramount seated row
- 1- Paramount rotary chest
- 1- Paramount seated leg curl
- 1- Paramount leg extension
- 1- Paramount leg press
- 1- Paramount dip/leg lift
- 1- Paramount multi hip
- 1- Paramount chest press
- 1- Paramount pectoral fly/rear deltoid
- 1- Precor stretch trainer (2020 replaced)
- 1- Technogym hip abductor
- 1- Technogym hip adductor
- 1- Hoist Fitness shoulder press
- 1- Hoist Fitness biceps curl

2022- The Paramount leg press was out of order.
 2020- \$1,000 was expended to replace one Precor stretch trainer.
 2019- \$10,839 was expended per client 6/14/2019.
 2018- \$6,265 was expended to replace rotary torso machine.
 2017- \$10,673 was expended.

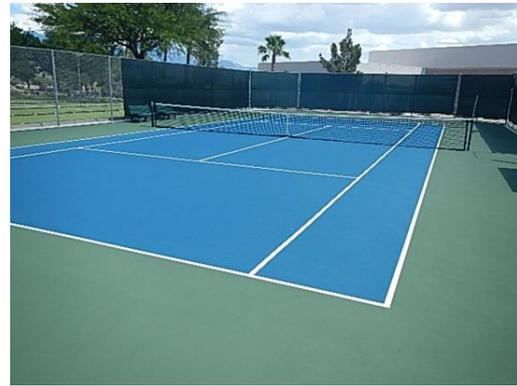
140 - Reseal	Useful Life 4	Remaining Life 2	
14,000 sf [2] Tennis Courts	Quantity 14,000	Unit of Measure Square Feet	
	Cost /SqFt \$0.710		
	% Included 100.00%	Total Cost/Study \$9,940	
Summary	Replacement Year 2024	Future Cost \$10,443

This is to prepare the courts, repair cracks with acrylic crack patch, paint with epoxy coating mixed with silica sand, and restripe. These courts are post-tensioned concrete and don't require overlay.

2020- \$9,200 was expended.
 2019- \$4,700/court every 4 years per client 7/22/2019 estimate.
 2017- Client advises done in 2016.

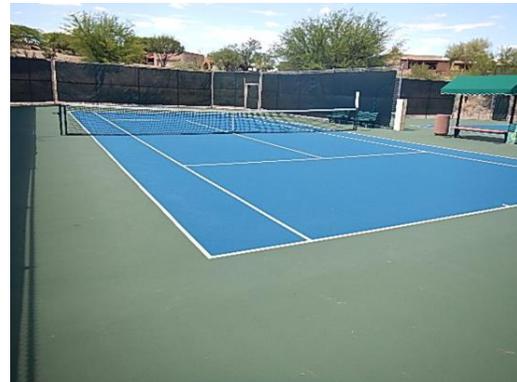
504 - Resurface	Useful Life 21	Remaining Life 10	
14,000 sf [2] Tennis Courts	Quantity 14,000	Unit of Measure Square Feet	
	Cost /SqFt \$3.20		
	% Included 100.00%	Total Cost/Study \$44,800	
Summary	Replacement Year 2032	Future Cost \$57,348

This is to resurface the tennis courts utilizing an overlay, color coat and striping.

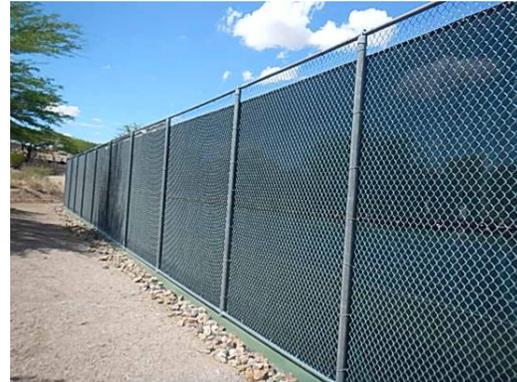
160 - Chain Link: 10'	Useful Life 30	Remaining Life 9
580 lf Tennis Court Fence	Quantity 580	Unit of Measure Linear Feet
	Cost /l.f. \$42.00	
	% Included 100.00%	Total Cost/Study \$24,360
Summary	Replacement Year 2031	Future Cost \$30,422

This is to replace the 10' chain link fencing.

2017- \$12,806 was expended.

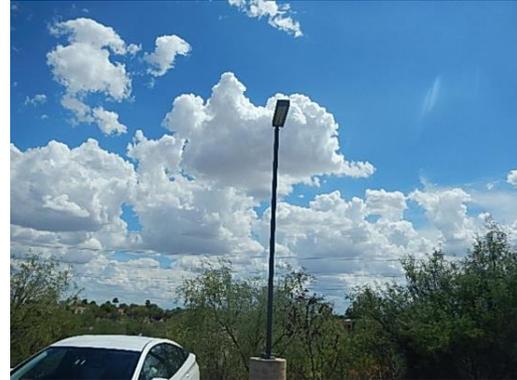
220 - Pole Lights	Useful Life 40	Remaining Life 14	
24 Parking Lot & Walkway Lights	Quantity 24	Unit of Measure	Items
	Cost /Itm \$2,942		
	% Included 100.00%	Total Cost/Study	\$70,600
Summary	Replacement Year 2036	Future Cost	\$99,756

This is to replace the pole lights reusing the existing wiring and conduits.

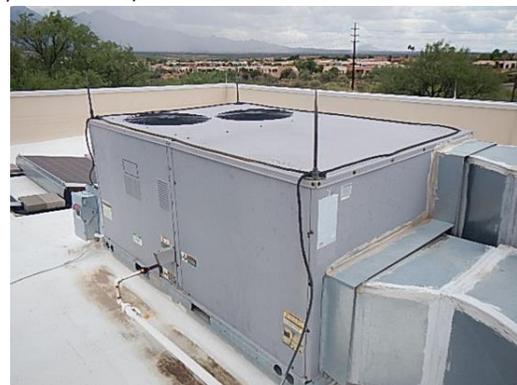
220 - HVAC	Useful Life 15	Remaining Life 1	
6 Rooftop Carrier Units- 2007	Quantity 6	Unit of Measure	Items
	Cost /Itm \$8,892		
	% Included 100.00%	Total Cost/Study	\$53,352
Summary	Replacement Year 2023	Future Cost	\$54,686

This is to replace the Carrier HVAC systems. It is possible that sub-components of these systems can be replaced or rebuilt to extend their life.

- Unit 1- Fitness- Carrier- 7.5T
- Unit 2- Locker Room-Carrier- 5T
- Unit 6- Saguaro Room- Carrier- 5T
- Unit 7- Saguaro Room- Carrier- 7.5T
- Unit 8- Palo Verde Room- Carrier- 4T
- Unit 9- Palo Verde Room- Carrier- 5T

2021- Changed quantity from 7 to 6, Unit #4 was replaced, see 23000/230.

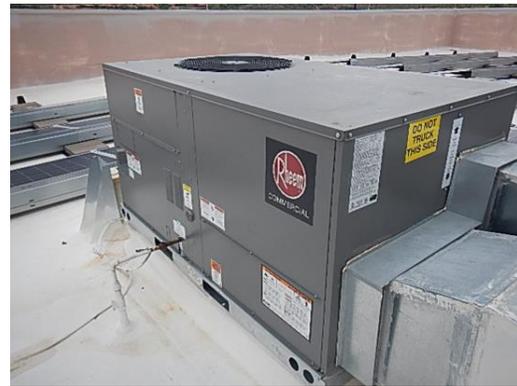
230 - HVAC	Useful Life 15	Remaining Life 14	
Rooftop Carrier Unit #4- 2021	Quantity 1	Unit of Measure	Items
	Cost /Itm \$8,892		
	% Included 100.00%	Total Cost/Study	\$8,892
Summary	Replacement Year 2036	Future Cost	\$12,564

This is to replace the Rheem HVAC system. It is possible that sub-components of these systems can be replaced or rebuilt to extend their life.

Unit 4- Bath- Rheem- 5T

2021- \$8,550 was expended to replace Unit #4.

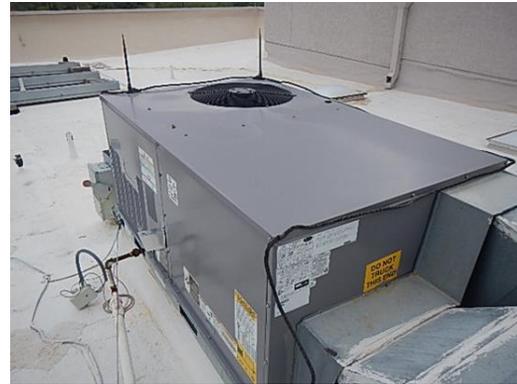
340 - HVAC	Useful Life 15	Remaining Life 14
Rooftop Carrier Unit #5- 2021	Quantity 1	Unit of Measure Items
	Cost /Itm \$8,892	
	% Included 100.00%	Total Cost/Study \$8,892
Summary	Replacement Year 2036	Future Cost \$12,564

This is to replace the Carrier HVAC system. It is possible that sub-components of this system can be replaced or rebuilt to extend its life.

2021- \$8,550 was expended.

2020- Per client 6/16/2020, move remaining life from 2020 to 2023.

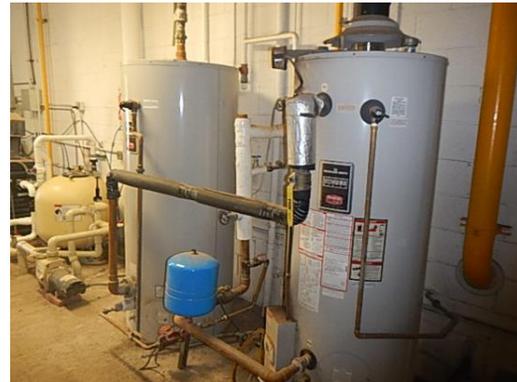
600 - Water Heater	Useful Life 12	Remaining Life 3	
Pool Eq Room Heater & Tank	Quantity 1	Unit of Measure	Lump Sum
	Cost /LS	\$14,120	
	% Included	100.00%	Total Cost/Study \$14,120
Summary	Replacement Year	2025	Future Cost \$15,206

- 1- Bradford White D100T1993N, gas, 100 gal, water heater, SN KD18209360, mfg. 4/2013
- 1- Bradford White M3ST200R5A, 200 gal storage tank, SN JL 17416073, mfg. 2012
- 1- B/G recirculation pump
- 1- expansion tank

2019- Per client 7/22/2019, keep this water heater in study.

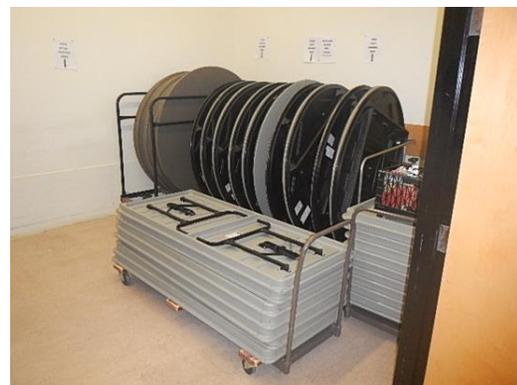
560 - Miscellaneous	Useful Life 10	Remaining Life 2	
Folding Tables & Chairs	Quantity 1	Unit of Measure	Lump Sum
	Cost /LS	\$14,095	
	% Included	100.00%	Total Cost/Study \$14,095
Summary	Replacement Year	2024	Future Cost \$14,809

This is to replace miscellaneous furnishings.

2019- \$5,000 was expended to replace card tables per client 6/14/2019.

2017- \$1,072 was expended for 2 poker tables.

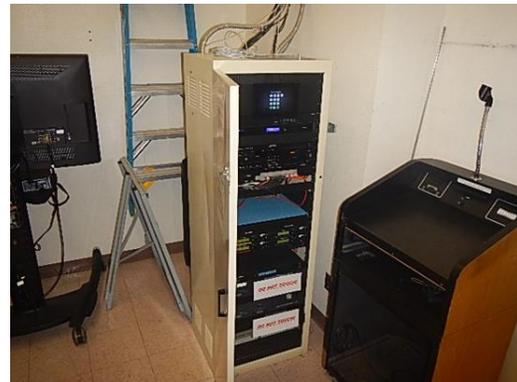
330 - Miscellaneous	Useful Life 30	Remaining Life 14	
Sound Rack- Total Induction Loop	Quantity 1	Unit of Measure System	
	Cost /Sys \$18,075		
	% Included 100.00%	Total Cost/Study \$18,075	
Summary	Replacement Year 2036	Future Cost \$25,539

This is to replace the total induction loop.

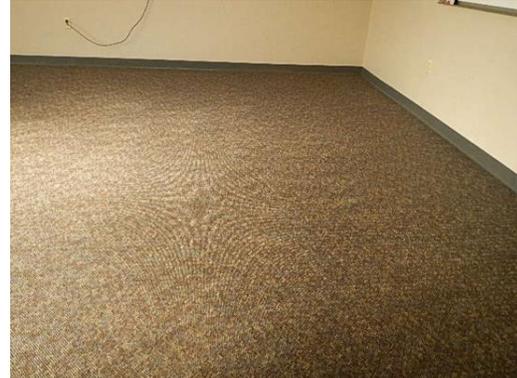
254 - Carpeting	Useful Life 10	Remaining Life 1
418 Sq. Yds. Clubhouse Carpeting	Quantity 418	Unit of Measure Square Yard
	Cost /SqYd \$43.70	
	% Included 100.00%	Total Cost/Study \$18,267
Summary	Replacement Year 2023	Future Cost \$18,723

This is to replace the carpeting.

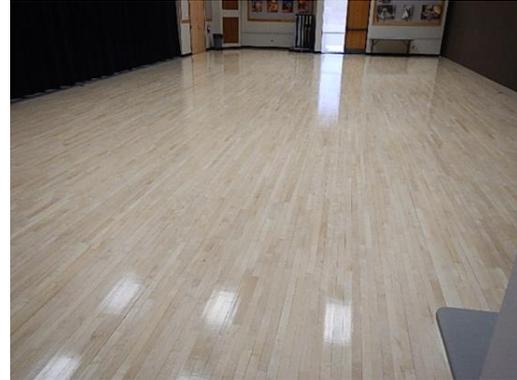
750 - Hardwood Floors	Useful Life 10	Remaining Life 8	
6,150 sf Wood Floor- Refinish	Quantity 6,150	Unit of Measure Square Feet	
	Cost /SqFt \$3.53		
	% Included 100.00%	Total Cost/Study \$21,710	
Summary	Replacement Year 2030	Future Cost \$26,451

This is to refinish the hardwood flooring.

2020- \$20,336 was expended to sand floor to bare wood, apply 6 coats of Hillyard Pro200 Gym Finish.

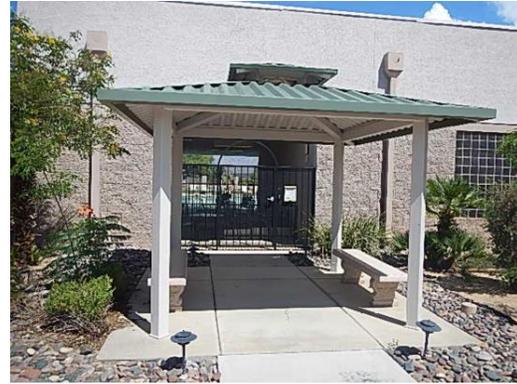
872 - Shade Structure	Useful Life 25	Remaining Life 20
Pool Area Wood Gazebo Structure	Quantity 1	Unit of Measure Items
	Cost /Itm \$10,380	
	% Included 100.00%	Total Cost/Study \$10,380
Summary	Replacement Year 2042	Future Cost \$17,009

This is to repair and replace the wood gazebo structure.

16' diameter gazebo structure east of pool.

2019- The structure appears to have been refurbished since the 2016 study.

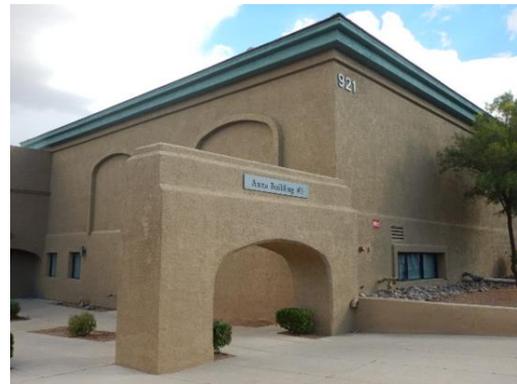
136 - Stucco	Useful Life 10	Remaining Life 5	
28,540 sf Building Exterior	Quantity 28,540	Unit of Measure Square Feet	
	Cost /SqFt \$1.65		
	% Included 100.00%	Total Cost/Study \$47,091	
Summary	Replacement Year 2027	Future Cost \$53,279

2019- Client reports that the exterior building surfaces were painted in 2018. The surfaces exhibit premature deterioration including wide spread efflorescence.
 2016- The surface is faded and exhibits efflorescence and dark stains.

This is to prepare, power wash, sand, scrape, caulk and paint the stucco surfaces with a premium paint.

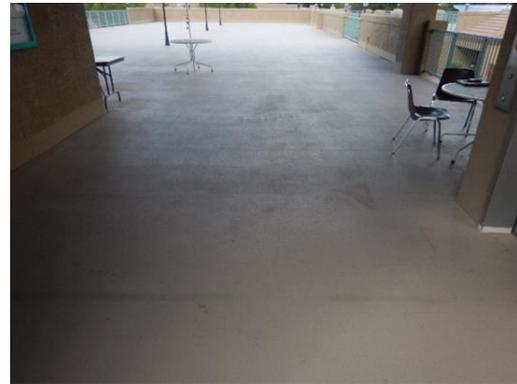
2019- Per client, conditions similar to 2016. Some repairs have been made. Per client 6/14/2019, extend remaining life from 2020 to 2033.

2016- Client indicated that deck membrane leak issues are being investigated and that repairs are needed. Some ceilings below the deck exhibited water stains.

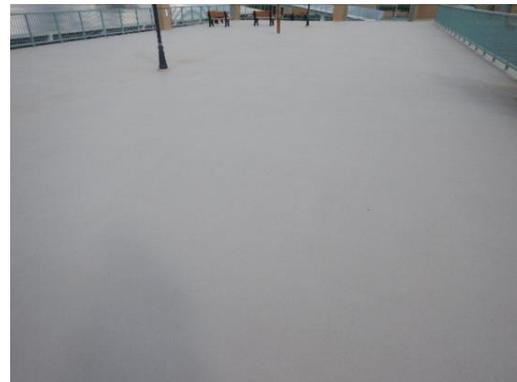
2016- Client indicated that deck membrane leak issues are being investigated and that repairs are needed. Some ceilings below the deck exhibited water stains.

This is seal and repair the Fiesta and Santa Cruz building rooftop decking.

2019- Per client 6/14/2019, repairs completed in 2018 so extend remaining life from 2019 to 2023.

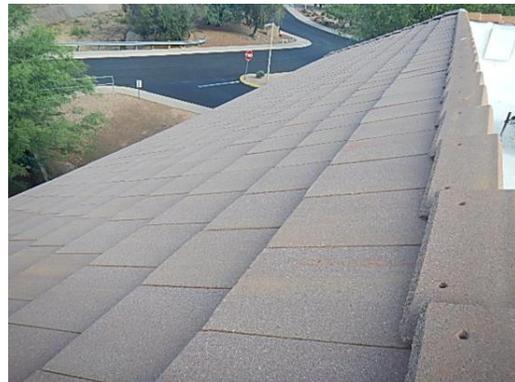
604 - Pitched: Tile 84 Squares- Building Roof	Useful Life 30 Quantity 84 Cost /Sqrs \$710 % Included 100.00%	Remaining Life 7 Unit of Measure Squares Total Cost/Study \$59,640 Future Cost \$70,893
Summary	Replacement Year 2029

2019- The west side of the building has had some repair/replacement work done. \$38,500 was expended to remove tile, repair deck, and reuse tile per client 6/14/2019. Remaining life set to 2029 due to 2019 roofing project.

This is to replace the tile roofing system. Tile roofs should be regularly inspected and repaired as indicated to ensure maximum life.

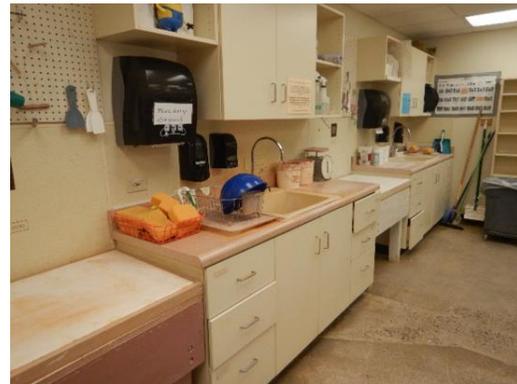
2019- Per client 6/14/2019, extend remaining life from 2019 to 2023.
 2016- The countertops are very worn.

This is for replacing the cabinets per existing. Replacement costs will depend on the scope of work at replacement.

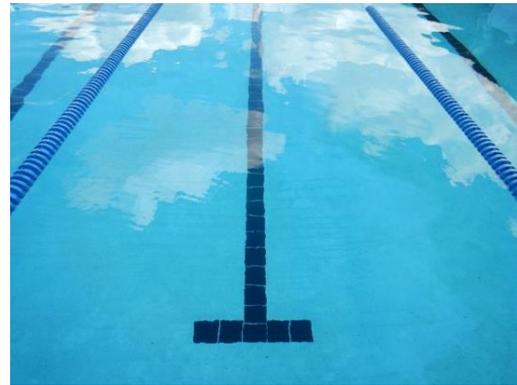
130 - Resurface	Useful Life 10	Remaining Life 1	
240 lf Pool	Quantity 240	Unit of Measure	Linear Feet
	Cost /l.f. \$188		
	% Included 100.00%	Total Cost/Study	\$45,120
Summary	Replacement Year 2023	Future Cost	\$46,248

2022- Splotchy appearance.
 2017- Life estimates per client.

This is to resurface the pool including start-up costs. Includes 5 tile lanes with targets.

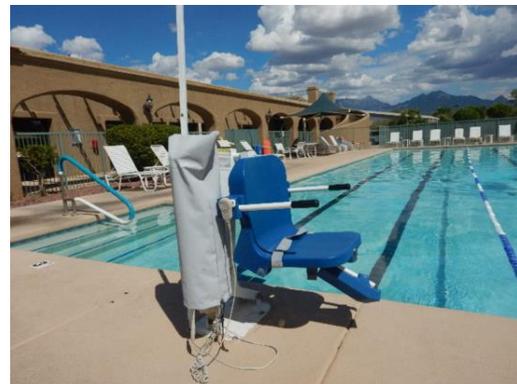
408 - ADA Chair Lift	Useful Life 10	Remaining Life 7	
Pool Area ADA Lift	Quantity 1	Unit of Measure	Items
	Cost /Itm \$5,500		
	% Included 100.00%	Total Cost/Study	\$5,500
Summary	Replacement Year 2029	Future Cost	\$6,538

Model # F-411RPL-AT1
 Serial # 34345
 Max Weight 350 LB
 Mfg. March 2019

2019- \$3,313 was expended per client 6/14/2019.
 2009- Lift installed.

This is to replace the pool's ADA compliant chair lift.

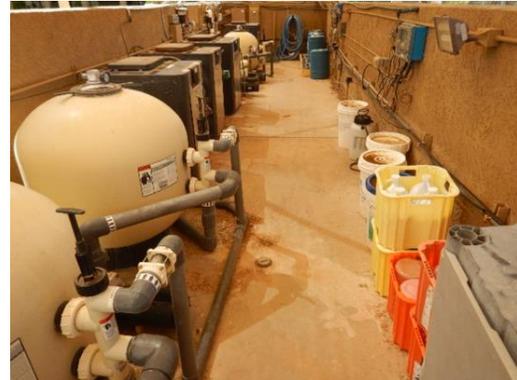
750 - Equipment: Replacement	Useful Life 5	Remaining Life 1	
Pool & Spa Equipment (50%)	Quantity 1	Unit of Measure Lump Sum	
	Cost /LS \$57,564	Qty * \$/LS \$57,564	
	% Included 50.00%	Total Cost/Study \$28,782	
Summary	Replacement Year 2023	Future Cost \$29,502

- Pool- 2 ladders, 1 grab bar, 6 lights, 5 skimmers, 4 drain covers
- Spa- 1 grab bar, 1 light, 5 drain covers, 1 skimmer

2020- \$454 was expended. \$9,000 was expended for the pool Clear Comfort Sanitation system.
 2018- \$9,697 total was expended for pool heater #3, spa jet pump #1, misc. Aquasols.

This is to periodically replace the pool and spa equipment. Since not all equipment will fail simultaneously, this component provides for one half replacement every five years.

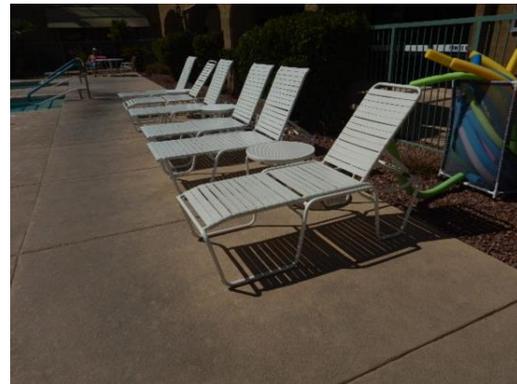
940 - Furniture: Misc	Useful Life 6	Remaining Life 3	
Pool Area Furniture	Quantity 1	Unit of Measure Lump Sum	
	Cost /LS \$8,237		
	% Included 100.00%	Total Cost/Study \$8,237	
Summary	Replacement Year 2025	Future Cost \$8,870

- 17- chairs
- 4- tables
- 32- lounges

This is to replace miscellaneous pool furniture.

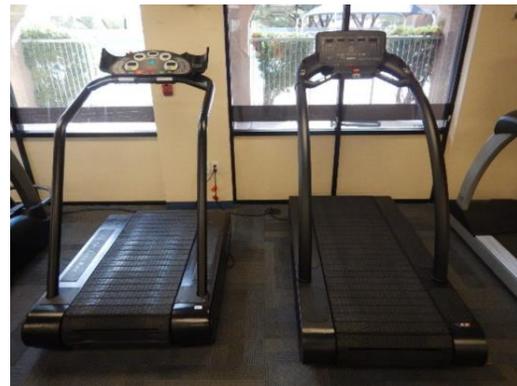
240 - Exercise: Cardio Equipment	Useful Life 3	Remaining Life 2
16 Fitness Center Cardio Machines (25%)	Quantity 16	Unit of Measure Items
	Cost /Itm \$6,519	Qty * \$/Itm \$104,306
	% Included 25.00%	Total Cost/Study \$26,076
Summary	Replacement Year 2024	Future Cost \$27,397

- 1- Assault Fitness fan bike
- 3- True recumbent bikes
- 2- Technogym upright bike
- 1- True elliptical
- 1- True EFX elliptical
- 1- Precor elliptical
- 1- Concept-2 rower
- 1- Stairmaster stepper
- 1- Technogym treadmill
- 1- True treadmill
- 2- Woodway treadmills
- 1- Cybex arc trainer

2021- \$11,200 was expended to replace 1 rower, 1 cross-trainer, 1 recumbent bike.
 2020- \$25,000 was expended to replace one Technogym recumbent bike & upright bike and one Cybex Arc Trainer.
 2019- \$17,899 was expended per client 6/14/2019.
 2017- \$7,140 was expended.

This is to periodically replace the cardio equipment on a percentage basis. Strength equipment is provided for within other components.

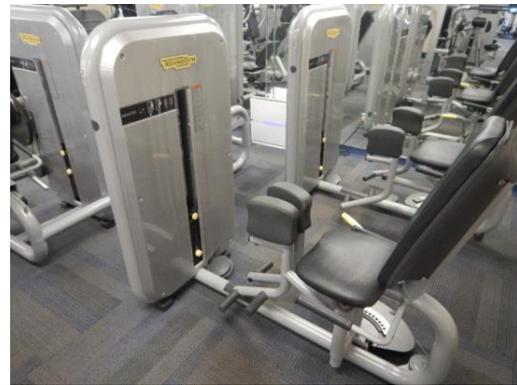
340 - Exercise: Strength Equipment	Useful Life 8	Remaining Life 1	
23 Fitness Center Strength Machines (50%)	Quantity 23	Unit of Measure	Items
	Cost /Itm \$3,733	Qty * \$/Itm	\$85,864
	% Included 50.00%	Total Cost/Study	\$42,932
Summary	Replacement Year 2023	Future Cost	\$44,005

- 1- Technogym hip abductor
- 1- Technogym hip adductor
- 1- Technogym multi hip
- 1- Technogym low row
- 1- Technogym lat pull down
- 1- Technogym arm curl
- 1- Technogym arm extension
- 1- Technogym abdominal crunch
- 1- Technogym lower back
- 1- Technogym leg extension
- 1- Technogym leg curl
- 1- Technogym leg press
- 1- Technogym pectoral
- 1- Technogym chest press
- 1- Technogym shoulder press
- 1- Technogym anterior flexibility
- 1- Technogym posterior flexibility
- 1- Precor stretch trainer
- 3- benches
- 1- dumbbell rack
- 1- static leg lift

This is to periodically replace strength equipment on a percentage basis. Cardio equipment is provided for within other components.

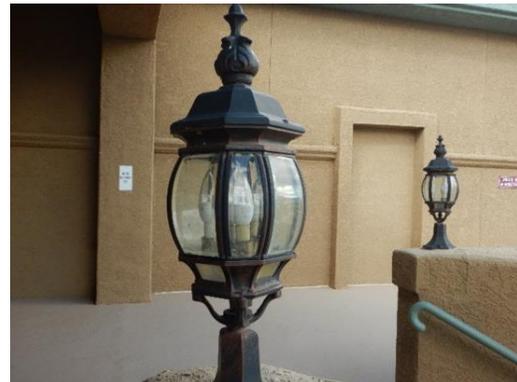
100 - Exterior: Misc. Fixtures	Useful Life 25	Remaining Life 6
40 Wall & Wall Top Lantern Lights	Quantity 40	Unit of Measure Items
	Cost /itm \$601	
	% Included 100.00%	Total Cost/Study \$24,038
Summary	Replacement Year 2028	Future Cost \$27,877

- 19- wall-top
- 21- building and wall

This is to replace wall-top and wall common area lantern lighting fixtures.

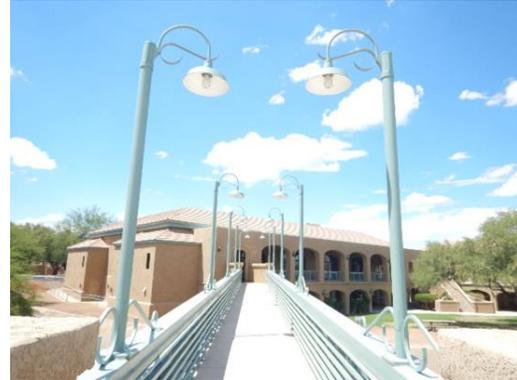
230 - Pole Lights	Useful Life 25	Remaining Life 6	
10 Bridge Lights	Quantity 10	Unit of Measure	Items
	Cost /Itm \$1,736		
	% Included 100.00%	Total Cost/Study	\$17,356
Summary	Replacement Year 2028	Future Cost	\$20,127

This is to replace the pole lights reusing the existing wiring and conduits.

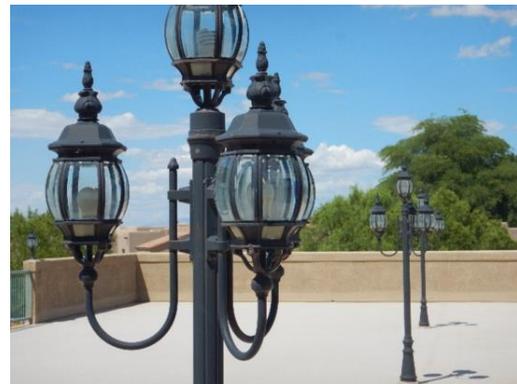
280 - Pole Lights	Useful Life 25	Remaining Life 6	
5 2nd Level Deck- Pole Lights	Quantity 5	Unit of Measure	Items
	Cost /Itm \$1,366		
	% Included 100.00%	Total Cost/Study	\$6,829
Summary	Replacement Year 2028	Future Cost	\$7,920

This is to replace the pole lights reusing the existing wiring and conduits.

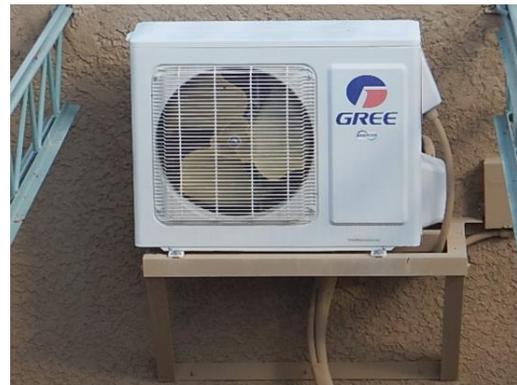
232 - HVAC	Useful Life 15	Remaining Life 6	
6 Miscellaneous Units- 2013	Quantity 6	Unit of Measure	Items
	Cost /Itm \$5,163		
	% Included 100.00%	Total Cost/Study	\$30,977
Summary	Replacement Year 2028	Future Cost	\$35,923

- Unit 1- Pottery- Carrier- 2.5T, Model 25HBC530A300, Serial 3913E06486
- Unit 2- Clay Studio- Carrier- 3T Model 25HCD336A600, Serial 2113E12280
- Unit 10- Coordinator's Office- Gree- 1T Model GWH12AB-D3DNA2D/0
- Unit 12- Santa Cruz- Carrier- 3T
- Unit 13- Fiesta Bath Room- Carrier- 2T
- Unit 16- Comp Mac Room- Carrier- 4T

This is to replace the HVAC systems. It is possible that sub-components of these systems can be replaced or rebuilt to extend their life.

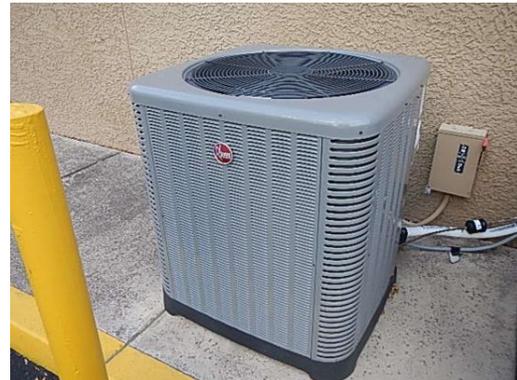
312 - HVAC	Useful Life 15	Remaining Life 9	
Carrier Unit #8- 2016	Quantity 1	Unit of Measure	Items
	Cost /Itm \$7,075		
	% Included 100.00%	Total Cost/Study	\$7,075
Summary	Replacement Year 2031	Future Cost	\$8,836

Unit 8- Fitness- Rheem- 5T

2016- \$6,150 was expended for Unit 8 only, so BRG separated unit #3 to its own component.

This is to replace the Rheem HVAC system. It is possible that sub-components of this system can be replaced or rebuilt to extend its life.

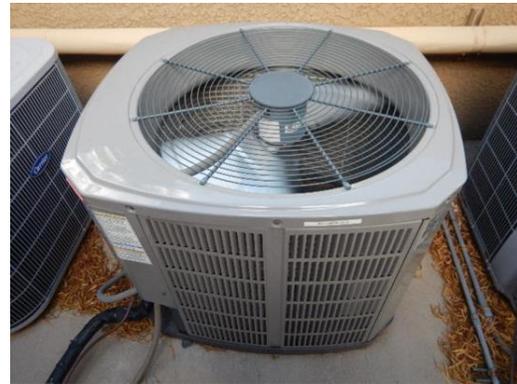
316 - HVAC	Useful Life 15	Remaining Life 11
American Standard Unit #3- 2018	Quantity 1	Unit of Measure Items
	Cost /Itm \$7,075	
	% Included 100.00%	Total Cost/Study \$7,075
Summary	Replacement Year 2033	Future Cost \$9,283

Unit 3- Sculpture- American Standard- 3T, Model 4A6C4036A4000AA, Serial # 1836545A4F, MFR Date 9/2018.

2018- \$6,150 was expended.

This is to replace the American Standard HVAC system. It is possible that sub-components of this system can be replaced or rebuilt to extend its life.

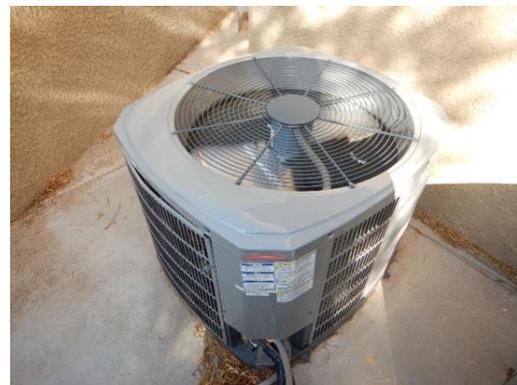
344 - HVAC	Useful Life 15	Remaining Life 12
2 Units- 2019	Quantity 2	Unit of Measure Items
	Cost /Itm \$7,060	
	% Included 100.00%	Total Cost/Study \$14,120
Summary	Replacement Year 2034	Future Cost \$18,990

Unit 9- Fitness- Carrier- 5T

2019- \$12,923 was expended per client 6/14/2019.

This is to replace the HVAC systems. It is possible that sub-components of these systems can be replaced or rebuilt to extend their life.

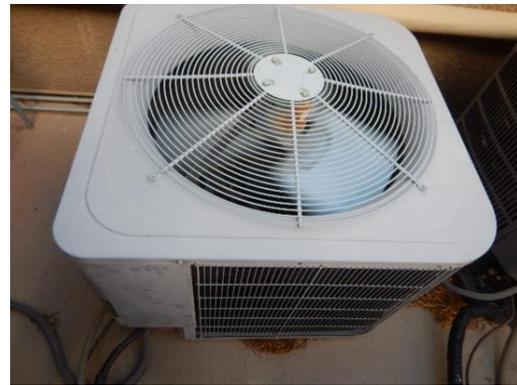
368 - HVAC	Useful Life 15	Remaining Life 5	
2 Carrier Units- 2012	Quantity 2	Unit of Measure	Items
	Cost /Itm \$8,195		
	% Included 100.00%	Total Cost/Study	\$16,390
Summary	Replacement Year 2027	Future Cost	\$18,543

Unit 5- Fiesta Room- Carrier- 5T, Model 25HBC360A600, Serial 4212E01407
 Unit 24- Art Room- Carrier- 5T

This is to replace the Carrier HVAC systems. It is possible that sub-components of these systems can be replaced or rebuilt to extend their life.

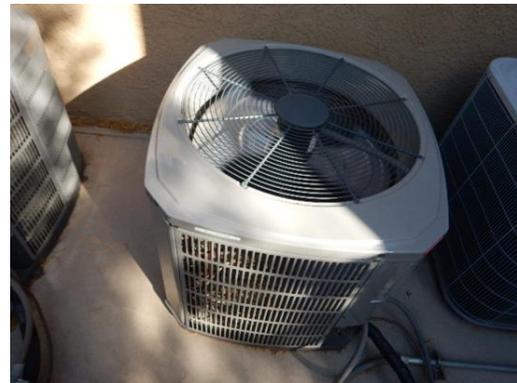
392 - HVAC	Useful Life 15	Remaining Life 11	
2 Units- 2018	Quantity 2	Unit of Measure	Items
	Cost /Itm \$6,075		
	% Included 100.00%	Total Cost/Study	\$12,149
Summary	Replacement Year 2033	Future Cost	\$15,941

Unit 14- Kitchen- Carrier- 2.5T

2019- Per client 6/14/2019, replaced in 2018 for \$5,424 of which half was paid in 2018 and 2019.

This is to replace the Carrier HVAC systems. It is possible that sub-components of these systems can be replaced or rebuilt to extend their life.
