Reserve Study Transmittal Letter

Re: Green Valley Recreation Inc; Update w/ Site Visit Review

RESERVE STUDY

Update w/ Site Visit Review

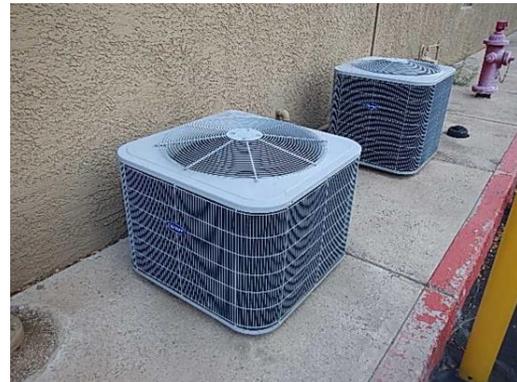
436 - HVAC	Useful Life 15	Remaining Life 7	
Carrier Unit #11- 2014	Quantity 1	Unit of Measure	Items
	Cost /Itm	\$8,195	
	% Included	100.00%	Total Cost/Study \$8,195
Summary	Replacement Year	2029	Future Cost \$9,741

Unit 11- Locker Room- Carrier- 5T

This is to replace the Carrier HVAC system. It is possible that sub-components of this system can be replaced or rebuilt to extend its life.

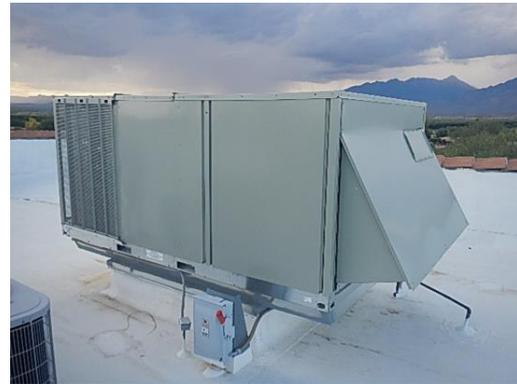
448 - HVAC	Useful Life 15	Remaining Life 11	
8 Rooftop Carrier Units- 2018	Quantity 8	Unit of Measure Items	
	Cost /Itm \$12,800		
	% Included 100.00%	Total Cost/Study \$102,396	
Summary	Replacement Year 2033	Future Cost \$134,353

- Unit 15- Comp Pecan Room- Carrier- 3T
- Unit 17- Comp Lobby- Carrier- 3T
- Unit 18- Comp Ed Hall- Carrier- 5T
- Unit 19- Comp Multi Room- Carrier- 5T
- Unit 20- Comp General- Carrier- 4T
- Unit 21- Comp Laptop Room- Carrier- 3T
- Unit 22- Anza Building- Carrier- 12.5T
- Unit 23- Anza Building- Carrier- 12.5T

2019- Per client 6/14/2019, replaced in 2018 for \$91,428 of which half was paid in 2018 and 2019.

This is to replace the Carrier HVAC systems. It is possible that sub-components of these systems can be replaced or rebuilt to extend their life.

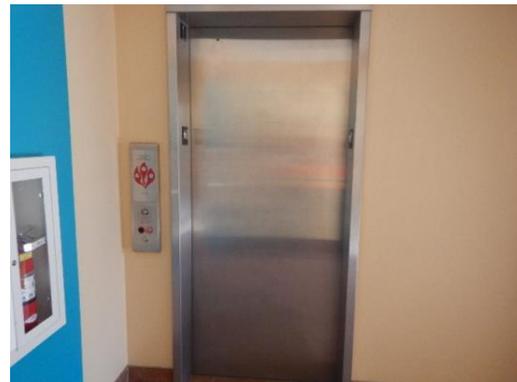
200 - Modernize/Overhaul	Useful Life 25	Remaining Life 22	
Anza Building Elevator	Quantity 1	Unit of Measure	Items
	Cost /Itm \$133,304		
	% Included 100.00%	Total Cost/Study	\$133,304
Summary	Replacement Year 2044	Future Cost	\$229,492

- 2019- \$107,095 was expended per client 6/14/2019. Per client 7/22/2019, increase estimate from \$107,095 to \$122,000.
- 2018- The actual quote is higher than the initial projection of approximately \$48,000. \$88,000 is the updated quote.

This is to modernize or overhaul the elevator system.

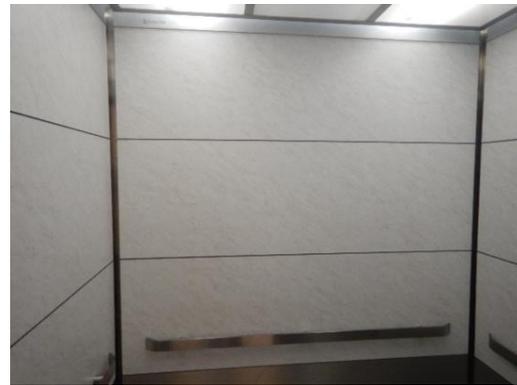
300 - Cab Rehab	Useful Life 20	Remaining Life 17	
Anza Elevator Cab	Quantity 1	Unit of Measure	Items
	Cost /Itm \$19,569		
	% Included 100.00%	Total Cost/Study	\$19,569
Summary	Replacement Year 2039	Future Cost	\$29,777

2019- \$20,250 was expended per client 6/14/2019. Per client 7/22/2019, reduce estimate from \$20,250 to \$17,910.

2018- Accelerated the remaining life to 2019.

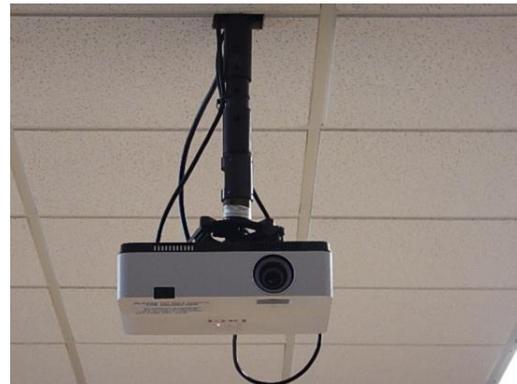
160 - Projector	Useful Life 4	Remaining Life 1	
3 Projectors (33%)	Quantity 3	Unit of Measure Items	
	Cost /Itm \$1,366	Qty * \$/Itm \$4,097	
	% Included 33.33%	Total Cost/Study \$1,366	
Summary	Replacement Year 2023	Future Cost \$1,400

- 1- Ansel Adams Sanyo PROxrtraX
- 1- Kino Room Epson
- 1- Anza Room Optoma

2022- No work indicated, move remaining life from 2022 to 2023.

This is to periodically replace the video projectors on a percentage basis.

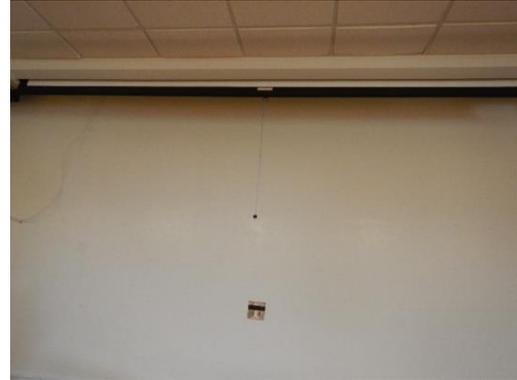
170 - Projection Screen	Useful Life 20	Remaining Life 2	
Anza Room	Quantity 1	Unit of Measure	Items
	Cost /Itm	\$9,397	
	% Included	100.00%	Total Cost/Study \$9,397
Summary	Replacement Year	2024	Future Cost \$9,873

This is to replace the projection screen.

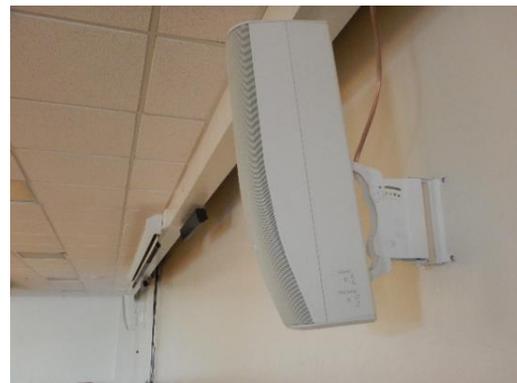
324 - PA System	Useful Life 10	Remaining Life 9	
Anza Room- Sound System	Quantity 1	Unit of Measure	System
	Cost /Sys	\$18,075	
	% Included	100.00%	Total Cost/Study \$18,075
Summary	Replacement Year	2031	Future Cost \$22,573

2022- \$7,360 was expended.
 2021- \$17,380 was expended, did not get replaced in 2020 as anticipated.
 2020- \$16,400 is anticipated.
 2019- Per client, decrease useful life from 20 to 10 years, remaining life from 2031 to 2020 and increase estimate from \$6,823 to \$16,000.
 2017- Per client, \$5,600 was expended in 2011.

This is to replace the Anza room Tech-Unique sound system.

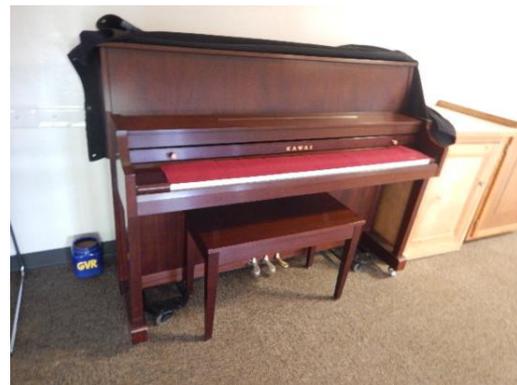
760 - Piano	Useful Life 25	Remaining Life 16	
Anza Room Kawai Upright	Quantity 1	Unit of Measure Items	
	Cost /Itm \$7,603		
	% Included 100.00%	Total Cost/Study \$7,603	
Summary	Replacement Year 2038	Future Cost \$11,286

Kawai upright, 506N, SN F054134

2017- Per client, \$6,000 was expended in 2013.

This is to replace the piano, bench and dolly.

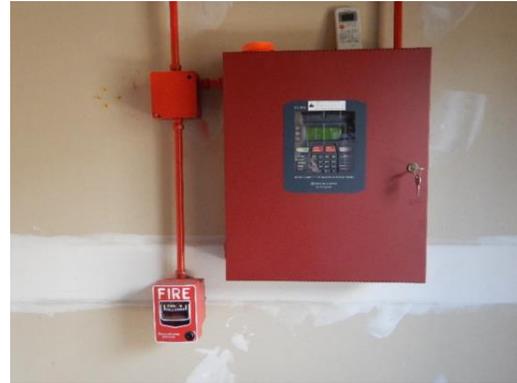
240 - Fire Control Misc	Useful Life 20	Remaining Life 3	
Fire Alarm System	Quantity 1	Unit of Measure Lump Sum	
	Cost /LS \$33,599		
	% Included 100.00%	Total Cost/Study \$33,599	
Summary	Replacement Year 2025	Future Cost \$36,182

2021- \$9,400 was expended to replace fire sprinkler pendants only.

This is to repair and replace the fire alarm control panel, fire suppression system, alarms, sensors, pull stations, etc.

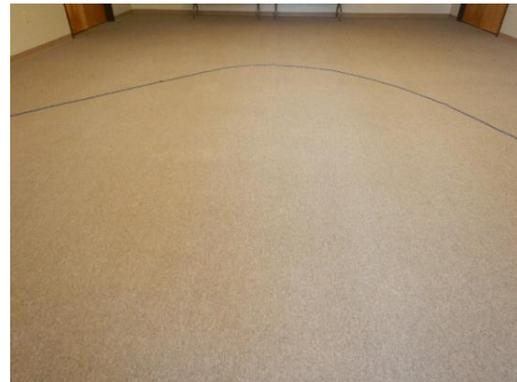
270 - Carpeting	Useful Life 10	Remaining Life 4	
400 Sq. Yds. Kino, Fitness, Office Areas	Quantity 400	Unit of Measure Square Yard	
	Cost /SqYd \$42.00		
	% Included 100.00%	Total Cost/Study \$16,800	
Summary	Replacement Year 2026	Future Cost \$18,544

2022- \$5,500 was expended. Move remaining life from 2022 to 2023.
 2017- These areas were added by client, and need to be verified.

This is to replace the carpeting.

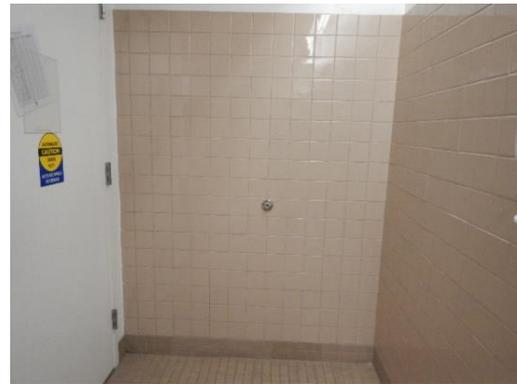
460 - Tile 1,825 sf Clubhouse Walls & Floors	Useful Life 20 Quantity 1,825 Cost /SqFt \$14.20 % Included 100.00%	Remaining Life 1 Unit of Measure Square Feet Total Cost/Study \$25,915	
Summary	Replacement Year 2023	Future Cost \$26,563

2022- Per client, move remaining life from 2022 to 2023.

2020- Per client 8/6/2020, extend remaining life from 2021 to 2022.

This is to replace the wall and floor tile.

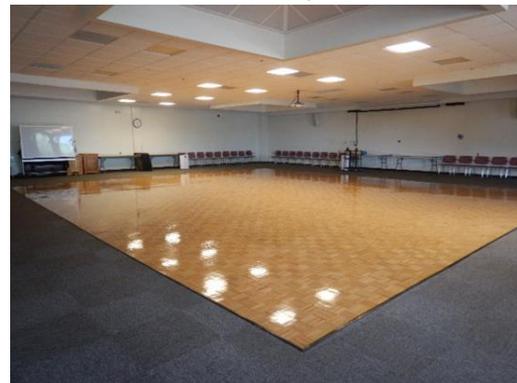
730 - Hardwood Floors 2,150 sf Anza & Santa Cruz- Replace	Useful Life 40 Quantity 2,150 Cost /SqFt \$12.95 % Included 100.00%	Remaining Life 14 Unit of Measure Square Feet Total Cost/Study \$27,843	
Summary	Replacement Year 2036	Future Cost \$39,341

This is to replace the hardwood flooring. Refinishing is provided for within another component.

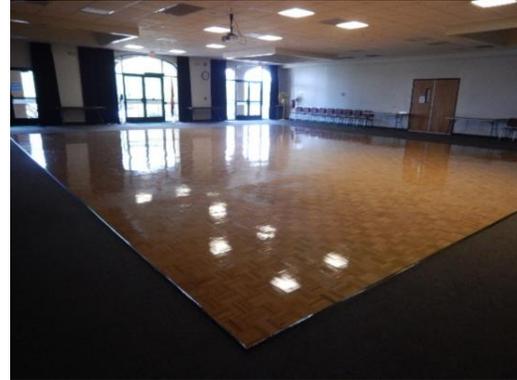
760 - Hardwood Floors	Useful Life 10	Remaining Life 4
2,150 sf Anza & Santa Cruz- Refinish	Quantity 2,150	Unit of Measure Square Feet
	Cost /SqFt \$7.06	
	% Included 100.00%	Total Cost/Study \$15,179
Summary	Replacement Year 2026	Future Cost \$16,755

This is to refinish the hardwood flooring.

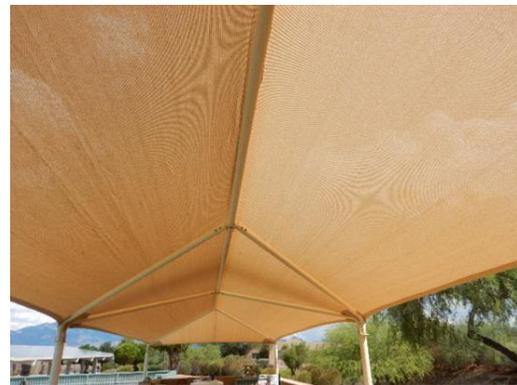
804 - Shade Structure	Useful Life 15	Remaining Life 8
100 sf Small Shade Canopy	Quantity 100	Unit of Measure Square Feet
	Cost /SqFt \$22.95	
	% Included 100.00%	Total Cost/Study \$2,295
Summary	Replacement Year 2030	Future Cost \$2,796

1- metal frame and post with 10' x 10' canvas canopy southeast of pool.

2015- Canopy installed.

This is to repair, replace and maintain the canvas canopy shade structure.

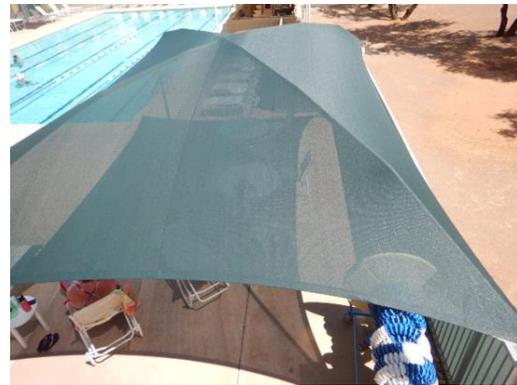
820 - Shade Structure	Useful Life 15	Remaining Life 4
600 sf NW of Pool- Large Shade Canopy	Quantity 600	Unit of Measure Square Feet
	Cost /SqFt \$22.95	
	% Included 100.00%	Total Cost/Study \$13,770
Summary	Replacement Year 2026	Future Cost \$15,200

1- metal frame and post with 20' x 30' canvas canopy northwest side of pool.

2011- Canopy installed.

This is to repair, replace and maintain the canvas canopy shade structure.

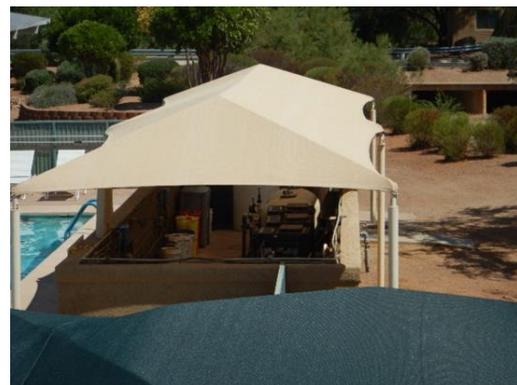
824 - Shade Structure	Useful Life 15	Remaining Life 6
450 sf Pool Equip Encl Shade Canopy	Quantity 450	Unit of Measure Square Feet
	Cost /SqFt \$22.95	
	% Included 100.00%	Total Cost/Study \$10,328
Summary	Replacement Year 2028	Future Cost \$11,977

1- metal frame and 6 posts with 10' x 45' canvas canopy over pool equipment enclosure.

2013- Canopy installed.

This is to repair, replace and maintain the canvas canopy shade structure.

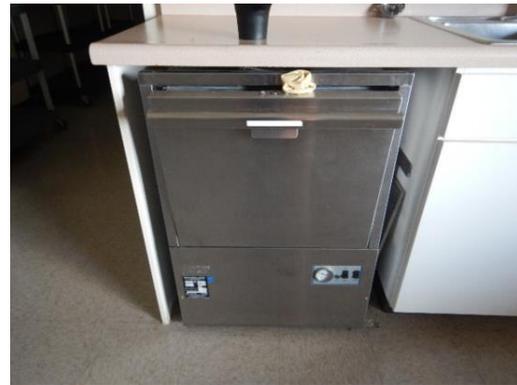
780 - Miscellaneous	Useful Life 5	Remaining Life 2
10 Kitchen Appliances (33%)	Quantity 10	Unit of Measure Items
	Cost /Itm \$3,850	Qty * \$/Itm \$38,503
	% Included 33.33%	Total Cost/Study \$12,834
Summary	Replacement Year 2024	Future Cost \$13,484

- 1- True double door reach in refrigerator, MN T-43, SN 8138575
- 1- Manitowoc undercounter ice maker
- 1- Moyer Diebel undercounter commercial dishwasher, MN 401LTM2, SN W9186
- 1- Speed Queen clothes dryer & front load washer
- 1- True single door reach in freezer, MN T-19F-HC, SN 9276436
- 1- Vollrath warming station
- 1- GE Oven/Stove
- 1- GE Microwave
- 2- Duke Ovens

2021- \$2,000 was expended to replace range.
 2018- \$1,937 was expended to replace prior McCall Freezer.

This is to repair or replace miscellaneous appliances.

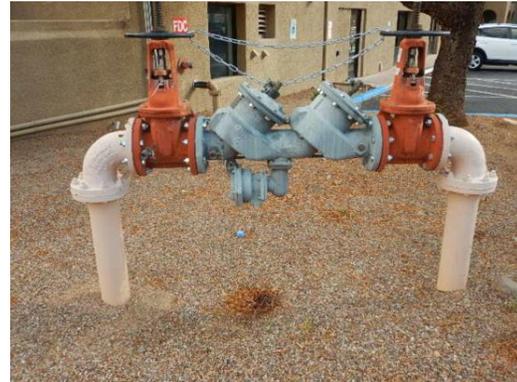
142 - Backflow Valves	Useful Life 12	Remaining Life 8	
4" Backflow #1	Quantity 1	Unit of Measure	Items
	Cost /Itm \$9,578		
	% Included 100.00%	Total Cost/Study	\$9,578
Summary	Replacement Year 2030	Future Cost	\$11,670

2020- \$8,553 was expended to replace in 2018 per client 6/15/2020.

This is to replace the backflow prevention valve.

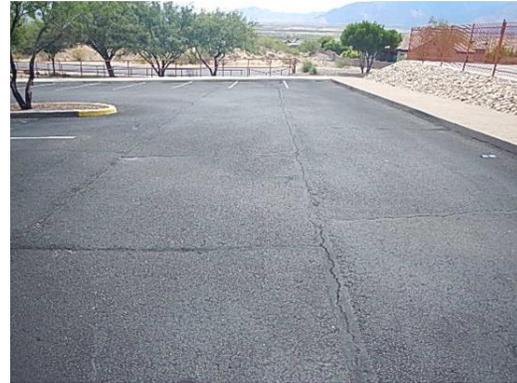
132 - Asphalt: Sealing	Useful Life 5	Remaining Life 2	
64,068 sf Drives & Parking	Quantity 64,068	Unit of Measure Square Feet	
	Cost /SqFt \$0.250		
	% Included 100.00%	Total Cost/Study \$16,017	
Summary	Replacement Year 2024	Future Cost \$16,828

This is to prepare the surface, apply a single coat asphalt emulsion product and restripe to match the existing layout. If a second coat is desired the cost is generally 10% to 20% higher.

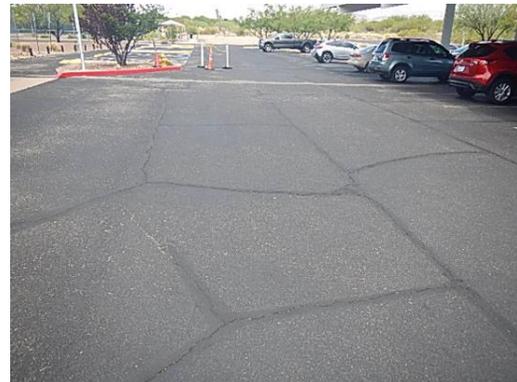
246 - Asphalt: Ongoing Repairs	Useful Life 5	Remaining Life 2	
64,068 sf Drives & Parking (3%)	Quantity 64,068	Unit of Measure Square Feet	
	Cost /SqFt \$3.85	Qty * \$/SqFt \$246,662	
	% Included 2.50%	Total Cost/Study \$6,167	
Summary	Replacement Year 2024	Future Cost \$6,479

This is for miscellaneous repairs including crack fill, skin patching and minor dig out & fill. Cracks 1/4" or wider should be filled when observed.

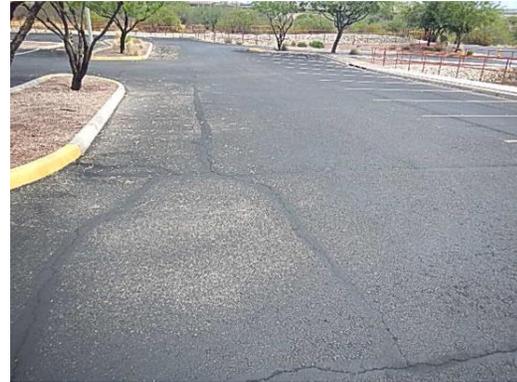
342 - Asphalt: Overlay w/ Interlayer	Useful Life 25	Remaining Life 11	
64,068 sf Drives & Parking	Quantity 64,068	Unit of Measure Square Feet	
	Cost /SqFt \$2.10		
	% Included 100.00%	Total Cost/Study \$134,543	
Summary	Replacement Year 2033	Future Cost \$176,532

This is to apply a paving fabric interlayer to the existing asphalt surface and overlay with a minimum of 1.5" of new hot mix asphalt. Generally this includes edge grinding and utility box extensions.

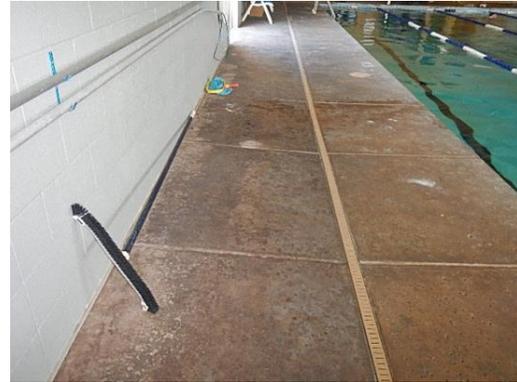
418 - Pool Deck	Useful Life 5	Remaining Life 4	
2,650 sf Pool/Spa Area Concrete Repair (5%)	Quantity 2,650	Unit of Measure Square Feet	
	Cost /SqFt \$23.50	Qty * \$/SqFt \$62,275	
	% Included 5.00%	Total Cost/Study \$3,114	
Summary	Replacement Year 2026	Future Cost \$3,437

This is to periodically repair and replace concrete pool deck, deck drains and deck mastic to remove abrupt elevation shifts and to maintain functionality. Since concrete pool deck useful life typically exceeds the scope of the 30-year study, this component provides for repair only and not full replacement. However, as the deck ages and undergoes multiple repairs and patches, this component may revert from occasional partial repairs to full replacement.

2019- Delayed 5-year replacement cycle until 2026 due to recent replacement.
 2018- Replacement deck is not coated, so deck recoating has been excluded.
 2016- The deck coating was in very poor condition with many bubbled and chipped areas. The root cause for the surface's failure needs to be determined prior to removing and replacing the surface. It is possible that some concrete preparation may be required during the deck recoating process. Per client 4/21/2016, \$36,000 total is anticipated to replace in 2016. Tinted sweat finish deck replaced prior coated deck.

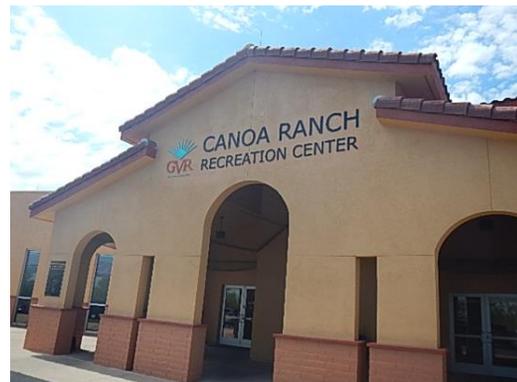
142 - Stucco	Useful Life 10	Remaining Life 6	
14,760 sf Building Exterior	Quantity 14,760	Unit of Measure Square Feet	
	Cost /SqFt \$1.40	Total Cost/Study \$20,664	
	% Included 100.00%	Future Cost \$23,964	
Summary	Replacement Year 2028

This is to prepare, power wash, sand, scrape, caulk and paint the stucco surfaces with a premium paint.

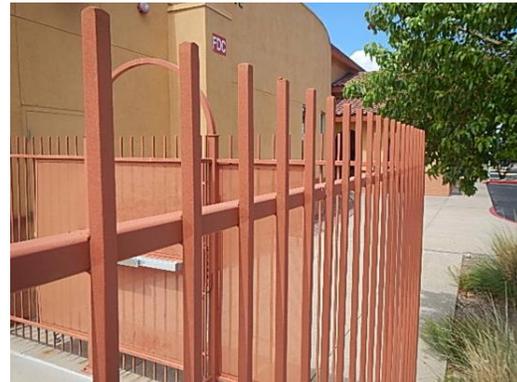
406 - Wrought Iron	Useful Life 4	Remaining Life 3
614 lf Metal Fencing & Railings	Quantity 614	Unit of Measure Linear Feet
	Cost /l.f. \$10.60	
	% Included 100.00%	Total Cost/Study \$6,508
Summary	Replacement Year 2025	Future Cost \$7,009

4' metal rail, north side parking lot @ ditch- 300 lf
 6' wrought iron fencing @ patio perimeter- 264 lf
 Pickleball court walkway metal hand rail- 50 lf

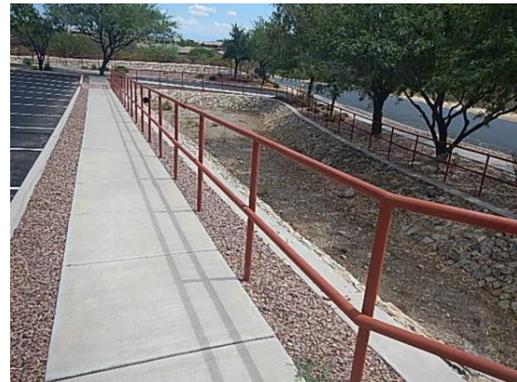
606 - Metal Railings	Useful Life 20	Remaining Life 6	
350 lf Parking & Pickleball	Quantity 350	Unit of Measure Linear Feet	
	Cost /l.f. \$29.41		
	% Included 100.00%	Total Cost/Study \$10,294	
Summary	Replacement Year 2028	Future Cost \$11,937

This is to replace the metal railings. Painting is provided for within another component.

north side parking lot at ditch- 300 lf
 pickleball courts walkway- 50 lf

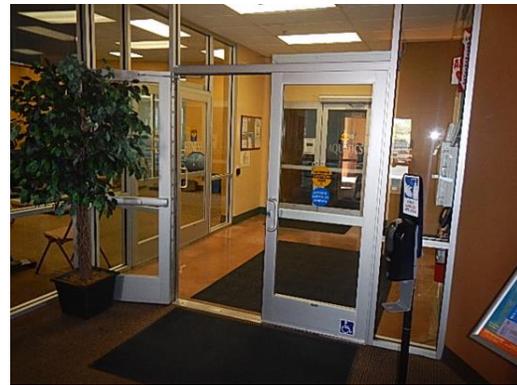
928 - Doors	Useful Life 10	Remaining Life 2
40 Exterior & Interior Doors (25%)	Quantity 40	Unit of Measure Items
	Cost /Itm \$1,750	Qty * \$/Itm \$70,000
	% Included 25.00%	Total Cost/Study \$17,500
Summary	Replacement Year 2024	Future Cost \$18,386

This is to periodically repair, replace and maintain exterior and interior doors including items such as panic exit hardware, automatic door operators, door closers, frames/jambs, posts, locks/latches, etc.

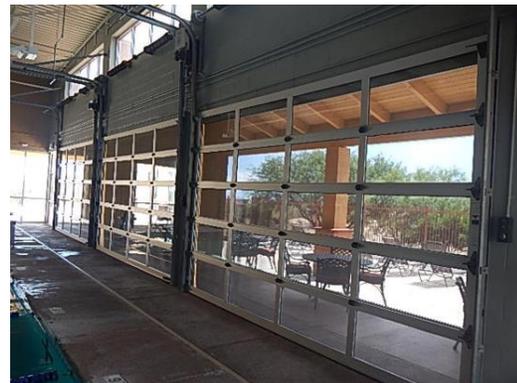
932 - Doors	Useful Life 20	Remaining Life 6
3 Pool East Patio Doors	Quantity 3	Unit of Measure Items
	Cost /Itm \$18,800	
	% Included 100.00%	Total Cost/Study \$56,400
Summary	Replacement Year 2028	Future Cost \$65,407

This is to repair, replace and maintain the 5-panel glass doors, operators and hardware.

- 3- 10' x 16.5' glass doors
- 3- LiftMaster operators

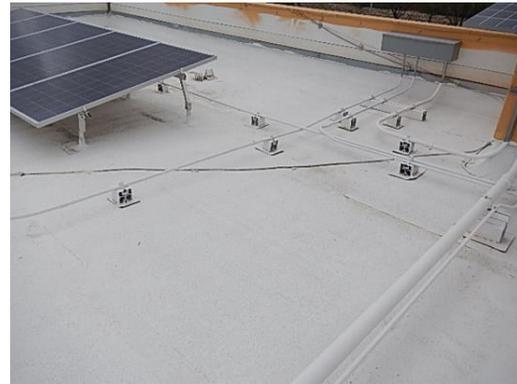
200 - Low Slope: BUR 133 Squares- Building Roof	Useful Life 20 Remaining Life 6 Quantity 133 Unit of Measure Squares Cost /Sqrs \$437 % Included 100.00% Total Cost/Study \$58,129 Replacement Year 2028 Future Cost \$67,412
Summary

This is to replace the built-up roofing. All roofs should be regularly inspected and repaired as indicated to ensure maximum life.

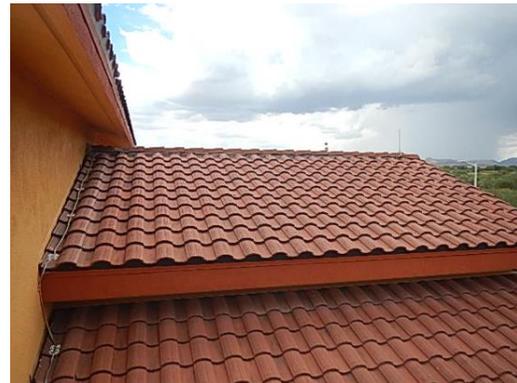
608 - Pitched: Tile 45 Squares- Building Roof	Useful Life 30 Remaining Life 16 Quantity 45 Unit of Measure Squares Cost /Sqrs \$710 % Included 100.00% Total Cost/Study \$31,950 Replacement Year 2038 Future Cost \$47,430
Summary

This is to replace the tile roofing system. Tile roofs should be regularly inspected and repaired as indicated to ensure maximum life.

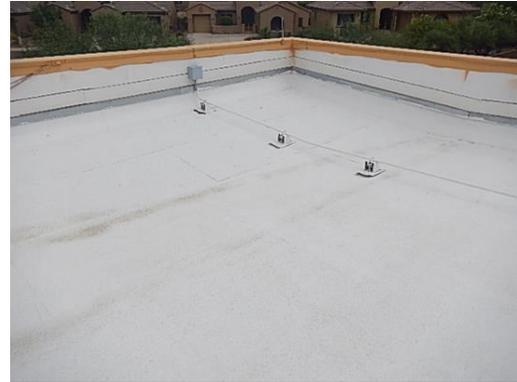
958 - Coating	Useful Life 5	Remaining Life 2
13,300 sf Low Slope Roof Recoating	Quantity 13,300	Unit of Measure Square Feet
	Cost /SqFt \$1.65	
	% Included 100.00%	Total Cost/Study \$21,945
Summary	Replacement Year 2024	Future Cost \$23,056

This to prepare the roof and apply a coating to extend the roof's serviceable life by protecting against ponding water and ultraviolet rays.

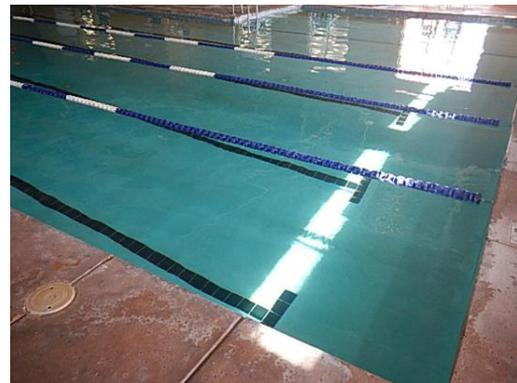
136 - Resurface	Useful Life 12	Remaining Life 6
256 lf Pool	Quantity 256	Unit of Measure Linear Feet
	Cost /l.f. \$188	
	% Included 100.00%	Total Cost/Study \$48,128
Summary	Replacement Year 2028	Future Cost \$55,814

This is to resurface the pool including start-up costs.

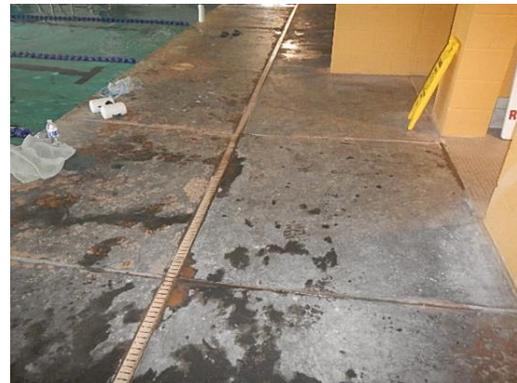
636 - Deck: Re-Surface	Useful Life 15	Remaining Life 1	
2,650 sf Pool Area Decking	Quantity 2,650	Unit of Measure	Square Feet
	Cost /SqFt \$15.99		
	% Included 100.00%	Total Cost/Study	\$42,374
Summary	Replacement Year 2023	Future Cost	\$43,433

This is to prepare and resurface the deck.

2022- Per client, move remaining life from 2022 to 2023.
 2021- Per client 6/30/2021, reinclude component with 2022 remaining life.
 2019- Deleted since replacement deck isn't coated.
 2018- Excluded as it will not be replaced within the study time frame.
 2016- Per client 4/21/2016, \$36,000 total is anticipated to replace in 2016. The deck coating was in very poor condition with many bubbled and chipped areas. The root cause for the surface's failure needs to be determined prior to removing and replacing the surface. Deck replaced with colored concrete and a sweat finish.

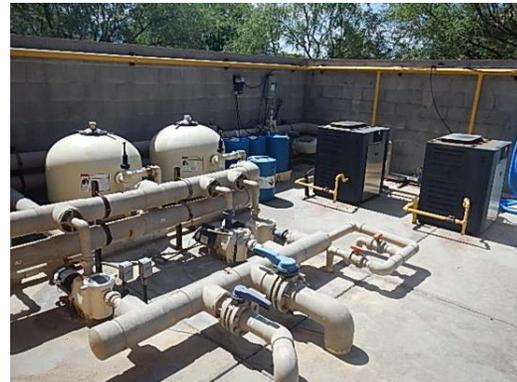
754 - Equipment: Replacement	Useful Life 5	Remaining Life 4	
Pool & Spa Equipment (50%)	Quantity 1	Unit of Measure	Lump Sum
	Cost /LS \$45,492	Qty * \$/LS	\$45,492
	% Included 50.00%	Total Cost/Study	\$22,746
Summary	Replacement Year 2026	Future Cost	\$25,108

This is to periodically replace pool and spa equipment. Since not all equipment will fail simultaneously, this component provides for one half replacement every five years.

- 1- pool filter #1, Pentair Triton II Commercial
- 1- pool filter #2, Pentair Triton II Commercial
- 1- pool filter #3, Pentair Triton II Commercial
- 1- spa filter, Pentair Triton II Commercial
- 3- Pentair IntelliFlo variable speed pumps
- 2- additional spa pumps
- 1- Dolphin Wave 100 pool vacuum
- 1- pool heater #1, Raypak Professional
- 1- pool heater #2, Raypak Professional
- 1- spa heater, Raypak Professional
- 1- pool Aquasol chemical controller
- 1- spa Aquasol chemical controller
- 1- Clear Comfort advanced oxidation system
- Assorted- chemical system probes, fittings, chem pumps, injectors, etc.
- Assorted- pipes, fittings, controls, lights, drain covers, hand rails, etc.

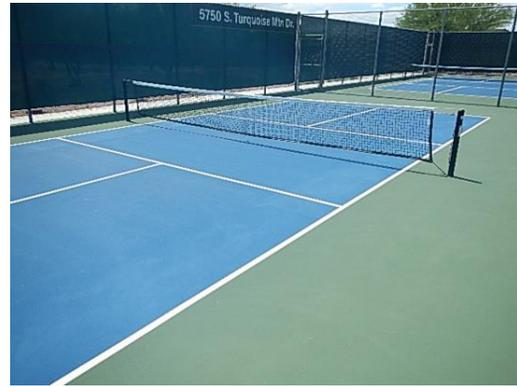
220 - Seal & Striping	Useful Life 4	Remaining Life 2	
8,650 sf [4] Pickleball Courts	Quantity 8,650	Unit of Measure Square Feet	
	Cost /SqFt \$0.800		
	% Included 100.00%	Total Cost/Study \$6,920	
Summary	Replacement Year 2024	Future Cost \$7,270

This is to prepare the courts, repair cracks with acrylic crack patch, paint with epoxy coating mixed with silica sand, and restripe. These courts are post-tensioned concrete and don't require overlay.

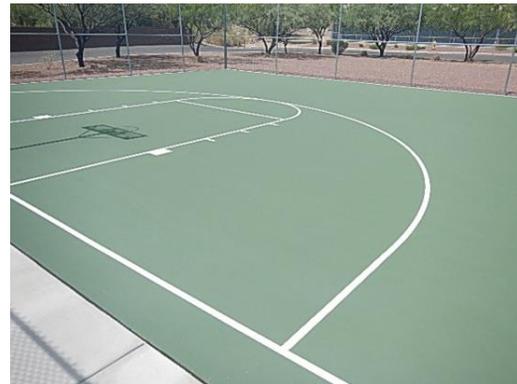
224 - Seal & Striping	Useful Life 4	Remaining Life 2	
2,690 sf Basketball 1/2 Court	Quantity 2,690	Unit of Measure Square Feet	
	Cost /SqFt \$1.38		
	% Included 100.00%	Total Cost/Study \$3,712	
Summary	Replacement Year 2024	Future Cost \$3,900

This is to prepare the court, repair cracks with acrylic crack patch, paint with epoxy coating mixed with silica sand, and restripe. The court is post-tensioned concrete and doesn't require overlay.

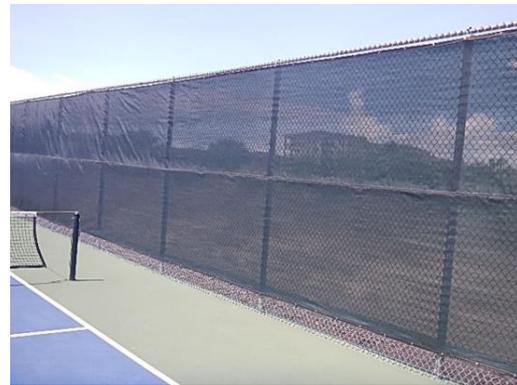
100 - Chain Link	Useful Life 30	Remaining Life 18
788 lf Pickleball & Basketball Courts	Quantity 788	Unit of Measure Linear Feet
	Cost /l.f. \$35.30	
	% Included 100.00%	Total Cost/Study \$27,816
Summary	Replacement Year 2040	Future Cost \$43,384

This is to replace the chain link fencing.

10' chain link fence at basketball court- 200 lf
 10' chain link fence at pickleball courts- 460 lf
 4' chain link fence at pickleball courts- 128 lf

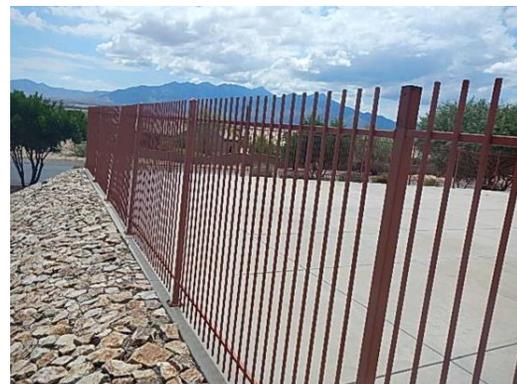
230 - Wrought Iron: 6'	Useful Life 30	Remaining Life 16
264 lf Patio Perimeter	Quantity 264	Unit of Measure Linear Feet
	Cost /l.f. \$42.36	
	% Included 100.00%	Total Cost/Study \$11,183
Summary	Replacement Year 2038	Future Cost \$16,601

This is to replace the 6' wrought iron fencing. With aggressive paint maintenance, this component's life may be extended. Painting is provided for within another component.

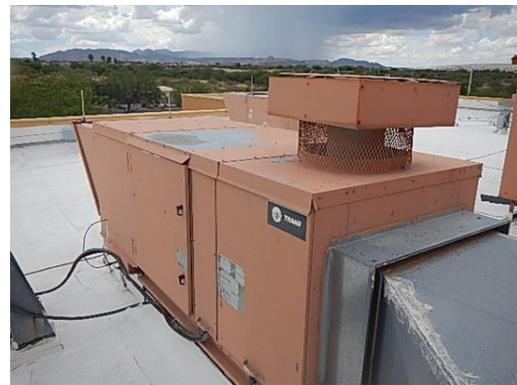
236 - HVAC	Useful Life 15	Remaining Life 1	
6 Rooftop HVAC Units- 2008	Quantity 6	Unit of Measure Items	
	Cost /itm \$14,095		
	% Included 100.00%	Total Cost/Study \$84,570	
Summary	Replacement Year 2023	Future Cost \$86,684

This is to replace the HVAC systems. It is possible that sub-components of these systems can be replaced or rebuilt to extend their life.

- Unit 1- Lobby- Trane- 5T
- Unit 2- Multi Room- Trane- 12T
- Unit 3- Women's- Aaon- 6T
- Unit 4- Men's- Aaon- 6T
- Unit 5- Fitness- Trane- 5T
- Unit 12- HPCU1- Carrier

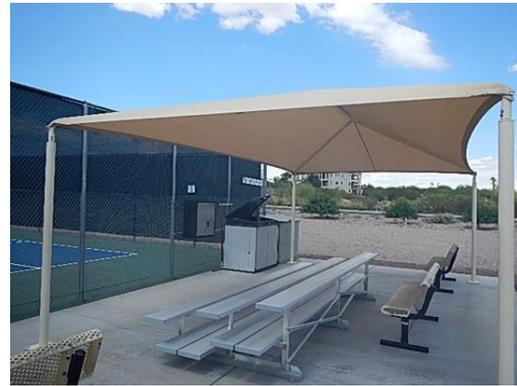
808 - Shade Structure	Useful Life 15	Remaining Life 4
500 sf [3] Shade Canopies	Quantity 500	Unit of Measure Square Feet
	Cost /SqFt \$22.95	
	% Included 100.00%	Total Cost/Study \$11,475
Summary	Replacement Year 2026	Future Cost \$12,666

This is to repair, replace and maintain the canvas canopy shade structures.

- 1- 10' x 10' metal frame, canvas top between building and basketball court.
- 2- 10' x 20' metal frame, canvas top at pickleball courts.

2011- Structures installed.

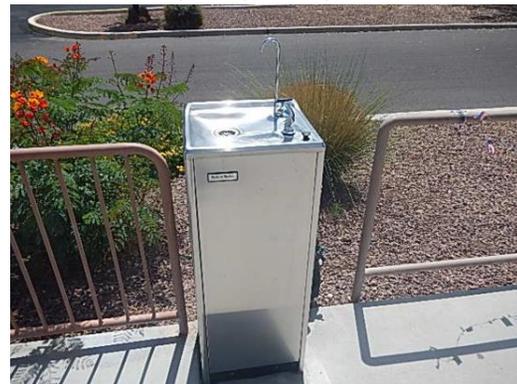
248 - Ice Machine	Useful Life 10	Remaining Life 9
Pickleball Courts	Quantity 1	Unit of Measure Items
	Cost /Itm \$6,468	
	% Included 100.00%	Total Cost/Study \$6,468
Summary	Replacement Year 2031	Future Cost \$8,078

This is for the ice machine with water dispenser and stand.

2021- \$6,220 was expended for the ice machine. Added as a reserve study component per client direction.

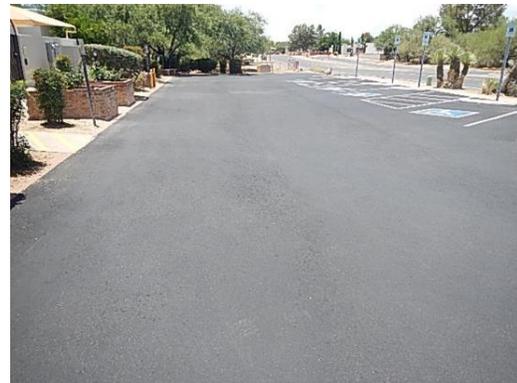
232 - Asphalt: Ongoing Repairs	Useful Life 5	Remaining Life 2	
18,768 sf 2019 Replacement Area (10%)	Quantity 18,768	Unit of Measure Square Feet	
	Cost /SqFt \$3.85	Qty * \$/SqFt \$72,257	
	% Included 10.00%	Total Cost/Study \$7,226	
Summary	Replacement Year 2024	Future Cost \$7,591

This is for miscellaneous repairs including emulsion sealing, crack fill, skin patching, minor dig out & fill, and re-striping to match the existing layout. Cracks 1/4" or wider should be filled when observed.

2019- Lot was removed and replaced.

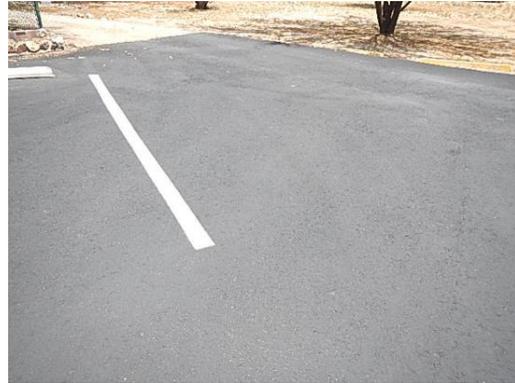
236 - Asphalt: Ongoing Repairs 15,000 sf 2020 Addition Area (10%)	Useful Life 5 Remaining Life 4 Quantity 15,000 Cost /SqFt \$3.85 % Included 10.00%	Unit of Measure Square Feet Qty * \$/SqFt \$57,750 Total Cost/Study \$5,775 Future Cost \$6,375
Summary	Replacement Year 2026

This is for miscellaneous repairs including emulsion sealing, crack fill, skin patching, minor dig out & fill, and re-striping to match the existing layout. Cracks 1/4" or wider should be filled when observed.

2020- Per client 6/15/2020, 15,000 sf was added to the east side for \$28,910 in 2020.

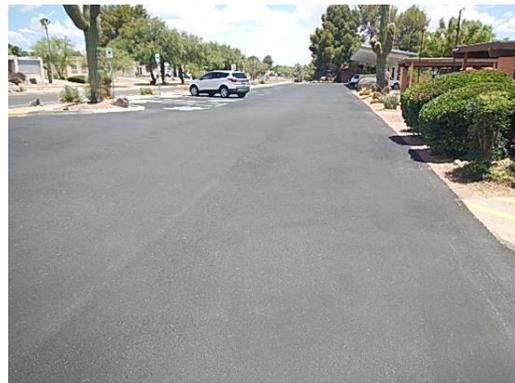
348 - Asphalt: Overlay w/ Interlayer 18,768 sf 2019 Replacement Area	Useful Life 25 Remaining Life 22 Quantity 18,768 Cost /SqFt \$2.10 % Included 100.00%	Unit of Measure Square Feet Total Cost/Study \$39,413 Future Cost \$67,852
Summary	Replacement Year 2044

This is to apply a geotextile interlayer to the existing asphalt surface and overlay with a minimum of 1.5" of new hot mix asphalt. Generally this includes edge grinding and utility box extensions.

2019- \$36,000 was expended to R&R the lot per client 6/14/2019. This component is reverted from current major repair to future overlay.

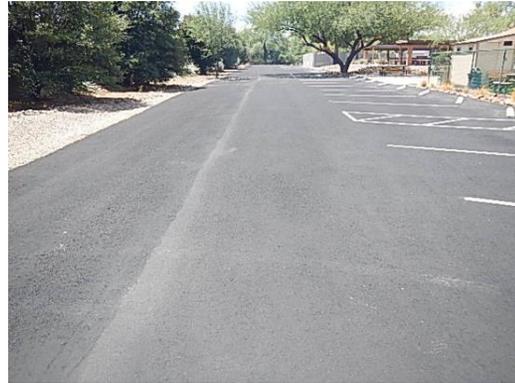
352 - Asphalt: Overlay w/ Interlayer	Useful Life 25	Remaining Life 23	
15,000 sf 2020 Addition Area	Quantity 15,000	Unit of Measure Square Feet	
	Cost /SqFt \$2.10		
	% Included 100.00%	Total Cost/Study \$31,500	
Summary	Replacement Year 2045	Future Cost \$55,585

This is to apply a geotextile interlayer to the existing asphalt surface and overlay with a minimum of 1.5" of new hot mix asphalt. Generally this includes edge grinding and utility box extensions.

2020- Per client 6/15/2020, 15,000 sf was added in 2020.

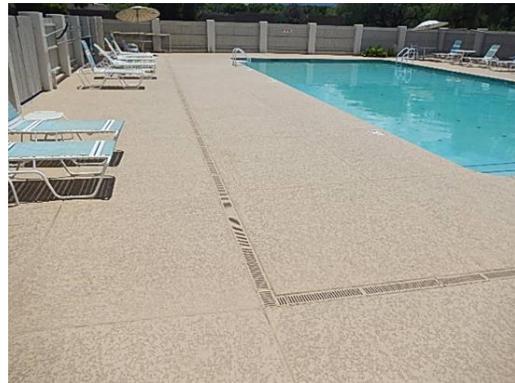
442 - Pool Deck	Useful Life 2	Remaining Life 2	
5,565 sf Pool/Spa Area Concrete Repair (5%)	Quantity 5,565	Unit of Measure Square Feet	
	Cost /SqFt \$23.50	Qty * \$/SqFt \$130,778	
	% Included 5.00%	Total Cost/Study \$6,539	
Summary	Replacement Year 2024	Future Cost \$6,870

This is to periodically repair and replace concrete pool deck, deck drains and deck mastic to remove abrupt elevation shifts and to maintain functionality. Since concrete pool deck useful life typically exceeds the scope of the 30-year study, this component provides for repair only and not full replacement. However, as the deck ages and undergoes multiple repairs and patches, this component may revert from occasional partial repairs to full replacement. Deck acrylic lace coating replacement is provided for within another component.

2019- \$9,532 was expended per client 6/14/2019. Per client 7/22/2019, decrease useful life from 5 to 2 years.

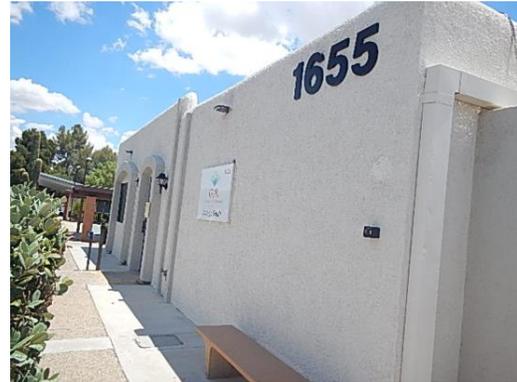
200 - Surface Restoration	Useful Life 10	Remaining Life 6
7,191 sf Exterior Surfaces	Quantity 7,191	Unit of Measure Square Feet
	Cost /SqFt \$1.40	
	% Included 100.00%	Total Cost/Study \$10,067
Summary	Replacement Year 2028	Future Cost \$11,675

This is to prepare, power wash, sand, scrape, caulk and paint with a 100% premium acrylic paint.

2019- Paint appears in excellent condition, per client recently painted.

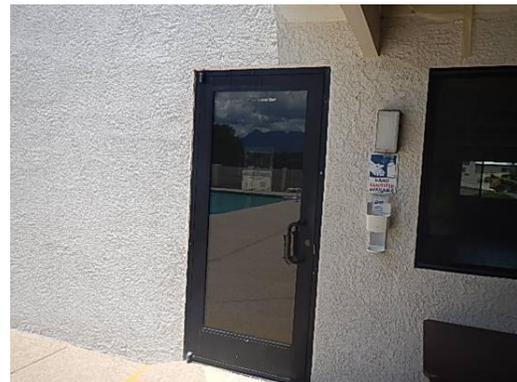
936 - Doors	Useful Life 10	Remaining Life 2
16 Exterior & Interior Doors (25%)	Quantity 16	Unit of Measure Items
	Cost /Itm \$1,750	Qty * \$/Itm \$28,000
	% Included 25.00%	Total Cost/Study \$7,000
Summary	Replacement Year 2024	Future Cost \$7,354

This is to periodically repair, replace and maintain exterior and interior doors including items such as panic exit hardware, automatic door operators, door closers, frames/jambes, posts, locks/latches, etc.

- 3- interior
- 13- exterior

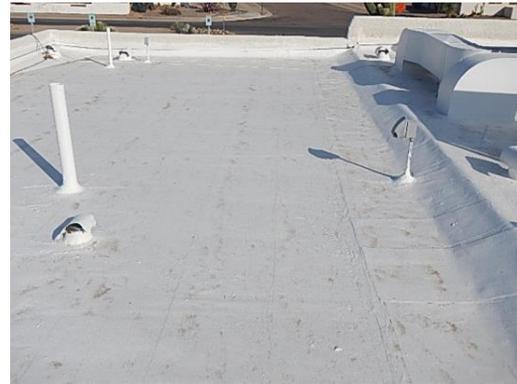
360 - Low Slope: Vinyl 49 Squares- Pool Building Roofs	Useful Life 20 Quantity 49 Cost /Sqrs \$710 % Included 100.00%	Remaining Life 9 Unit of Measure Squares Total Cost/Study \$34,790 Future Cost \$43,448
Summary	Replacement Year 2031

This is to replace the low slope single-ply vinyl roofing system. All roofs should be regularly inspected and repaired as indicated to ensure maximum life.

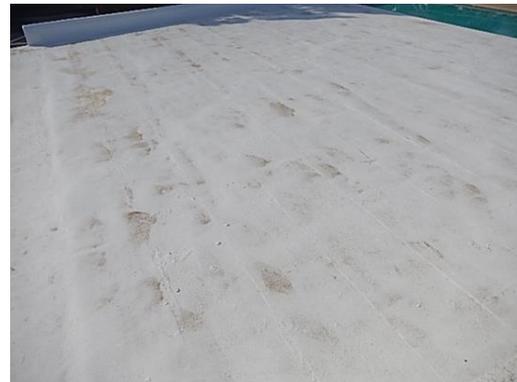
962 - Coating 4,900 sf Low Slope Roof Recoating	Useful Life 5 Quantity 4,900 Cost /SqFt \$1.06 % Included 100.00%	Remaining Life 2 Unit of Measure Square Feet Total Cost/Study \$5,194 Future Cost \$5,457
Summary	Replacement Year 2024

This to prepare the roof and apply a coating to extend the roof's serviceable life by protecting against ponding water and ultraviolet rays.

2019- Some chipping exhibited. Sealing and recoating needed. Per client 6/14/2019, MSC building given 5 year life, so all coating components were adjusted to 5 year useful life. Per client 7/22/2019, Anticipate \$4,755 to recoat in 2019.

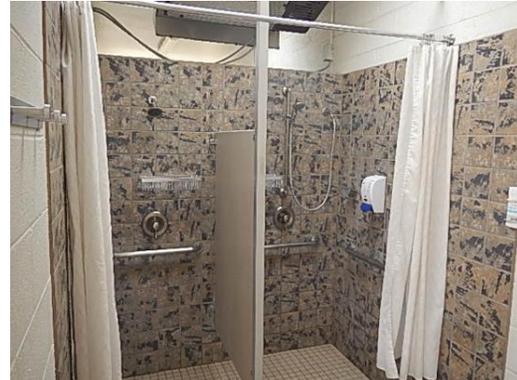
236 - Locker Rooms	Useful Life 20	Remaining Life 4	
2 Men's & Women's	Quantity 2	Unit of Measure Room	
	Cost /Rm \$38,242		
	% Included 100.00%	Total Cost/Study \$76,484	
Summary	Replacement Year 2026	Future Cost \$84,424

Men's- 2 auto-sensor sinks, 2 mirrors, 1 urinal, 1 stall, 2 showers, 3 benches, 2 electric heaters, 1 gas heater, 5 stainless steel bars, 3 lights, 1 electric hand dryer, 1 toilet paper dispenser, 2 soap dispensers, 1 paper towel dispenser, 3 clothes hangers

Women's- 2 auto-sensor sinks, 2 mirrors, 2 stalls, 2 showers, 3 benches, 2 electric heaters, 1 gas heater, 5 stainless steel bars, 3 lights, 1 electric hand dryer, 2 toilet paper dispensers, 2 soap dispensers, 1 paper towel dispenser, 3 clothes hangers

2019- Increased estimate from \$9,000 to \$35,000 per room. Client input will further define this component.

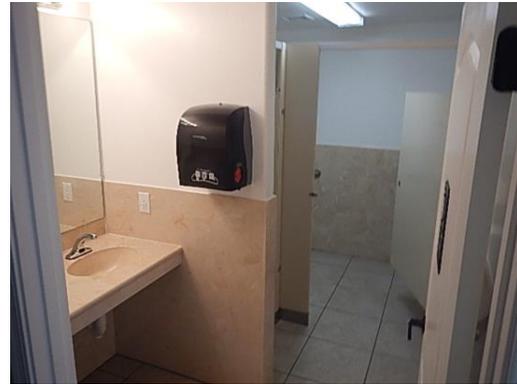
342 - Restrooms	Useful Life 20	Remaining Life 5
2 Restrooms	Quantity 2	Unit of Measure Room
	Cost /Rm \$16,390	
	% Included 100.00%	Total Cost/Study \$32,780
Summary	Replacement Year 2027	Future Cost \$37,088

Women's- 2 sinks, 2 stalls, 2 soap dispensers, 2 toilet paper dispensers, 1 soap dispenser, 1 floor light, 1 wall light

2019- Increased estimate from \$4,000 to \$15,000 per restroom.

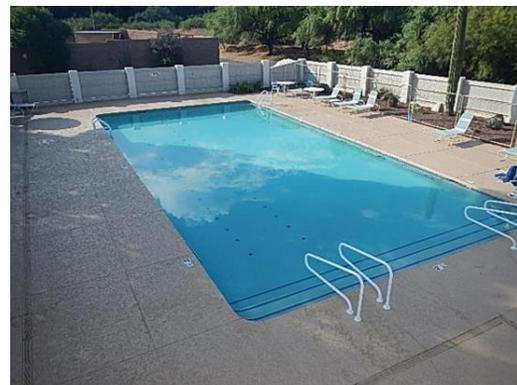
140 - Resurface	Useful Life 12	Remaining Life 4
170 lf Pool	Quantity 170	Unit of Measure Linear Feet
	Cost /l.f. \$160	
	% Included 100.00%	Total Cost/Study \$27,200
Summary	Replacement Year 2026	Future Cost \$30,024

This is to resurface the pool including start-up costs.

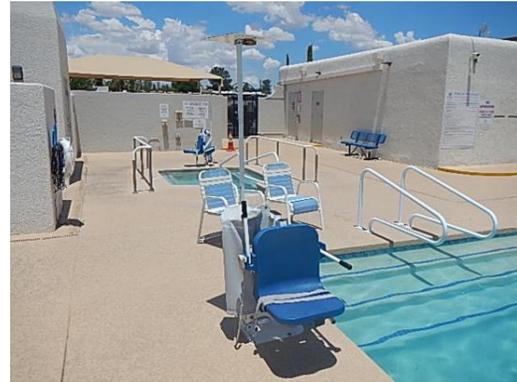
422 - ADA Chair Lift	Useful Life 10	Remaining Life 7	
Pool ADA Lift	Quantity 1	Unit of Measure	Items
	Cost /Itm \$4,218		
	% Included 100.00%	Total Cost/Study	\$4,218
Summary	Replacement Year 2029	Future Cost	\$5,014

This is to replace the pool ADA compliant chair lift.

2019- \$3,861 was expended per client 6/14/2019.

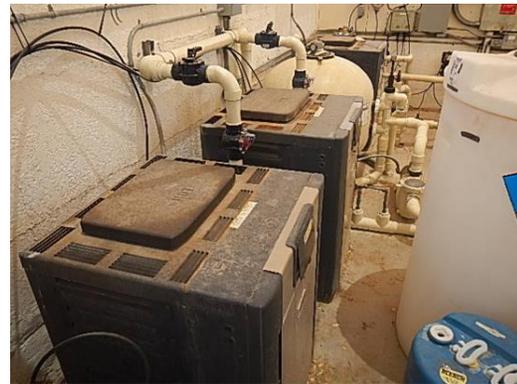
758 - Equipment: Replacement	Useful Life 5	Remaining Life 3	
Pool & Spa Equipment (50%)	Quantity 1	Unit of Measure Lump Sum	
	Cost /LS \$36,670	Qty * \$/LS \$36,670	
	% Included 50.00%	Total Cost/Study \$18,335	
Summary	Replacement Year 2025	Future Cost \$19,745

This is to periodically replace pool and spa equipment. Since not all equipment will fail simultaneously, this component provides for one half replacement every five years.

Assorted- chemical system probes, fittings, 2 chem pumps, injectors, etc.
 Assorted- pipes, fittings, controls, lights, drain covers, hand rails, etc.

2022- \$9,000 is anticipated. Move remaining life from 2022 to 2025.
 2021- Per client 6/1/2021, move remaining life from 2021 to 2022.
 2020- Per client 6/16/2020, added water level system to inventory, approximate cost \$1,564. Increased current cost by \$782, from \$16,418 to \$17,200.
 2019- \$629 was expended per client 6/14/2019.
 2018- \$1,200 was expended for spa jet pump.

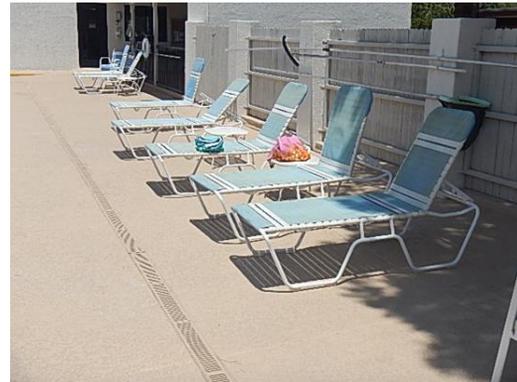
944 - Furniture: Misc	Useful Life 6	Remaining Life 3	
Pool Area Furniture	Quantity 1	Unit of Measure Lump Sum	
	Cost /LS \$7,650		
	% Included 100.00%	Total Cost/Study \$7,650	
Summary	Replacement Year 2025	Future Cost \$8,238

This is to replace miscellaneous pool furniture.

- 16- lounge chairs
- 8- chairs
- 6- tables
- 3- umbrellas

2019- \$7,000 was expended per client 6/14/2019.

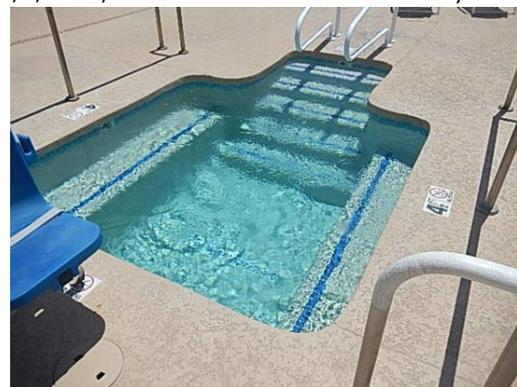
138 - Resurface	Useful Life 8	Remaining Life 0	
Spa	Quantity 1	Unit of Measure Items	
	Cost /Itm \$4,023		
	% Included 100.00%	Total Cost/Study \$4,023	
Summary	Replacement Year 2022	Future Cost \$4,023

2022- \$4,023 was expended for work currently in progress.

2019- Per client 7/22/2019, resurfaced 6/2014. Per client 8/5/2019, increase useful life from 6 to 8 years.

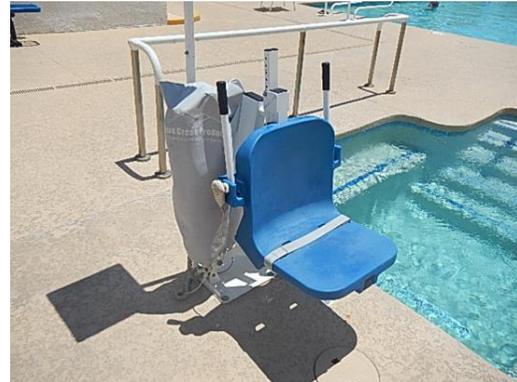
418 - ADA Chair Lift	Useful Life 10	Remaining Life 5	
Spa ADA Lift	Quantity 1	Unit of Measure	Items
	Cost /Itm \$4,982		
	% Included 100.00%	Total Cost/Study	\$4,982
Summary	Replacement Year 2027	Future Cost	\$5,637

This is to replace the spa ADA compliant chair lift.

2017- The spa lift was replaced for \$4,340.

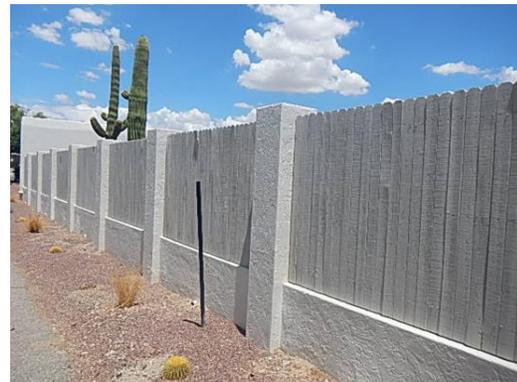
900 - Miscellaneous	Useful Life 20	Remaining Life 9	
258 If Pool Perimeter Wall/Fence	Quantity 258	Unit of Measure	Linear Feet
	Cost /l.f. \$29.41		
	% Included 100.00%	Total Cost/Study	\$7,588
Summary	Replacement Year 2031	Future Cost	\$9,476

This is for miscellaneous repairs and replacement to the pool perimeter fencing, walls and pedestrian gates.

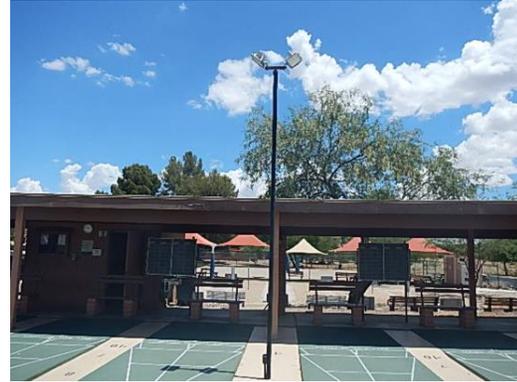
240 - Pole Lights	Useful Life 20	Remaining Life 4	
8 Shuffleboard Lights	Quantity 8	Unit of Measure	Items
	Cost /Itm \$1,412		
	% Included 100.00%	Total Cost/Study	\$11,296
Summary	Replacement Year 2026	Future Cost	\$12,469

This is to replace the shuffleboard pole lights reusing the existing wiring and conduits.

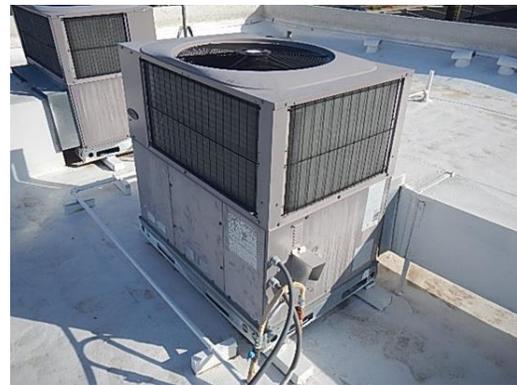
240 - HVAC	Useful Life 15	Remaining Life 4	
2 Rooftop Carrier Units- 2011	Quantity 2	Unit of Measure	Items
	Cost /Itm \$11,200		
	% Included 100.00%	Total Cost/Study	\$22,400
Summary	Replacement Year 2026	Future Cost	\$24,725

This is to replace the Carrier 4T HVAC systems. It is possible that sub-components of these systems can be replaced or rebuilt to extend their life.

- Unit 1- West Lobby- Carrier- 4T
- Unit 2- East Lobby/Restrooms- Carrier- 4T

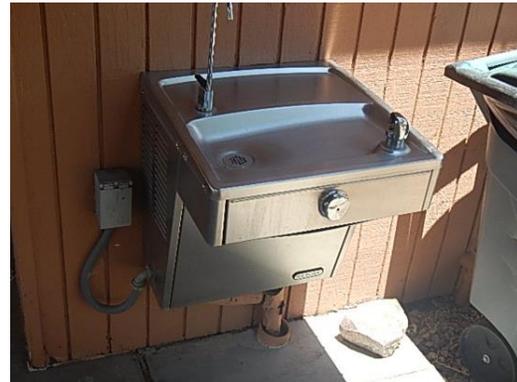
480 - Drinking Fountain	Useful Life 20	Remaining Life 4	
2 Drinking Fountain	Quantity 2	Unit of Measure	Items
	Cost /Itm \$3,278		
	% Included 100.00%	Total Cost/Study	\$6,556
Summary	Replacement Year 2026	Future Cost	\$7,237

This is to replace the drinking fountain. The fountain should be inspected, cleaned and sanitized frequently. Handle assemblies should be lubricated every six months.

- 1- pool area
- 1- volleyball court

2019- Per client 7/22/2019, increase estimate from \$1,800 to \$3,000 and keep this drinking fountain component in study.

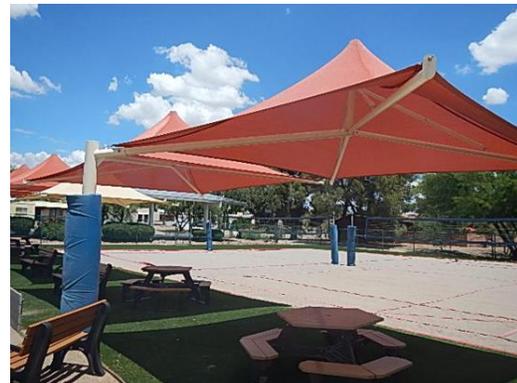
812 - Shade Structure	Useful Life 15	Remaining Life 10	
564 [3] Volleyball Shade Canopies	Quantity 564	Unit of Measure	Items
	Cost /Itm \$22.95		
	% Included 100.00%	Total Cost/Study	\$12,944
Summary	Replacement Year 2032	Future Cost	\$16,569

This is to repair and replace the canvas canopy shade structures.

- 1- 12'x12'
- 2- 14'x15' (2017)

2018- Verified \$11,890/each for 2 structures installed in 2017.

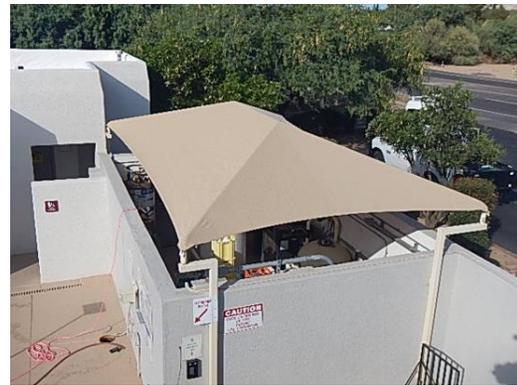
880 - Shade Structure 264 sf Pool Shade Canopy	Useful Life 15 Quantity 264 Cost /SqFt \$22.95 % Included 100.00%	Remaining Life 7 Unit of Measure Square Feet Total Cost/Study \$6,059 Replacement Year 2029 Future Cost \$7,202
---	--	---

This is to repair and replace the canvas canopy shade structure.

1- 10'x20'

2014- Structure installed.

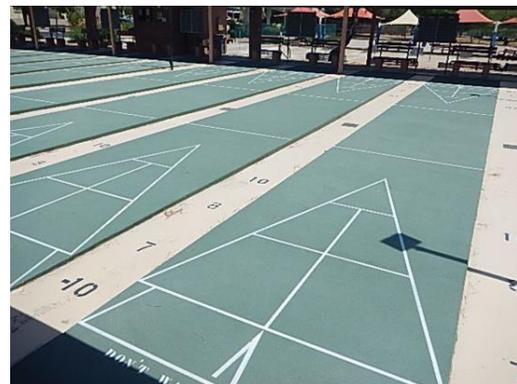
900 - Shuffleboard Court 3,744 sf [12] Shuffleboard Courts	Useful Life 8 Quantity 3,744 Cost /SqFt \$4.41 % Included 100.00%	Remaining Life 3 Unit of Measure Square Feet Total Cost/Study \$16,511 Replacement Year 2025 Future Cost \$17,781
---	--	---

This is to resurface the shuffleboard courts.

2017- The surface was replaced.

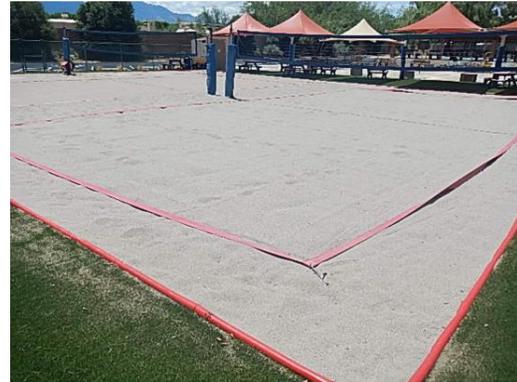
910 - Miscellaneous	Useful Life 7	Remaining Life 3	
3,500 sf [2] Volleyball Court Sand	Quantity 3,500	Unit of Measure Square Feet	
	Cost /SqFt \$9.37		
	% Included 100.00%	Total Cost/Study \$32,795	
Summary	Replacement Year 2025	Future Cost \$35,317

This is to replenish the volleyball court sand.

2019- \$30,000 total was expended to install 1 court in 2018 and 1 in 2019 with a 7 year life per client 6/14/2019.

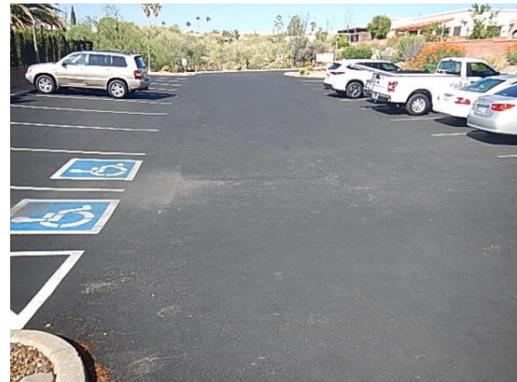
404 - Asphalt: Overlay	Useful Life 20	Remaining Life 18	
6,726 sf Parking Lot	Quantity 6,726	Unit of Measure Square Feet	
	Cost /SqFt \$2.10		
	% Included 100.00%	Total Cost/Study \$14,125	
Summary	Replacement Year 2040	Future Cost \$22,030

This is for major excavation, re-compaction and installation of new hot mix asphalt to selected areas.

2020- \$18,100 was expended for pavement overlay.
 2017- Client advises this was sealed in 2015, but sealing has been excluded.
