Reserve Study Transmittal Letter

Re: Green Valley Recreation Inc; Update w/ Site Visit Review

RESERVE STUDY

Update w/ Site Visit Review

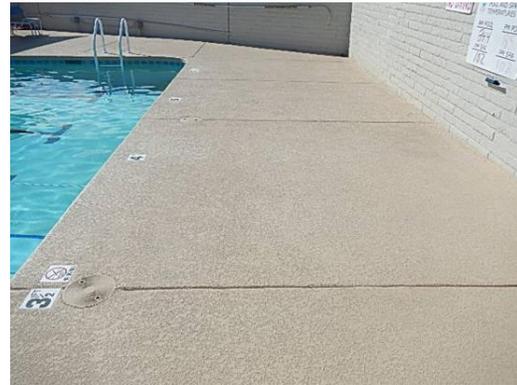
448 - Pool Deck	Useful Life 2	Remaining Life 1	
4,748 sf Pool/Spa Area Concrete Repair (6%)	Quantity 4,748	Unit of Measure Square Feet	
	Cost /SqFt \$29.00	Qty * \$/SqFt \$137,692	
	% Included 6.00%	Total Cost/Study \$8,262	
Summary	Replacement Year 2023	Future Cost \$8,468

This is to periodically repair and replace concrete pool deck, deck drains and deck mastic to remove abrupt elevation shifts and to maintain functionality. Since concrete pool deck useful life typically exceeds the scope of the 30-year study, this component provides for repair only and not full replacement. However, as the deck ages and undergoes multiple repairs and patches, this component may revert from occasional partial repairs to full replacement. Deck acrylic lace coating replacement is provided for within another component.

2020- \$7,747 is anticipated in 2020. Per client 8/6/2020, the 2020 work has been cancelled and now anticipated during 2023.

2019- Per client 7/22/2019, decrease useful life from 5 to 2 years.

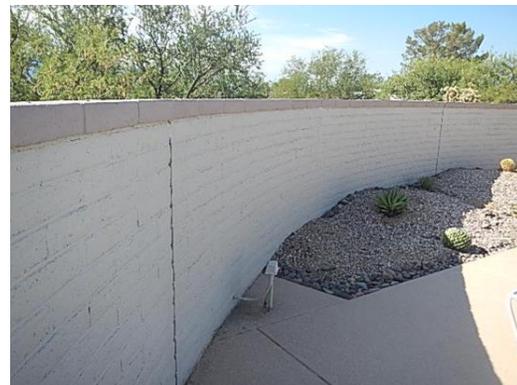
120 - Surface Restoration	Useful Life 10	Remaining Life 5	
3,600 sf Recreation Building & Walls	Quantity 3,600	Unit of Measure Square Feet	
	Cost /SqFt \$1.70	Total Cost/Study \$6,120	
	% Included 100.00%	Future Cost \$6,924	
Summary	Replacement Year 2027

This is to prepare, power wash, sand, scrape, caulk and paint with a 100% premium acrylic paint.

2018- Added to study for first time. Scope and quantity estimated.

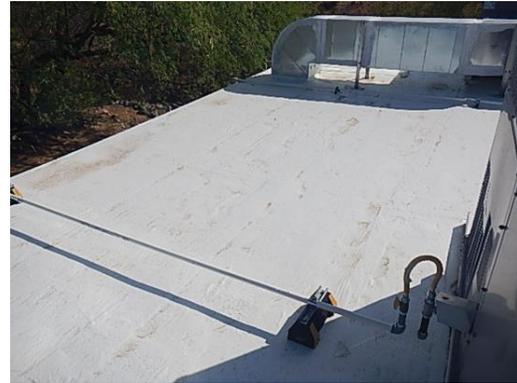
340 - Low Slope: Vinyl	Useful Life 20	Remaining Life 19	
20 Squares- Pool Building Roof	Quantity 20	Unit of Measure Squares	
	Cost /Sqrs \$1,144		
	% Included 100.00%	Total Cost/Study \$22,880	
Summary	Replacement Year 2041	Future Cost \$36,577

This is to replace the low slope single-ply vinyl roofing system. All roofs should be regularly inspected and repaired as indicated to ensure maximum life.

2021- \$22,000 was expended.

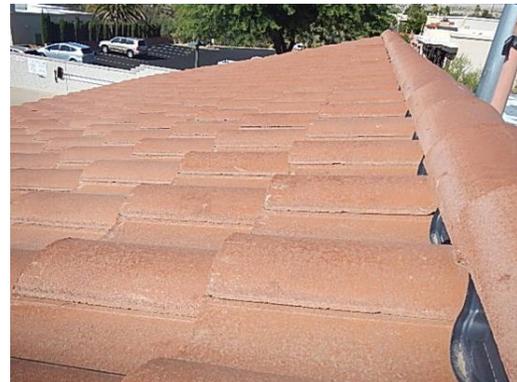
612 - Pitched: Tile	Useful Life 30	Remaining Life 29	
13 Squares- Pool Building Roof	Quantity 13	Unit of Measure Squares	
	Cost /Sqrs \$1,120		
	% Included 100.00%	Total Cost/Study \$14,560	
Summary	Replacement Year 2051	Future Cost \$29,796

This is to replace the tile roofing system. Tile roofs should be regularly inspected and repaired as indicated to ensure maximum life.

2021- \$14,000 was expended.

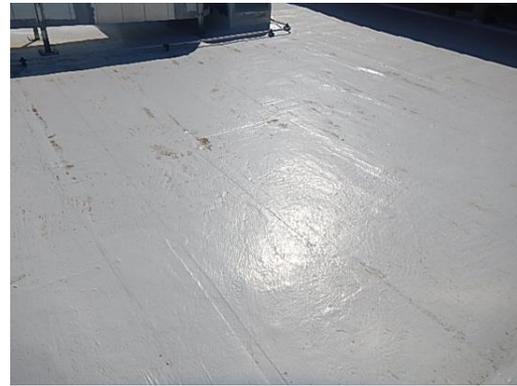
966 - Coating	Useful Life 5	Remaining Life 3
2,000 sf Low Slope Roof Recoating	Quantity 2,000	Unit of Measure Square Feet
	Cost /SqFt \$3.06	
	% Included 100.00%	Total Cost/Study \$6,120
Summary	Replacement Year 2025	Future Cost \$6,591

This to prepare the roof and apply a coating to extend the roof's serviceable life by protecting against ponding water and ultraviolet rays.

2020- \$2,500 was expended for roof coating done in-house by staff.
 2019- Per client 6/14/2019, MSC building given 5 year life, so all coating components were adjusted to 5 year useful life.

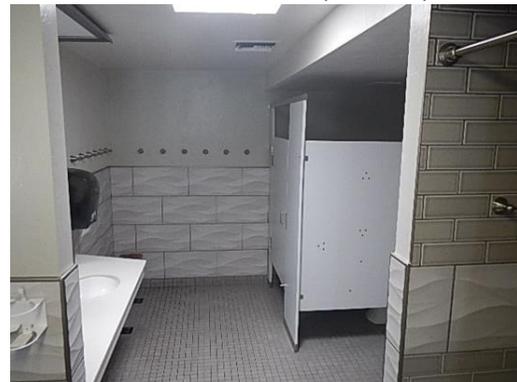
242 - Locker Rooms	Useful Life 20	Remaining Life 15
2 Men's & Women's	Quantity 2	Unit of Measure Room
	Cost /Rm \$34,152	
	% Included 100.00%	Total Cost/Study \$68,304
Summary	Replacement Year 2037	Future Cost \$98,924

This is to rehab the locker rooms including items such as showers, fixtures, partitions, lighting, ventilation, etc. Client input will further define this component.

2017- \$59,500 was expended for rehab which was performed earlier and for more than previously estimated.

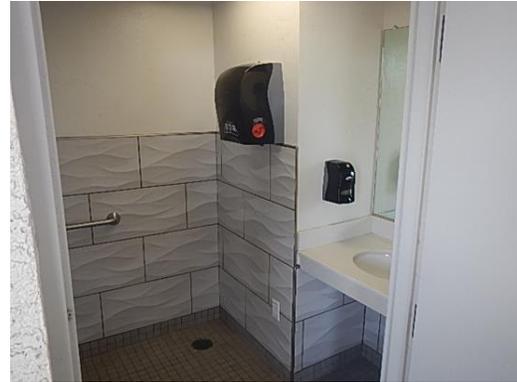
246 - Bathrooms	Useful Life 20	Remaining Life 15	
Companion Restroom	Quantity 1	Unit of Measure Room	
	Cost /Rm \$20,159		
	% Included 100.00%	Total Cost/Study \$20,159	
Summary	Replacement Year 2037	Future Cost \$29,197

This is to rehab and redecorate the bathrooms including items such as partitions, fixtures, lighting, tile, etc. Client input will further define this component.

2018- Per client, work was performed for unknown cost in 2017.
 2017- Scope includes countertops, sink, toilets, wall & floor tile.

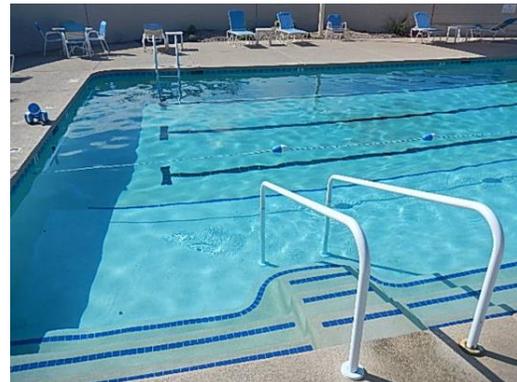
146 - Resurface	Useful Life 12	Remaining Life 8	
180 lf Pool	Quantity 180	Unit of Measure Linear Feet	
	Cost /l.f. \$160		
	% Included 100.00%	Total Cost/Study \$28,800	
Summary	Replacement Year 2030	Future Cost \$35,090

This is to resurface the pool including start-up costs.

2018- \$25,735 was expended to re-plaster in July.

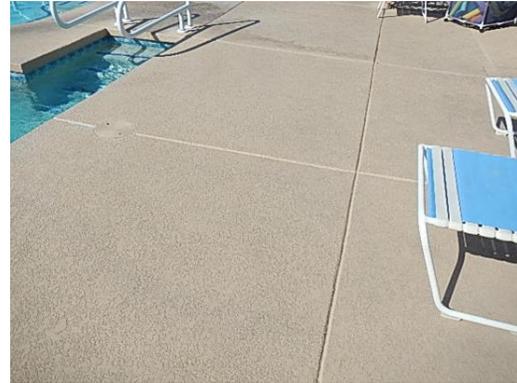
648 - Deck: Re-Surface	Useful Life 15	Remaining Life 14
4,748 sf Pool/Spa Deck Coating	Quantity 4,748	Unit of Measure Square Feet
	Cost /SqFt \$5.77	
	% Included 100.00%	Total Cost/Study \$27,396
Summary	Replacement Year 2036	Future Cost \$38,710

This is to scarify the concrete deck and apply an acrylic lace coating. Concrete deck repairs are provided for within another component.

2021- \$26,323 was expended.

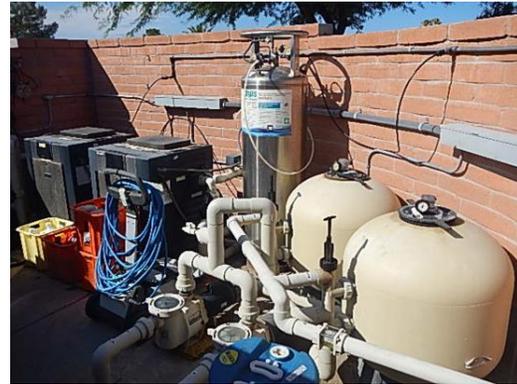
762 - Equipment: Replacement	Useful Life 5	Remaining Life 2	
Pool & Spa Equipment (50%)	Quantity 1	Unit of Measure Lump Sum	
	Cost /LS \$38,117	Qty * \$/LS \$38,117	
	% Included 50.00%	Total Cost/Study \$19,059	
Summary	Replacement Year 2024	Future Cost \$20,023

This is to periodically replace the pool and spa equipment. Since not all equipment will fail simultaneously, this component provides for one half replacement every five years.

- 1- pool filter #1, Pentair Triton II Commercial
- 1- pool filter #2, Pentair Triton II Commercial
- 1- spa filter, Pentair Triton II Commercial
- 3- Pentair IntelliFlo Variable Speed pumps- Spa & pool pumps (2) repl. 2018
- 1- additional spa pump
- 1- Dolphin C5 pool vacuum
- 1- pool heater, Raypak Professional
- 1- spa heater, Raypak Professional
- 1- pool Aquasol chemical controller- replaced 2018
- 1- spa Aquasol chemical controller- replaced 2018
- 1- Clear Comfort advanced oxidation system
- Assorted- chemical system probes, fittings, chem pumps, injectors, etc.
- Assorted- pipes, fittings, controls, lights, drain covers, hand rails, etc.

2022- \$6,000 was expended. Move remaining life from 2022 to 2024.
 2019- \$14,729 total was expended pool and spa equipment per client 6/14/2019.
 2018- \$5,803 total was expended for #1 pump motor, spa filter pump, pool/spa Aquasol systems.

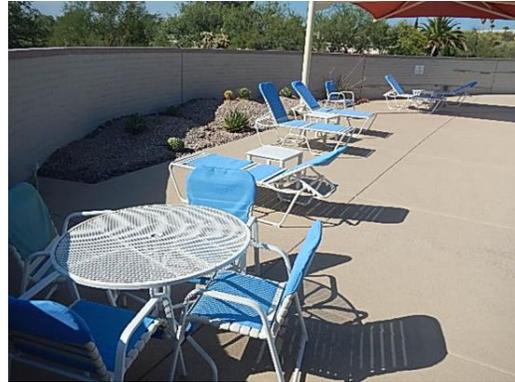
948 - Furniture: Misc	Useful Life 6	Remaining Life 0	
Pool Area Furniture	Quantity 1	Unit of Measure Lump Sum	
	Cost /LS \$7,538		
	% Included 100.00%	Total Cost/Study \$7,538	
Summary	Replacement Year 2022	Future Cost \$7,538

This is to replace miscellaneous pool furniture.

2022- \$7,538 is anticipated.
 2019- \$3,500 was expended to replace the slings only per client 6/14/2019.
 2017- \$2,463 total was expended to replace 2 tables and 8 chairs.

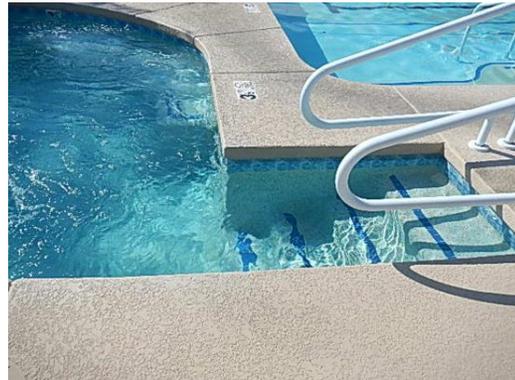
142 - Resurface	Useful Life 8	Remaining Life 7	
Spa	Quantity 1	Unit of Measure Items	
	Cost /Itm \$7,863		
	% Included 100.00%	Total Cost/Study \$7,863	
Summary	Replacement Year 2029	Future Cost \$9,347

This is to resurface the spa including start-up costs.

2021- \$7,561 was expended.
 2019- Per client 7/22/2019, resurfaced 9/2013. Per client 8/5/2019, increase useful life from 6 to 8 years.

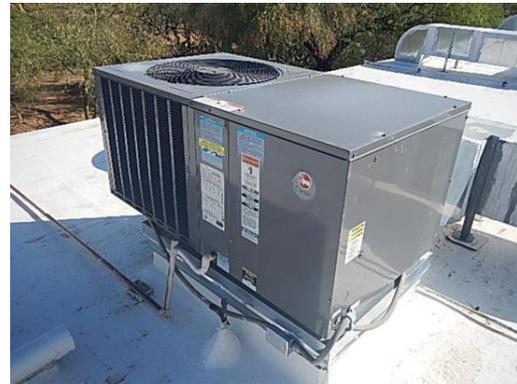
244 - HVAC	Useful Life 15	Remaining Life 12
Rooftop Rheem Unit #3- 2019	Quantity 1	Unit of Measure Items
	Cost /Itm \$8,468	
	% Included 100.00%	Total Cost/Study \$8,468
Summary	Replacement Year 2034	Future Cost \$11,389

This is to replace the Carrier HVAC system. It is possible that sub-components of this system can be replaced or rebuilt to extend its life.

Unit 3- Wash Room- Rheem- 2.5T

2019- \$7,750 was expended per client 6/14/2019.

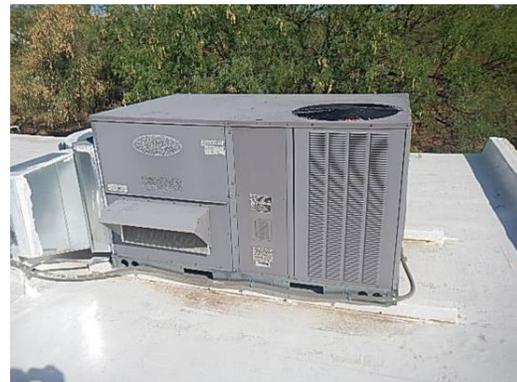
248 - HVAC	Useful Life 15	Remaining Life 6
2 Rooftop Carrier Units- 2013	Quantity 2	Unit of Measure Items
	Cost /Itm \$14,560	
	% Included 100.00%	Total Cost/Study \$29,119
Summary	Replacement Year 2028	Future Cost \$33,769

This is to replace the Carrier HVAC systems. It is possible that sub-components of these systems can be replaced or rebuilt to extend their life.

Unit 1- Building Roof- Carrier- 5T
 Unit 2- Building Roof- Carrier- 5T

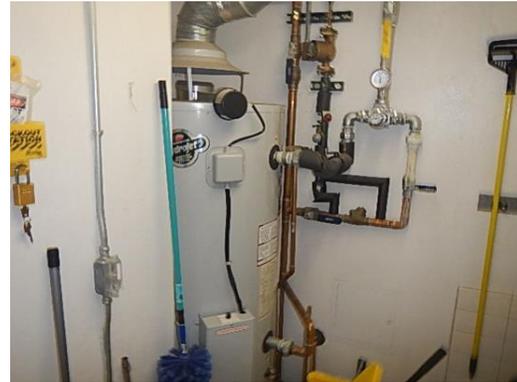
800 - Water Heater	Useful Life 12	Remaining Life 3	
Building Water Heater	Quantity 1	Unit of Measure	Items
	Cost /Itm \$5,463		
	% Included 100.00%	Total Cost/Study	\$5,463
Summary	Replacement Year 2025	Future Cost	\$5,883

This is to replace the Bradford White 100 gallon gas water heater.

2019- Per client 7/22/2019, keep this water heater component in study.

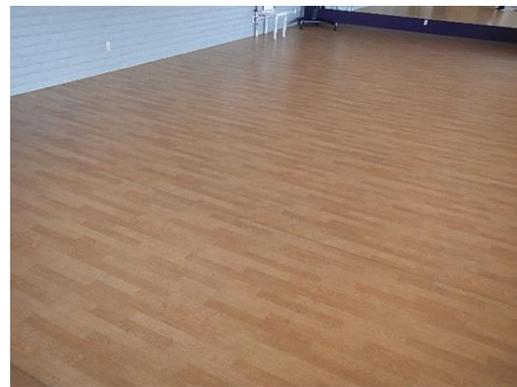
640 - Vinyl	Useful Life 10	Remaining Life 5	
125 Sq. Yds. Rec Room Sport Flooring	Quantity 125	Unit of Measure	Square Yard
	Cost /SqYd \$150		
	% Included 100.00%	Total Cost/Study	\$18,748
Summary	Replacement Year 2027	Future Cost	\$21,211

This is to replace the Rec Room Gerflor Taraflex Sport Flooring.

2018- \$16,739 was expended to install flooring in 2017 per client.

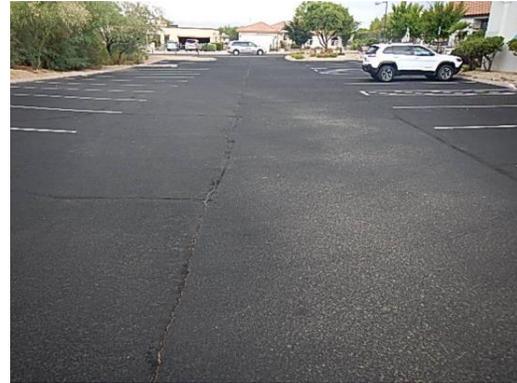
408 - Asphalt: Major Repairs	Useful Life 25	Remaining Life 10	
9,772 sf Parking Lot	Quantity 9,772	Unit of Measure Square Feet	
	Cost /SqFt \$5.85		
	% Included 100.00%	Total Cost/Study \$57,166	
Summary	Replacement Year 2032	Future Cost \$73,178

This is for major excavation, re-compaction and installation of new hot mix asphalt to selected areas.

2017- BRG had been asked to exclude the striping, crackfill and sealing. Client directed to show a 2017 expense of \$2,560 for same.

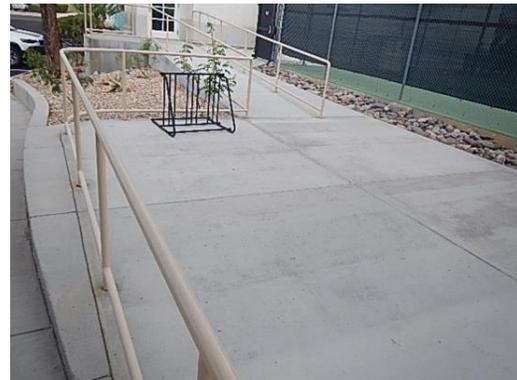
454 - Pool Deck	Useful Life 2	Remaining Life 2	
4,008 sf Pool/Spa Area Concrete Repair (7.5%)	Quantity 4,008	Unit of Measure Square Feet	
	Cost /SqFt \$23.50	Qty * \$/SqFt \$94,188	
	% Included 7.50%	Total Cost/Study \$7,064	
Summary	Replacement Year 2024	Future Cost \$7,422

This is to periodically repair and replace concrete pool deck, deck drains and deck mastic to remove abrupt elevation shifts and to maintain functionality. Since concrete pool deck useful life typically exceeds the scope of the 30-year study, this component provides for repair only and not full replacement. However, as the deck ages and undergoes multiple repairs and patches, this component may revert from occasional partial repairs to full replacement. Deck acrylic lace coating replacement is provided for within another component.

2022- No work indicated, extend remaining life from 2022 to 2023.
 2020- \$6,204 was expended.
 2019- Per client 7/22/2019, decrease useful life from 5 to 2 years.
 2018- Approximately \$5,000 was expended but not from reserves.

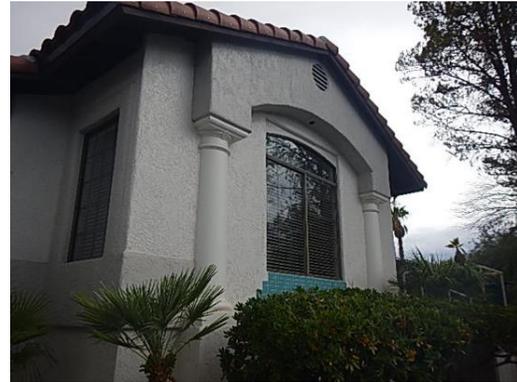
206 - Surface Restoration	Useful Life 10	Remaining Life 6
4,020 sf Exterior Surfaces	Quantity 4,020	Unit of Measure Square Feet
	Cost /SqFt \$1.80	
	% Included 100.00%	Total Cost/Study \$7,236
Summary	Replacement Year 2028	Future Cost \$8,392

This is to prepare, power wash, sand, scrape, caulk and paint with a 100% premium acrylic paint.

2019- Per client 7/22/2019, painted by staff in 2018.

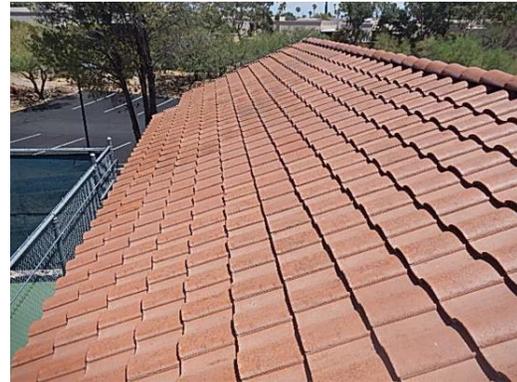
616 - Pitched: Tile	Useful Life 30	Remaining Life 29
39 Squares- Pool Building Roof	Quantity 39	Unit of Measure Squares
	Cost /Sqrs \$779	
	% Included 100.00%	Total Cost/Study \$30,368
Summary	Replacement Year 2051	Future Cost \$62,146

This is to replace the tile roofing system. Tile roofs should be regularly inspected and repaired as indicated to ensure maximum life.

2021- \$29,200 was expended.

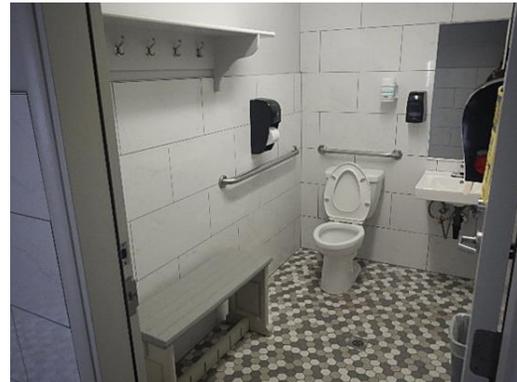
248 - Restrooms	Useful Life 20	Remaining Life 17
2 Men's & Women's	Quantity 2	Unit of Measure Room
	Cost /Rm \$8,195	
	% Included 100.00%	Total Cost/Study \$16,390
Summary	Replacement Year 2039	Future Cost \$24,939

Women's- similar to men's.

2019- \$15,000 was expended per client 6/14/2019.

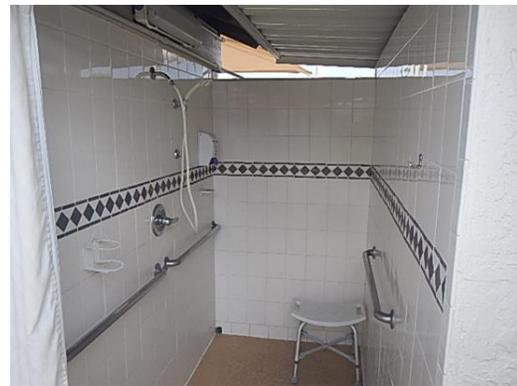
480 - Shower	Useful Life 15	Remaining Life 0	
Outdoor Pool Shower	Quantity 1	Unit of Measure Lump Sum	
	Cost /LS \$8,831		
	% Included 100.00%	Total Cost/Study \$8,831	
Summary	Replacement Year 2022	Future Cost \$8,831

This is to replace elements of the pool shower.

114 sf wall tile

2022- \$8,831 is anticipated.
 2018- Scope and cost pending in 2018.

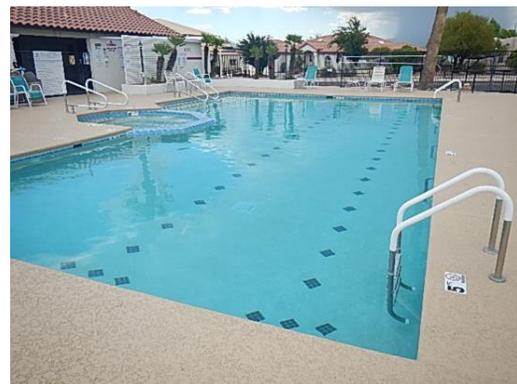
154 - Resurface	Useful Life 12	Remaining Life 6	
156 lf Pool	Quantity 156	Unit of Measure Linear Feet	
	Cost /l.f. \$160		
	% Included 100.00%	Total Cost/Study \$24,960	
Summary	Replacement Year 2028	Future Cost \$28,946

This is to resurface the pool including start-up costs.

2017- Client advises done in 2016.

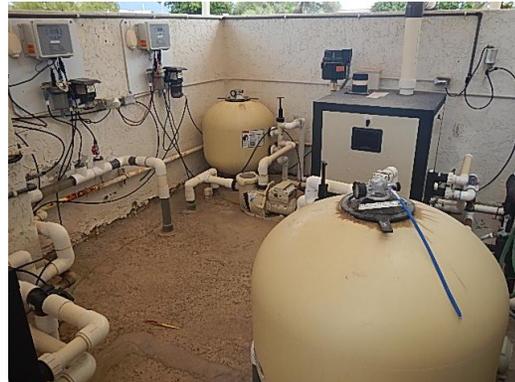
766 - Equipment: Replacement	Useful Life 5	Remaining Life 1	
Pool & Spa Equipment (50%)	Quantity 1	Unit of Measure Lump Sum	
	Cost /LS \$34,978	Qty * \$/LS \$34,978	
	% Included 50.00%	Total Cost/Study \$17,489	
Summary	Replacement Year 2023	Future Cost \$17,926

This is to periodically replace pool and spa equipment. Since not all equipment will fail simultaneously, this component provides for one half replacement every five years.

2019- \$25,126 total was expended for pool and spa equipment per client 6/14/2019.

2018- \$5,020 was expended for chlorinator Aquasol System.

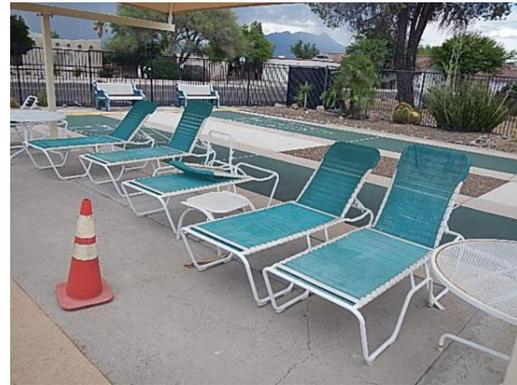
952 - Furniture: Misc	Useful Life 6	Remaining Life 5	
Pool Area Furniture	Quantity 1	Unit of Measure	Lump Sum
	Cost /LS	\$7,649	
	% Included	100.00%	Total Cost/Study \$7,649
Summary	Replacement Year	2027	Future Cost \$8,654

This is to replace miscellaneous pool furniture.

- 16- lounges
- 6- chairs
- 6- end tables
- 2- tables

2022- \$4,865 anticipated. Move remaining life from 2025 to 2027.
 2019- \$7,000 was expended per client 6/14/2019.

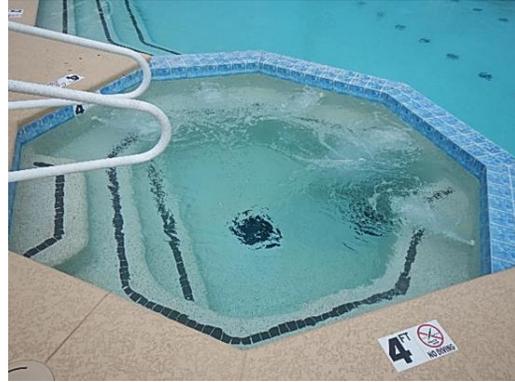
146 - Resurface Spa	Useful Life 8	Remaining Life 2	
	Quantity 1	Unit of Measure	Items
	Cost /Itm \$4,917		
	% Included 100.00%	Total Cost/Study	\$4,917
Summary	Replacement Year 2024	Future Cost	\$5,166

This is to resurface the spa including start-up costs.

2019- Per client 7/22/2019, resurfaced 9/2016. Per client 8/5/2019, increase useful life from 6 to 8 years.

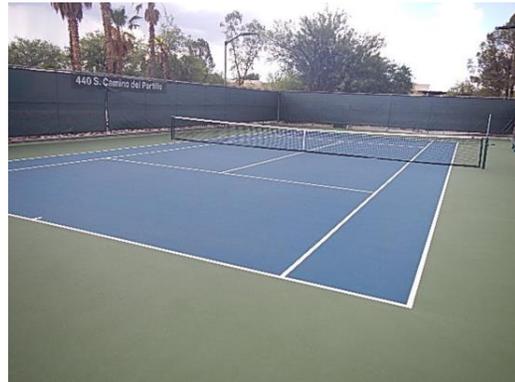
540 - Reseal 7,200 sf Tennis Court	Useful Life 4	Remaining Life 2	
	Quantity 7,200	Unit of Measure	Square Feet
	Cost /SqFt \$0.710		
	% Included 100.00%	Total Cost/Study	\$5,112
Summary	Replacement Year 2024	Future Cost	\$5,371

This is to prepare the court, repair cracks with acrylic crack patch, paint with epoxy coating mixed with silica sand, and restripe. This court is post-tensioned concrete and doesn't require overlay.

2019- \$21,322 was expended to pour new post-tension court in May per client 6/14/2019. \$4,700/court every 4 years per client 7/22/2019 estimate.

2018- Per client, reduce life to 2019.

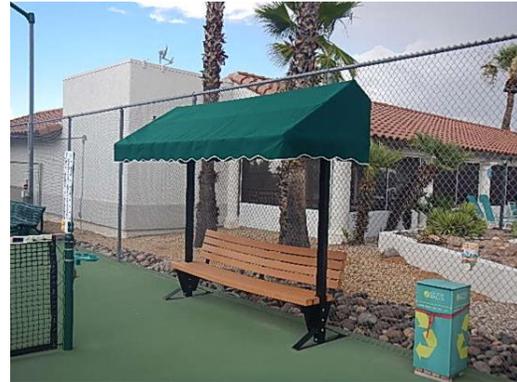
560 - Fixtures	Useful Life 15	Remaining Life 10	
Tennis Court Bench/Canopy	Quantity 1	Unit of Measure Items	
	Cost /Itm \$5,500		
	% Included 100.00%	Total Cost/Study \$5,500	
Summary	Replacement Year 2032	Future Cost \$7,040

This is to replace the tennis court bench and shade canopy.

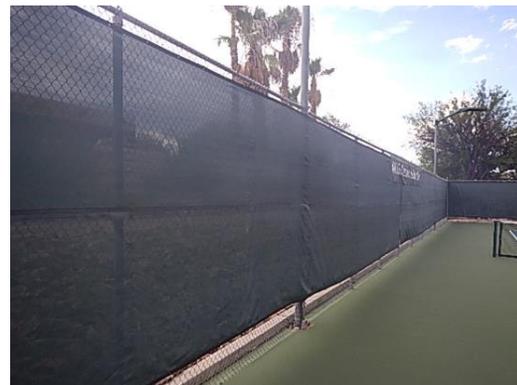
170 - Chain Link: 10'	Useful Life 30	Remaining Life 9	
360 lf Tennis Court Fence	Quantity 360	Unit of Measure Linear Feet	
	Cost /l.f. \$42.00		
	% Included 100.00%	Total Cost/Study \$15,120	
Summary	Replacement Year 2031	Future Cost \$18,883

This is to replace the 10' chain link fencing.

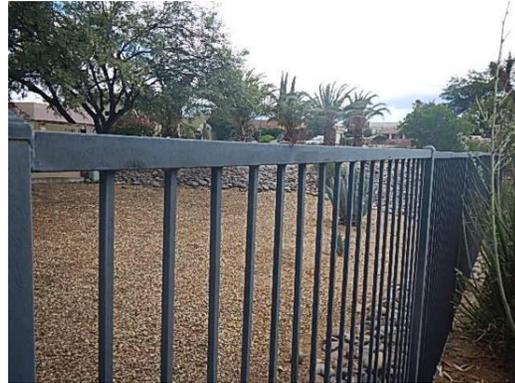
240 - Wrought Iron: 6'	Useful Life 30	Remaining Life 4
380 lf Pool Perimeter Fence	Quantity 380	Unit of Measure Linear Feet
	Cost /l.f. \$42.36	
	% Included 100.00%	Total Cost/Study \$16,097
Summary	Replacement Year 2026	Future Cost \$17,768

This is to replace the 6' wrought iron fencing. With aggressive paint maintenance, this component's life may be extended. Painting is provided for within another component.

2022- Fence exhibits faded paint. Appears structurally sound.

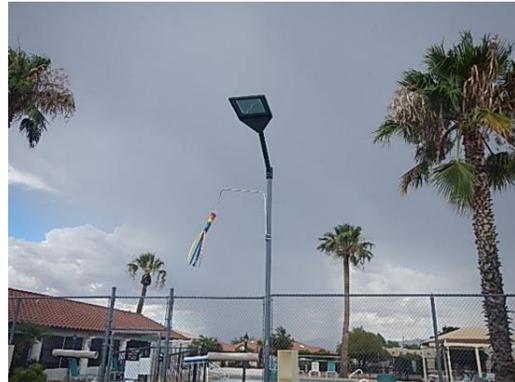
250 - Sports Field / Court	Useful Life 20	Remaining Life 17
4 Tennis Court Lights	Quantity 4	Unit of Measure Items
	Cost /itm \$2,732	
	% Included 100.00%	Total Cost/Study \$10,927
Summary	Replacement Year 2039	Future Cost \$16,626

This is to replace the tennis courts lights reusing the existing wiring and conduits.

2019- \$10,000 was expended per client 6/14/2019.

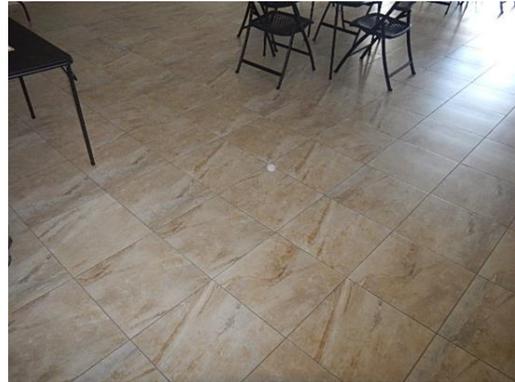
434 - Tile	Useful Life 20	Remaining Life 18	
Recreation Room & Storage	Quantity 1	Unit of Measure Lump Sum	
	Cost /LS \$10,865		
	% Included 100.00%	Total Cost/Study \$10,865	
Summary	Replacement Year 2040	Future Cost \$16,945

This is to replace the tile flooring.

2020- \$10,192 was expended to install porcelain tile in the recreation room and storage closet.

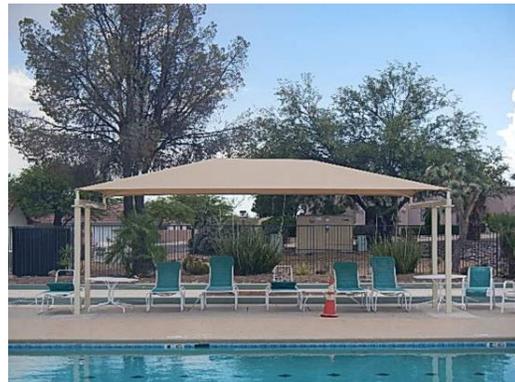
816 - Shade Structure	Useful Life 15	Remaining Life 9	
264 sf Pool Shade Canopy	Quantity 264	Unit of Measure Square Feet	
	Cost /SqFt \$22.95		
	% Included 100.00%	Total Cost/Study \$6,059	
Summary	Replacement Year 2031	Future Cost \$7,567

This is to repair and replace the canvas canopy shade structure.

1- 24'x11'

2016- Structure installed.

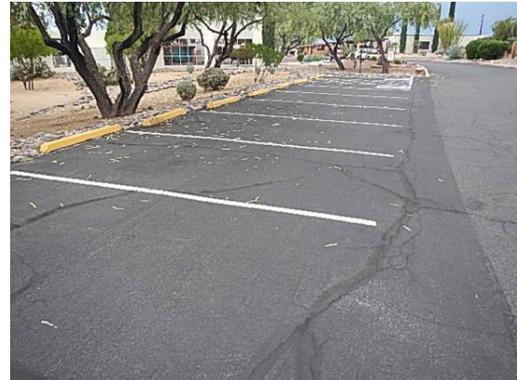
412 - Asphalt: Major Repairs	Useful Life 25	Remaining Life 2
7,128 sf Parking Areas	Quantity 7,128	Unit of Measure Square Feet
	Cost /SqFt \$5.85	
	% Included 100.00%	Total Cost/Study \$41,699
Summary	Replacement Year 2024	Future Cost \$43,810

This is for major excavation, re-compaction and installation of new hot mix asphalt to selected areas.

2021- Per client 6/30/2021, extend remaining life from 2022 to 2023.

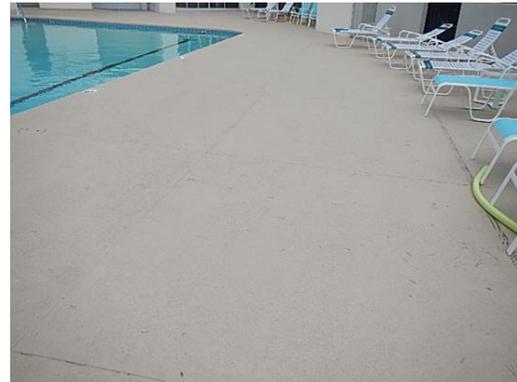
460 - Pool Deck	Useful Life 2	Remaining Life 2	
6,128 sf Pool/Spa Area Concrete Repair (8%)	Quantity 6,128	Unit of Measure Square Feet	
	Cost /SqFt \$23.50	Qty * \$/SqFt \$144,008	
	% Included 8.27%	Total Cost/Study \$11,912	
Summary	Replacement Year 2024	Future Cost \$12,515

This is to periodically repair and replace concrete pool deck, deck drains and deck mastic to remove abrupt elevation shifts and to maintain functionality. Since concrete pool deck useful life typically exceeds the scope of the 30-year study, this component provides for repair only and not full replacement. However, as the deck ages and undergoes multiple repairs and patches, this component may revert from occasional partial repairs to full replacement. Deck acrylic lace coating replacement is provided for within another component.

2021- Per client 6/1/2021, move remaining life from 2021 to 2024.
 2019- \$10,919 was expended per client 6/14/2019. Per client 7/22/2019, reduce useful life from 5 to 2 years.

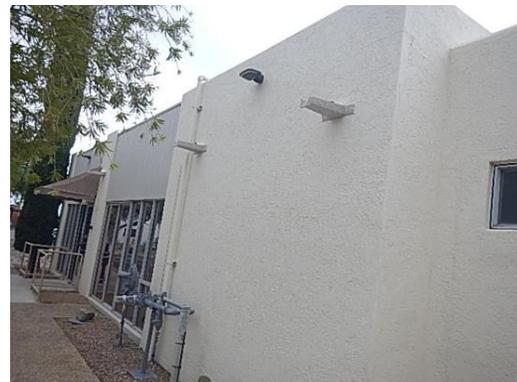
212 - Surface Restoration	Useful Life 10	Remaining Life 4	
7,470 sf Exterior Surfaces	Quantity 7,470	Unit of Measure Square Feet	
	Cost /SqFt \$1.40	Total Cost/Study \$10,458	
	% Included 100.00%	Future Cost \$11,544	
Summary	Replacement Year 2026

This is to prepare, power wash, sand, scrape, caulk and paint with a 100% premium acrylic paint.

2017- \$4,124 was expended for unknown scope.

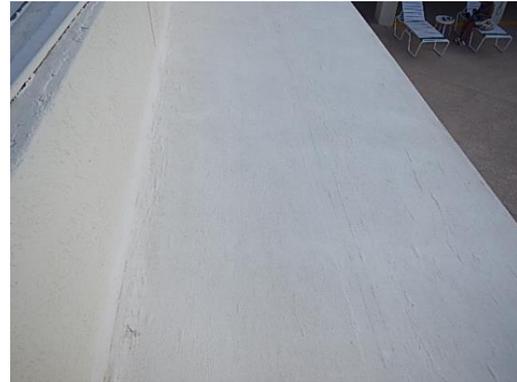
344 - Low Slope: Vinyl	Useful Life 20	Remaining Life 2	
61 Squares- Pool Building & Shade Structure Roofs	Quantity 61	Unit of Measure Squares	
	Cost /Sqrs \$710		
	% Included 100.00%	Total Cost/Study \$43,310	
Summary	Replacement Year 2024	Future Cost \$45,503

This is to replace the low slope single-ply vinyl roofing system. All roofs should be regularly inspected and repaired as indicated to ensure maximum life. Includes the re-roofing of the two 33' x 50' shuffleboard court shade structures.

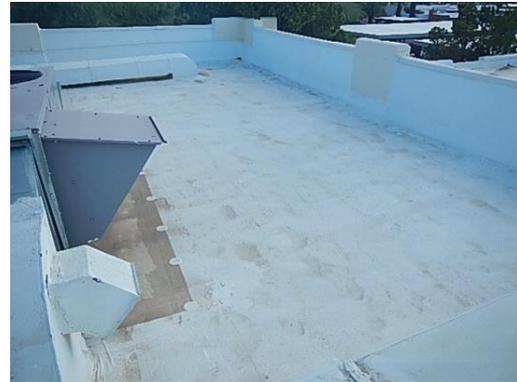
970 - Coating	Useful Life 5	Remaining Life 2	
6,100 sf Low Slope Roof Recoating	Quantity 6,100	Unit of Measure Square Feet	
	Cost /SqFt \$2.50		
	% Included 100.00%	Total Cost/Study \$15,250	
Summary	Replacement Year 2024	Future Cost \$16,022

This to prepare the roof and apply a coating to extend the roof's serviceable life by protecting against ponding water and ultraviolet rays.

2019- \$13,800 was expended per client 6/14/2019.

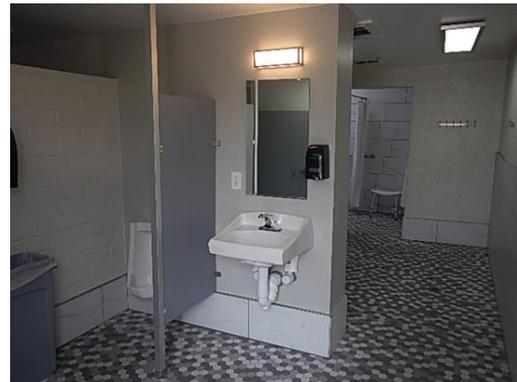
254 - Locker Rooms	Useful Life 20	Remaining Life 18
2 Men's, Women's & Outdoor Shower	Quantity 2	Unit of Measure Room
	Cost /Rm \$55,965	
	% Included 100.00%	Total Cost/Study \$111,930
Summary	Replacement Year 2040	Future Cost \$174,573

Men's- 325 sf floor tile, 356 sf- wall tile, 613 sf painted walls & ceiling, 6 lf partition, 1 skylight, 10 stainless steel grab bars, 2 showers, 5 lights, 1 bench, 1 sink, 1 urinal, 1 toilet, 1 toilet paper dispenser, 1 soap dispenser, 1 paper towel dispenser.

2019- Per client 6/14/2019, increase estimate from \$38,950 to \$108,950 and extend remaining life from 2019 to 2020.

2018- Estimate increased by \$20,000 per client.

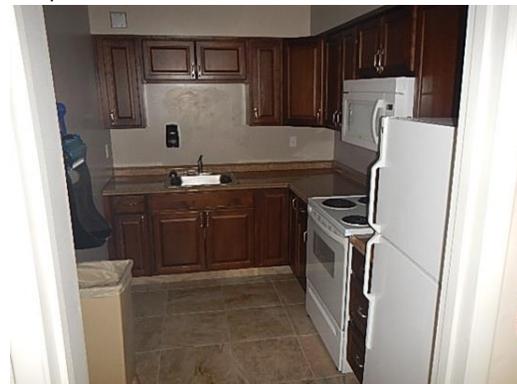
418 - Kitchen	Useful Life 20	Remaining Life 9
Clubhouse Kitchen	Quantity 1	Unit of Measure Room
	Cost /Rm \$7,649	
	% Included 100.00%	Total Cost/Study \$7,649
Summary	Replacement Year 2031	Future Cost \$9,552

This is to rehab and redecorate the kitchen including items such as cabinets, countertops, fixtures, lighting, etc. Client input will further define this component.

2020- Tile was installed and is provided for within another component.

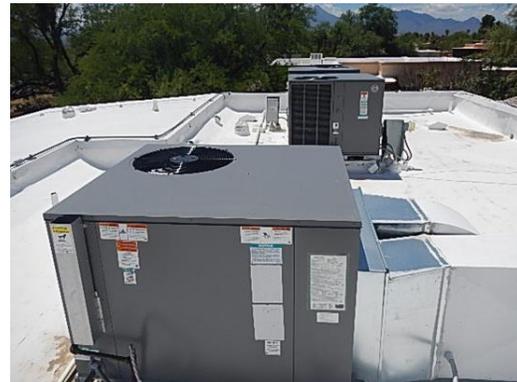
This is to replace the Rheem HVAC system. It is possible that sub-components of this system can be replaced or rebuilt to extend its life.

Model #- RGEA14036AJT08XAB, Serial #- F392000240, MFG 09/2020
 Model #- RQPL_B030JK, Serial # F0620001380, MFG 02/2020, Women's LR
 Model #- RQPL_B030JK, Serial #- F072000586, MFG 02/2020, Men's LR

2021- Per client 6/1/2021, \$6,250 expended to replace HVAC unit, 3T.
 2020- \$12,150 expended, for men's & women's locker room 2.5T units

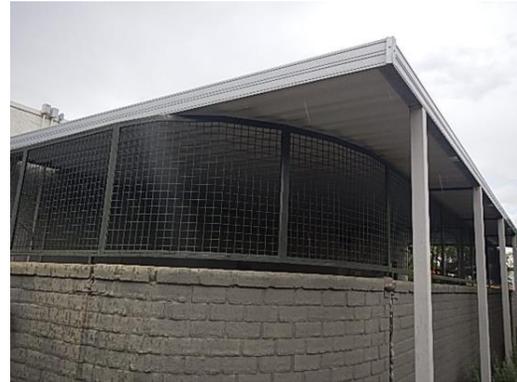
864 - Shade Structure	Useful Life 30	Remaining Life 21
367 sf Pool Equip Shade Structure	Quantity 367	Unit of Measure Square Feet
	Cost /SqFt \$27.32	
	% Included 100.00%	Total Cost/Study \$10,026
Summary	Replacement Year 2043	Future Cost \$16,840

This is to repair and replace the metal shade structure.

2013- Structure installed.

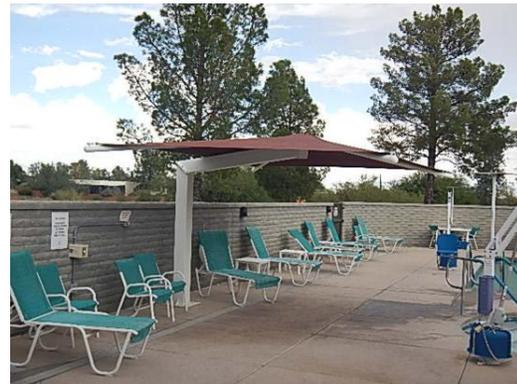
868 - Shade Structure	Useful Life 15	Remaining Life 10
378 sf [3] Pool Shade Canopies	Quantity 378	Unit of Measure Square Feet
	Cost /SqFt \$22.95	
	% Included 100.00%	Total Cost/Study \$8,675
Summary	Replacement Year 2032	Future Cost \$11,105

This is to repair and replace the canvas canopy shade structures.

2017- 2 structures installed.

2016- 1 structure installed.

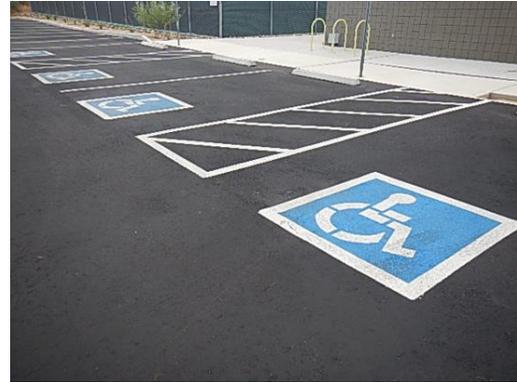
170 - Asphalt: Sealing	Useful Life 5	Remaining Life 4	
39,629 sf Parking Lot	Quantity 39,629	Unit of Measure Square Feet	
	Cost /SqFt \$0.250		
	% Included 100.00%	Total Cost/Study \$9,907	
Summary	Replacement Year 2026	Future Cost \$10,936

This is to prepare the surface, apply a single coat asphalt emulsion product and restripe to match the existing layout. If a second coat is desired the cost is generally 10% to 20% higher.

2021- \$6,885 was expended.
 2020- 39,629 sf with 2021 remaining life estimates per client 6/15/2020.

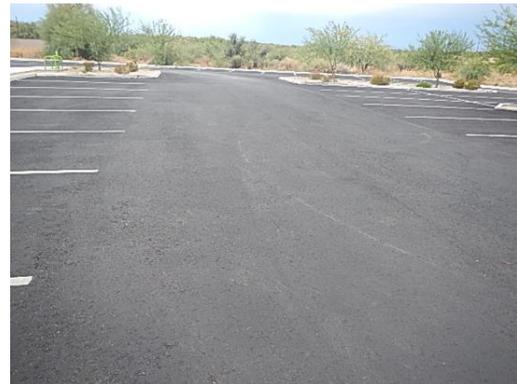
270 - Asphalt: Ongoing Repairs	Useful Life 5	Remaining Life 4	
39,629 sf Parking Lot (3.5%)	Quantity 39,629	Unit of Measure Square Feet	
	Cost /SqFt \$3.85	Qty * \$/SqFt \$152,572	
	% Included 3.50%	Total Cost/Study \$5,340	
Summary	Replacement Year 2026	Future Cost \$5,894

This is for miscellaneous repairs including crackfill, skin patching and minor dig out & fill. Cracks 1/4" or wider should be filled when observed.

2020- 39,629 sf estimate per client 6/15/2020. This component will be merged with the ongoing seal coat component after the 2021 seal coat.

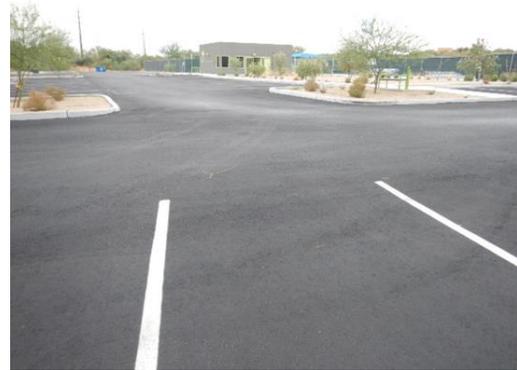
370 - Asphalt: Overlay w/ Interlayer 39,629 sf Parking Lot	Useful Life 25 Remaining Life 23 Quantity 39,629 Unit of Measure Square Feet Cost /SqFt \$2.10 % Included 100.00% Total Cost/Study \$83,221 Replacement Year 2045 Future Cost \$146,852
Summary

This is to apply a geotextile interlayer to the existing asphalt surface and overlay with a minimum of 1.5" of new hot mix asphalt. Generally this includes edge grinding and utility box extensions.

2020- 39,629 sf estimate per client 6/15/2020.

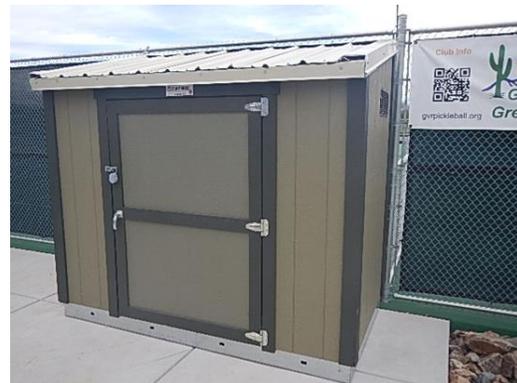
892 - Shed Shed	Useful Life 15 Remaining Life 13 Quantity 1 Unit of Measure Lump Sum Cost /LS \$5,000 % Included 100.00% Total Cost/Study \$5,000 Replacement Year 2035 Future Cost \$6,893
Summary

This is to replace the freestanding pre-fab shed.

4' x 8'

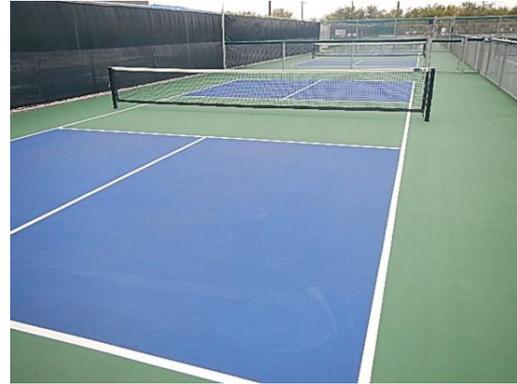
200 - Seal & Striping	Useful Life 2	Remaining Life 1	
54,600 sf [24] Pickleball Courts	Quantity 54,600	Unit of Measure Square Feet	
	Cost /SqFt \$0.800		
	% Included 100.00%	Total Cost/Study \$43,680	
Summary	Replacement Year 2023	Future Cost \$44,772

This is to prepare the courts, repair cracks with acrylic crack patch, paint with epoxy coating mixed with silica sand, and restripe. These courts are post-tensioned and don't require overlay.

2022- Per client, move remaining life from 2022 to 2023.
 2020- Seal/stripping every 2 years at \$3,613/court based on East Center estimates per client in 2019. Per client 8/6/2020, reduce estimate from \$3,613 to \$1,613 per court.

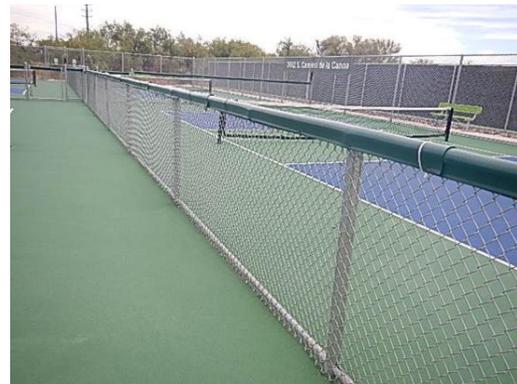
174 - Chain Link: 4'	Useful Life 25	Remaining Life 23	
1,414 lf Court Fences	Quantity 1,414	Unit of Measure Linear Feet	
	Cost /l.f. \$19.19		
	% Included 100.00%	Total Cost/Study \$27,135	
Summary	Replacement Year 2045	Future Cost \$47,882

This is to replace the 4' chain link fencing.

2020- 1,414 lf per client 6/15/2020.

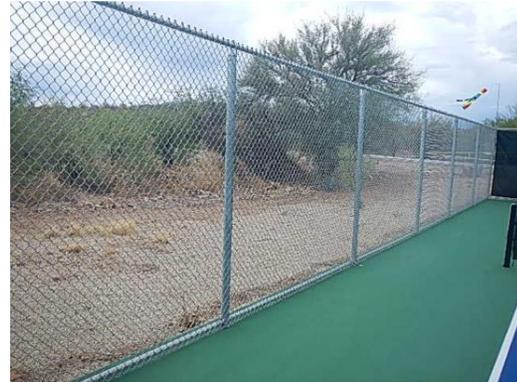
178 - Chain Link: 8'	Useful Life 25	Remaining Life 23
1,871 lf Court Fences	Quantity 1,871	Unit of Measure Linear Feet
	Cost /l.f. \$34.41	
	% Included 100.00%	Total Cost/Study \$64,381
Summary	Replacement Year 2045	Future Cost \$113,608

This is to replace the 8' chain link fencing.

2020- 1,871 lf per client 6/15/2020.

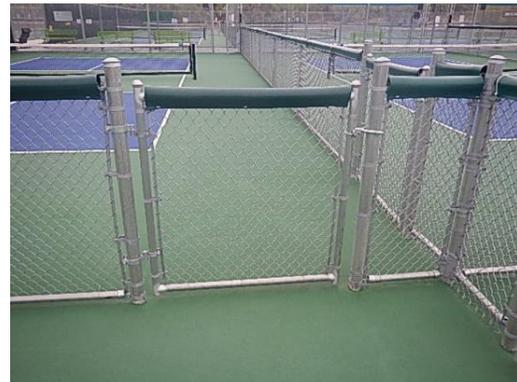
780 - Gates	Useful Life 20	Remaining Life 18
50 Court Gates	Quantity 50	Unit of Measure Items
	Cost /Itm \$298	
	% Included 100.00%	Total Cost/Study \$14,924
Summary	Replacement Year 2040	Future Cost \$23,276

This is to maintain, repair and replace the chain link gates and gate hardware.

28- 7' gates
 22- 4' gates

2022- Onsite observation revealed 50 gates listed above.
 2020- 53 gates per client 6/15/2020.

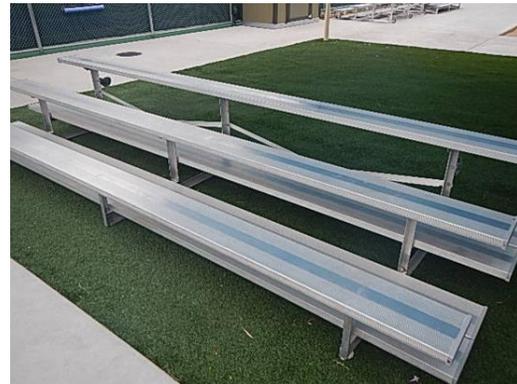
448 - Bleachers: Aluminum	Useful Life 20	Remaining Life 18	
6 Bleachers	Quantity 6	Unit of Measure	Items
	Cost /Itm \$3,000		
	% Included 100.00%	Total Cost/Study	\$18,000
Summary	Replacement Year 2040	Future Cost	\$28,074

This is to replace the aluminum bleachers.

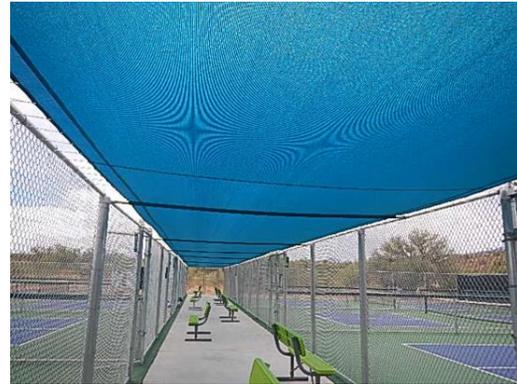
884 - Shade Structure	Useful Life 7	Remaining Life 5	
4,182 sf [3] Shade Structures	Quantity 4,182	Unit of Measure Square Feet	
	Cost /SqFt \$3.30		
	% Included 100.00%	Total Cost/Study \$13,801	
Summary	Replacement Year 2027	Future Cost \$15,614

This is to replace the shade structures.

- 12' x 135'
- 14' x' 135'
- 28' x 24'

2020- \$10,880 with 7 year useful life estimates per client 6/15/2020.

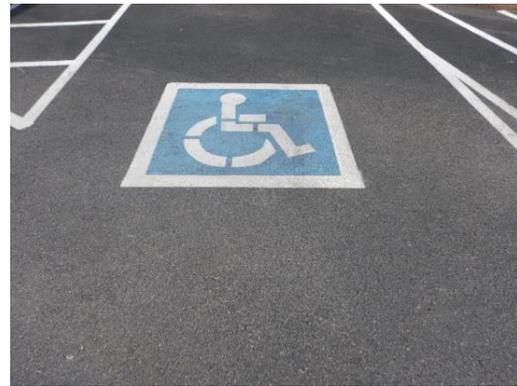
136 - Asphalt: Sealing	Useful Life 5	Remaining Life 3	
29,074 sf Parking Area	Quantity 29,074	Unit of Measure Square Feet	
	Cost /SqFt \$0.250		
	% Included 100.00%	Total Cost/Study \$7,269	
Summary	Replacement Year 2025	Future Cost \$7,827

This is to prepare the surface and apply a single coat asphalt emulsion product. If a second coat is desired the cost is generally 10% to 20% higher.

2020- \$2,888 was expended to seal coat approximately 15,024 sf of lot surface, included east, west and south lot.
 2019- 14,874 sf added 6/2019 which will be sealed in 2020 per client 6/14/2019. New total quantity 29,074 sf.
 \$1,930 was expended per client 6/14/2019.
 2018- Pavement rehabilitation complete.

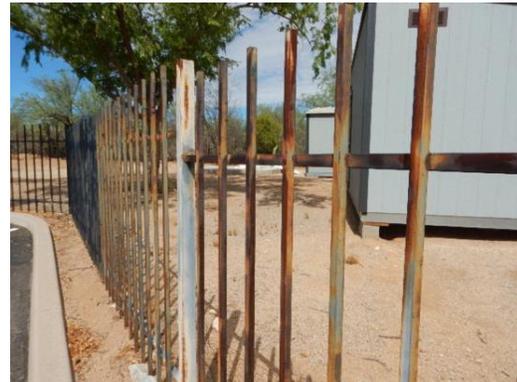
412 - Wrought Iron	Useful Life 4	Remaining Life 4	
835 lf Perimeter Fence	Quantity 835	Unit of Measure Linear Feet	
	Cost /l.f. \$9.85		
	% Included 100.00%	Total Cost/Study \$8,225	
Summary	Replacement Year 2026	Future Cost \$9,079

4' wrought iron fencing, westerly driveway to west perimeter- 65 lf
 west perimeter- 310 lf
 south and east perimeters- 460 lf

2022- \$11,800 anticipated. Rust exhibited.

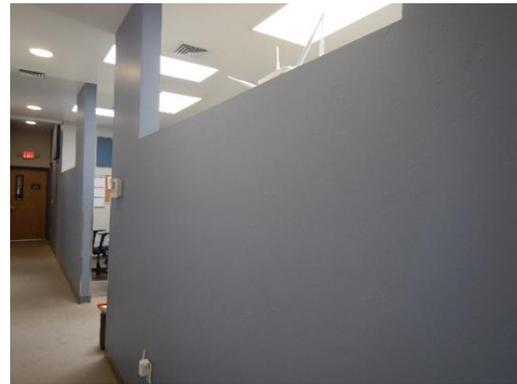
152 - Building	Useful Life 10	Remaining Life 6
10,000 sf All Interior Spaces	Quantity 10,000	Unit of Measure Square Feet
	Cost /SqFt \$1.30	
	% Included 100.00%	Total Cost/Study \$13,000
Summary	Replacement Year 2028	Future Cost \$15,076

This is to prepare and paint all building interior spaces.

2022- Scuffed paint exhibited.

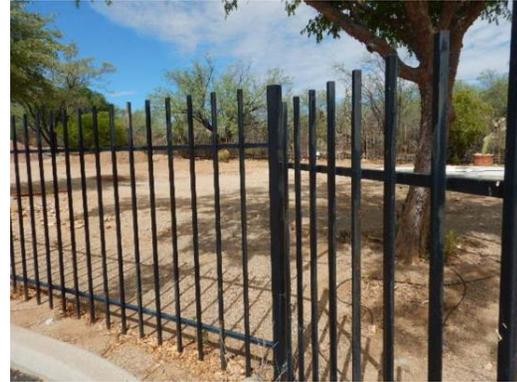
224 - Wrought Iron: 5'	Useful Life 30	Remaining Life 26	
835 lf Perimeter Fencing	Quantity 835	Unit of Measure Linear Feet	
	Cost /l.f. \$37.15		
	% Included 100.00%	Total Cost/Study \$31,020	
Summary	Replacement Year 2048	Future Cost \$58,948

This is to replace the wrought iron fencing. With aggressive paint maintenance, this component's life may be extended. Painting is provided for within another component.

4' wrought iron fencing, westerly driveway to west perimeter- 65 lf
 west perimeter- 310 lf
 south and east perimeters- 460 lf

2018- \$22,768 expended for 13 gauge metal fencing which was approximately \$10,000 less than planned.
 2017- Added as a placeholder. BRG has drawn a perimeter from an aerial view, but BRG is unsure of the new fence line location. Also this does not include gate motors, if any, or the install of new heavy duty slide gates.

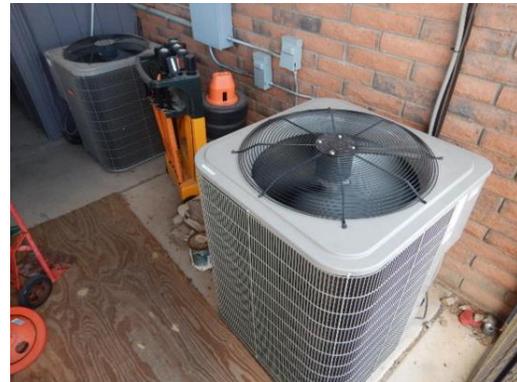
224 - HVAC	Useful Life 15	Remaining Life 10	
2 Ground Level Bryant Units- 2017	Quantity 2	Unit of Measure	Items
	Cost /Itm \$13,822		
	% Included 100.00%	Total Cost/Study	\$27,644
Summary	Replacement Year 2032	Future Cost	\$35,387

This is to replace the ground level Bryant HVAC systems. It is possible that sub-components of these systems can be replaced or rebuilt to extend their life.

- 1- Bryant Air Handler, 5 ton (CU1, North Office): 106ANA060-A, 3517E18989
- 1- Bryant Air Handler, 2.5 ton (CU2, South Office): 106ANA030-A, 2517E05957
- 2- Bryant Plus 80V gas furnaces, North Office 1 & South Office 2

2017- Per scope of work, the prior Mastercool units were replaced with Bryant Units.

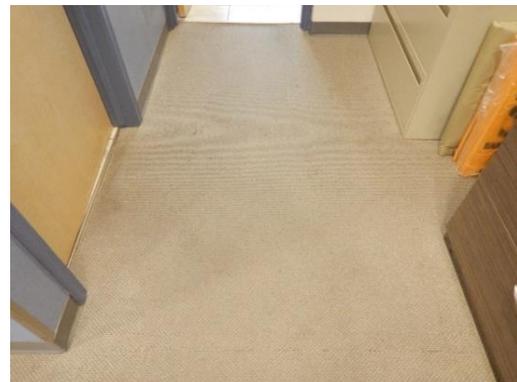
This is to replace the carpeting.

- 2022- Carpeting exhibits stained, poor condition.
- 2019- Per client 7/22/2019, original installation was base carpet and not expected to last 10 years, so reduce remaining life from 2028 to 2023.

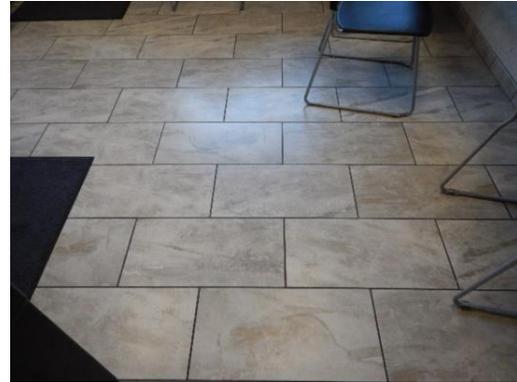
480 - Tile	Useful Life 20	Remaining Life 16
664 sf Floor & Wall Tile	Quantity 664	Unit of Measure Square Feet
	Cost /SqFt \$26.22	
	% Included 100.00%	Total Cost/Study \$17,410
Summary	Replacement Year 2038	Future Cost \$25,845

This is to replace the wall and floor tile.

- Restrooms
- Break room
- Hall/sink area

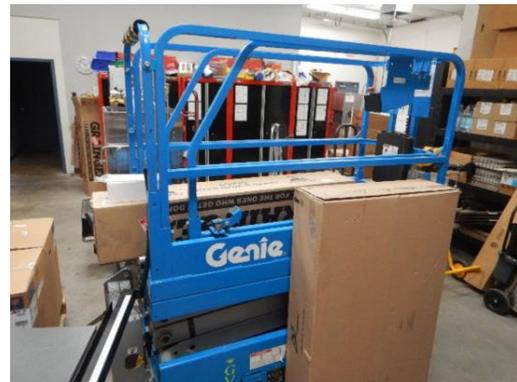
236 - Maintenance Equipment	Useful Life 20	Remaining Life 18
Genie Scissor Lift	Quantity 1	Unit of Measure Items
	Cost /Itm \$17,882	
	% Included 100.00%	Total Cost/Study \$17,882
Summary	Replacement Year 2040	Future Cost \$27,890

This is to repair and replace the electric scissor lift.

Genie Industries, GS-1530

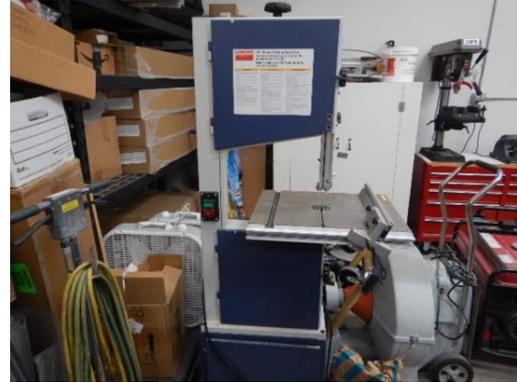
822 - Maintenance Equipment	Useful Life 10	Remaining Life 6	
11 Shop Tools, Portacoolers, Misc (50%)	Quantity 11	Unit of Measure Items	
	Cost /Itm \$3,785	Qty * \$/Itm \$41,630	
	% Included 50.00%	Total Cost/Study \$20,815	
Summary	Replacement Year 2028	Future Cost \$24,139

This is to periodically replace miscellaneous shop equipment on a percentage basis.

- 1- Jet drill press, MN J-2530, SN 18043036
- 1- Dayton band saw, MN 400H60, LN 17122812019
- 1- DeWalt chop saw
- 1- Miller Welder, Millermatic 211 auto-set
- 1- Powermatic table saw, MN 66-TA
- 1- Ingersoll Rand, 7.5-HP, 80-Gallon, MN 2475N7.5
- 1- Honda Generator, MN EM6500SX
- 2- Portacool portable evaporative cooling units, MN PACCY120GA1
- 2- Roll-around tool boxes

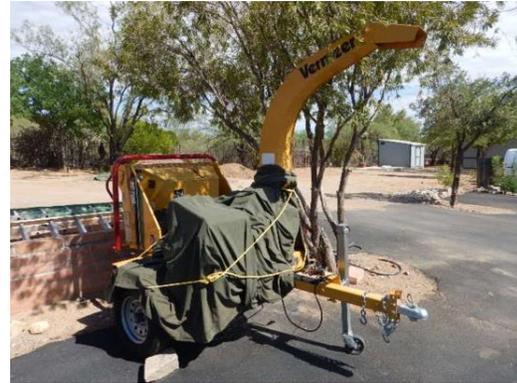
This is to replace Vermeer chipper.

Model #- BC700XL
 VIN/PIN- 1VRC101V9F10 00862

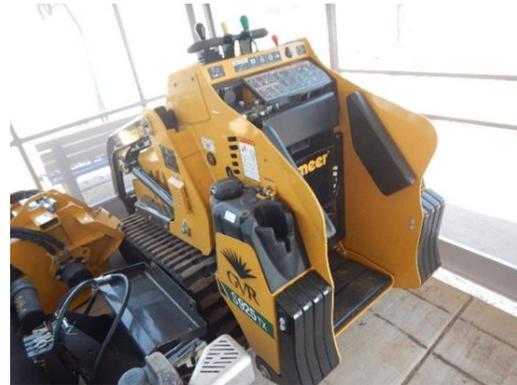
204 - Maintenance Equipment	Useful Life 15	Remaining Life 0	
Vermeer Skid Loader & Attachments	Quantity 1	Unit of Measure	Items
	Cost /Itm \$57,206		
	% Included 100.00%	Total Cost/Study	\$57,206
Summary	Replacement Year 2022	Future Cost	\$57,206

This is to replace the Vermeer track mini skid and attachments. Includes purchase, factory FRT & prep, and sales tax.

- S925TX Skid Loader, 40HP gas
- Berlon HD extended lip bucket- 42" wide
- Berlon bolt on cutting edge- 42" wide
- Rotary broom- 42", manual angle
- 2250LP welded shark 4in 52 pin trencher chain
- 24 Boom greaseless idler w/restraint bar- trencher boom kit
- Vermeer trencher attachment- STR48 boom kit

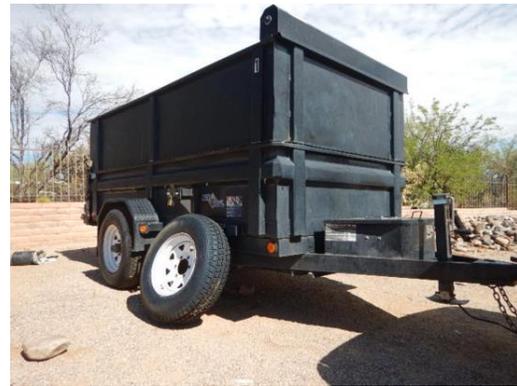
700 - Trailer	Useful Life 15	Remaining Life 3	
Load Trail	Quantity 1	Unit of Measure	Items
	Cost /Itm \$5,883		
	% Included 100.00%	Total Cost/Study	\$5,883
Summary	Replacement Year 2025	Future Cost	\$6,336

This is to replace the utility trailer.

Load Trail
 License- Y66945

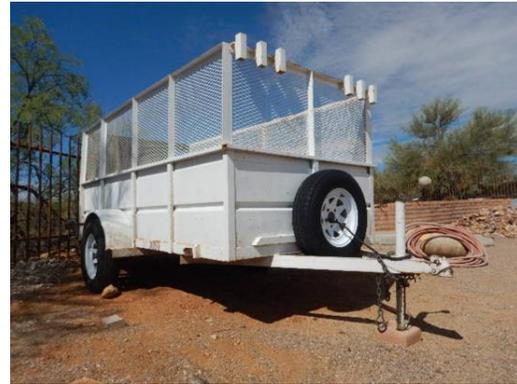
710 - Trailer	Useful Life 15	Remaining Life 0	
Big Tex	Quantity 1	Unit of Measure	Items
	Cost /Itm \$24,889		
	% Included 100.00%	Total Cost/Study	\$24,889
Summary	Replacement Year 2022	Future Cost	\$24,889

This is to replace the landscaping trailer.

Big Tex
 License- K00575
 30SV

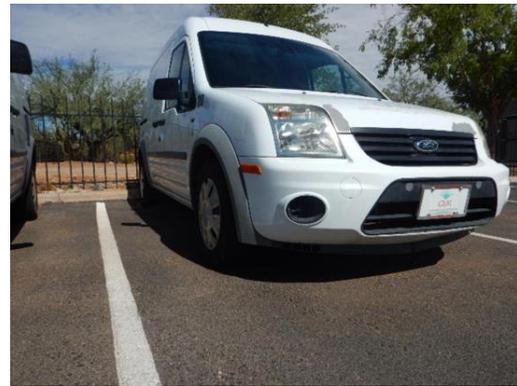
832 - Vehicle	Useful Life 10	Remaining Life 1	
3 2013 Ford Transit Connects- #20, 21, 23	Quantity 3	Unit of Measure	Items
	Cost /Itm \$29,417		
	% Included 100.00%	Total Cost/Study	\$88,250
Summary	Replacement Year 2023	Future Cost	\$90,456

This is to replace the utility vans.

2013 Ford Transit Connect XLTs and XL's
 Vehicle 20- License- CH45316 / VIN- NM0LS7DN3DT133374
 Vehicle 21- License- CH45315 / VIN- NM0LS7DN3DT132204
 Vehicle 22- License- BLM0931 / VIN- NM0LS7CNDT150137 (**Deleted in 2017**)
 Vehicle 23- License- BLM0930 / VIN- unavailable
