Reserve Study Transmittal Letter

Re: Green Valley Recreation Inc; Update w/ Site Visit Review

RESERVE STUDY

Update w/ Site Visit Review

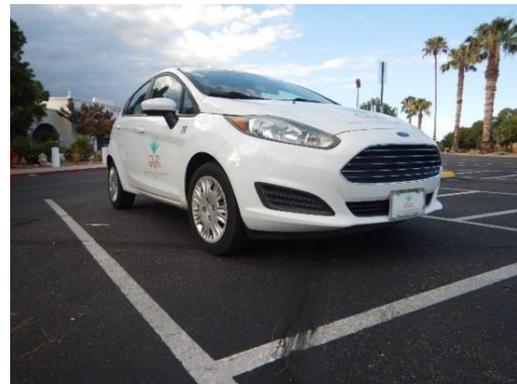
844 - Vehicle	Useful Life 10	Remaining Life 4	
2016 Ford Fiesta- #26	Quantity 1	Unit of Measure	Items
	Cost /Itm \$20,592		
	% Included 100.00%	Total Cost/Study	\$20,592
Summary	Replacement Year 2026	Future Cost	\$22,729

This is to replace the compact vehicle.

2016 Ford Fiesta
 License- BRW9820
 VIN- 3FA0P4TJ6GX1336

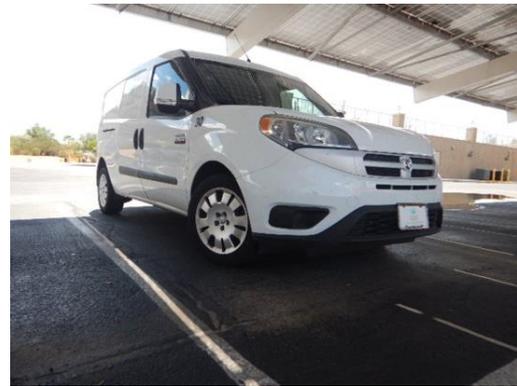
852 - Vehicle	Useful Life 10	Remaining Life 4	
2 2016 Ram Promaster City Vans- #29, 30	Quantity 2	Unit of Measure	Items
	Cost /Itm \$34,439		
	% Included 100.00%	Total Cost/Study	\$68,878
Summary	Replacement Year 2026	Future Cost	\$76,028

This is to replace the vans.

2016 Ram Promaster City vans
 License- CK49240 (#29), CK49241 (#30)
 VIN- ZFBERFBT1G6B90166 (#29), ZFBERFBT1G6B92239

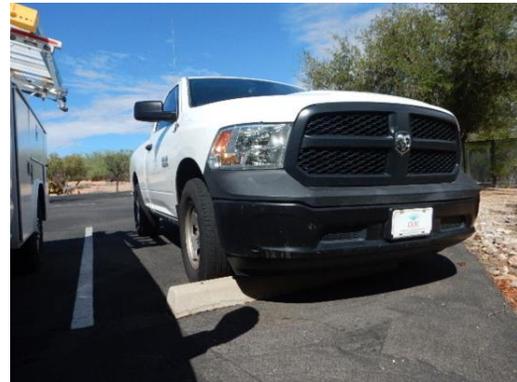
856 - Maintenance Truck	Useful Life 10	Remaining Life 4	
3 2016 Ram 1500 Pickups- #31, 32, 33	Quantity 3	Unit of Measure	Items
	Cost /Itm \$39,031		
	% Included 100.00%	Total Cost/Study	\$117,093
Summary	Replacement Year 2026	Future Cost	\$129,249

This is to replace the pickup trucks.

2016 Ram 1500
 License- CK49249 (#31), CK49248 (#32), CK49242 (#33)
 VIN- unavailable (#31), 3C6JR6AG8GG382364 (#32), 3C6JR6AG9GG334341 (#33)

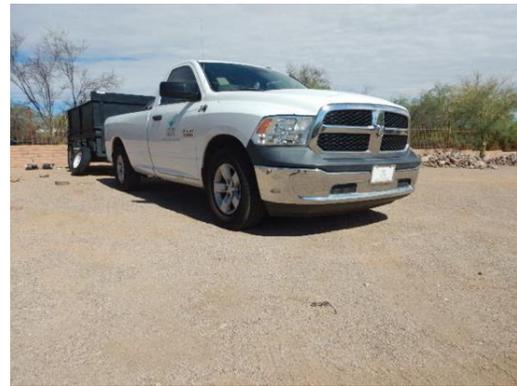
860 - Maintenance Truck	Useful Life 10	Remaining Life 5	
2017 Ram 1500 Pickup- #34	Quantity 1	Unit of Measure	Items
	Cost /Itm \$40,999		
	% Included 100.00%	Total Cost/Study	\$40,999
Summary	Replacement Year 2027	Future Cost	\$46,387

This is to replace the pickup truck.

2017 Ram 1500
 License- CK53480
 VIN- 3C6JF6DGOHG598741

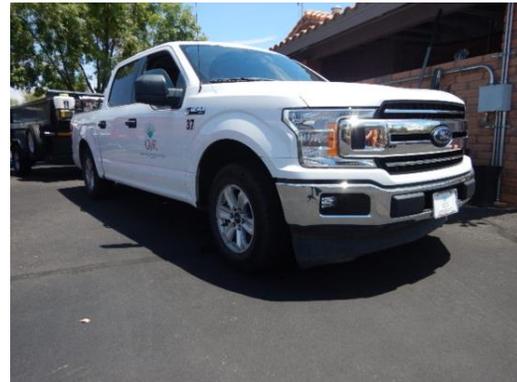
868 - Maintenance Truck	Useful Life 10	Remaining Life 6	
2018 Ford F150 Supercrew- #37	Quantity 1	Unit of Measure	Items
	Cost /Itm \$38,099		
	% Included 100.00%	Total Cost/Study	\$38,099
Summary	Replacement Year 2028	Future Cost	\$44,183

This is to replace the pickup truck.

2018 Ford F150 Supercrew
 License- CK99967
 VIN- 1FTEW1CP7JKC96126

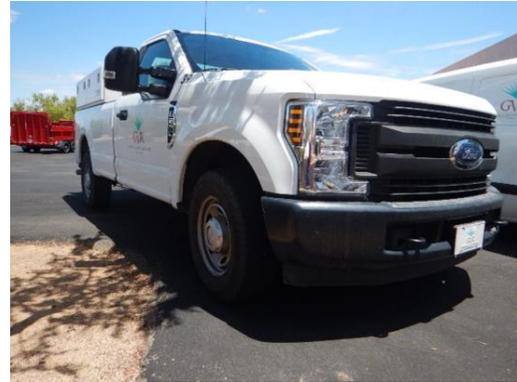
874 - Maintenance Truck	Useful Life 10	Remaining Life 6	
Ford F250 PU- #39	Quantity 1	Unit of Measure	Items
	Cost /Itm \$39,019		
	% Included 100.00%	Total Cost/Study	\$39,019
Summary	Replacement Year 2028	Future Cost	\$45,249

This is to replace the pickup truck.

2018 Ford F250, #39 replaced prior 2006 Ford F250 pickup truck.
 License- CL39574
 VIN- 1FTBF2A6XJEC41798

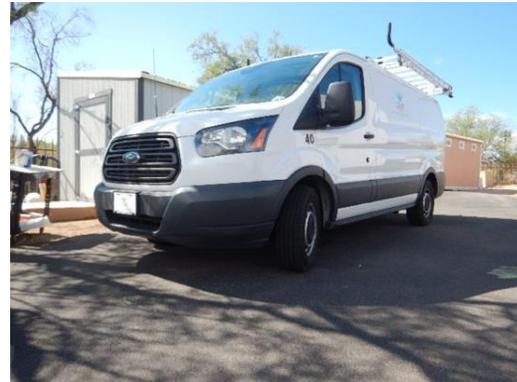
876 - Vehicle	Useful Life 10	Remaining Life 6	
Ford Transit Connect- #40	Quantity 1	Unit of Measure	Items
	Cost /Itm \$35,577		
	% Included 100.00%	Total Cost/Study	\$35,577
Summary	Replacement Year 2028	Future Cost	\$41,258

This is to replace the Ford Transit Connect cargo van.

Ford Transit Connect
 License Plate- CL58879
 VIN- 1FTYE1ZM4JKA60532

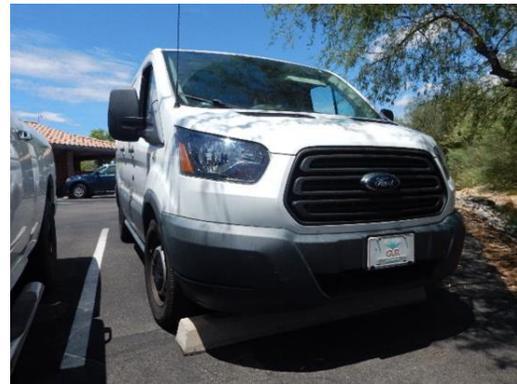
878 - Vehicle	Useful Life 10	Remaining Life 7	
2018 Ford Transit 150 Van- #41	Quantity 1	Unit of Measure	Items
	Cost /Itm \$35,578		
	% Included 100.00%	Total Cost/Study	\$35,578
Summary	Replacement Year 2029	Future Cost	\$42,291

This is to replace the Ford Transit 150 van.

Ford Transit 150 van
 License Plate- CL58880
 VIN- 1FTYE1ZM0JKA96198

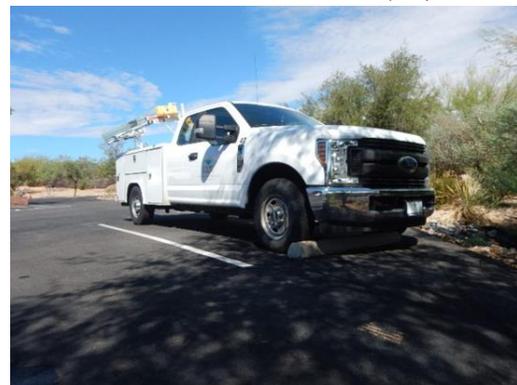
880 - Vehicle	Useful Life 10	Remaining Life 7	
2019 Ford F-250 Pickup Truck- #42	Quantity 1	Unit of Measure	Items
	Cost /Itm \$43,706		
	% Included 100.00%	Total Cost/Study	\$43,706
Summary	Replacement Year 2029	Future Cost	\$51,953

This is to replace the Ford F-250 pickup truck.

Ford F-250
 License- CL79162
 VIN- ___7X2A65KEC55175

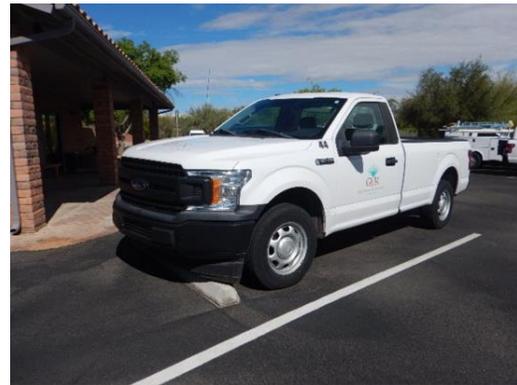
884 - Vehicle	Useful Life 10	Remaining Life 7	
2018 Ford F-150 Pickup Truck- #44	Quantity 1	Unit of Measure	Items
	Cost /Itm \$32,524		
	% Included 100.00%	Total Cost/Study	\$32,524
Summary	Replacement Year 2029	Future Cost	\$38,661

This is to replace the Ford F-150 pickup truck.

2018 Ford F-150
 License- CL70199
 VIN- 1FTMF1CB4JKE44944

2019- Truck was un-numbered and lacked Arizona license plates at the time of the site inspection, client input may further define this component. \$29,766, was expended for 2018 Ford F-150 per client 6/14/2019.

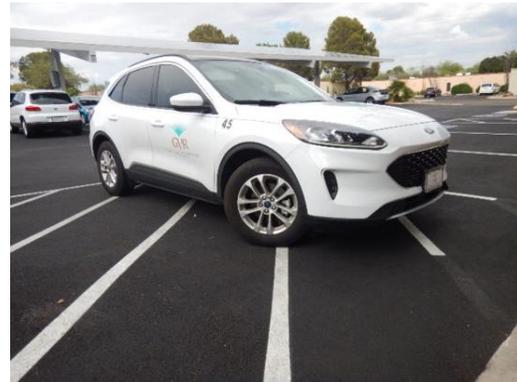
888 - Vehicle	Useful Life 10	Remaining Life 8	
2020 Ford Escape- #45	Quantity 1	Unit of Measure	Items
	Cost /Itm \$32,000		
	% Included 100.00%	Total Cost/Study	\$32,000
Summary	Replacement Year 2030	Future Cost	\$38,989

This is to replace the Ford Escape.

2020 Ford Escape
 License- HTA2CZA
 VIN- 1FMCU0G62LUA79188

2022- Information determined and component added per onsite observations. Client input may further define this component.

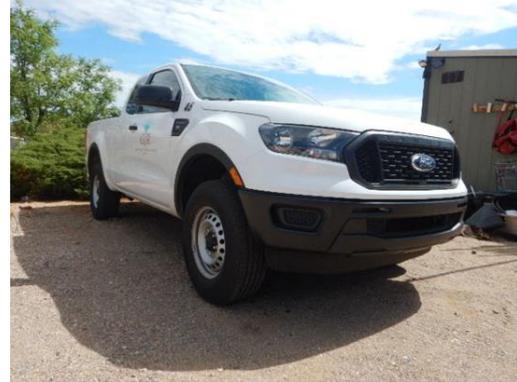
892 - Maintenance Truck	Useful Life 10	Remaining Life 9	
2021 Ford Ranger XL- #46	Quantity 1	Unit of Measure	Items
	Cost /Itm \$38,243		
	% Included 100.00%	Total Cost/Study	\$38,243
Summary	Replacement Year 2031	Future Cost	\$47,760

This is to replace the truck.

2021 Ford Ranger XL
 License- RAAOSE
 VIN- 1FTER1EH7MLD61276

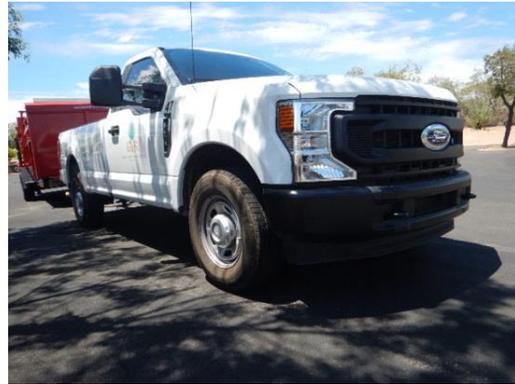
896 - Maintenance Truck	Useful Life 10	Remaining Life 9	
2021 Ford F250 Pickup- #47	Quantity 1	Unit of Measure	Items
	Cost /Itm \$43,750		
	% Included 100.00%	Total Cost/Study	\$43,750
Summary	Replacement Year 2031	Future Cost	\$54,638

This is to replace the pickup truck.

2021 Ford F250
 License- LVA13F
 VIN- Unavailable

2022- BRG added component based on onsite observations. Client input may further define this component.
