**RESERVE STUDY**

Full Study

**Green Valley Recreation Inc**

Published - June 28, 2016

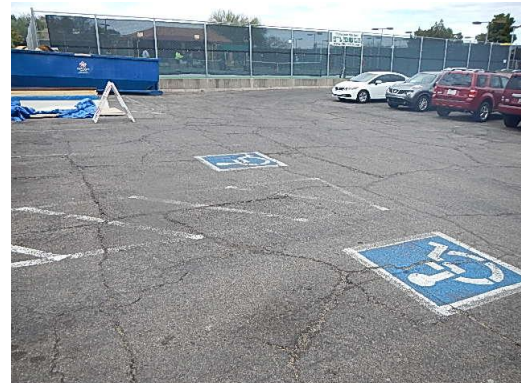
100 - Asphalt: Sealing	Useful Life 5	Remaining Life 1
27,762 Sq. Ft. Parking Lots- Seal/Stripe	Quantity 27,762	Unit of Measure Square Feet
	Cost /SqFt \$0.200	
	% Included 100.00%	Total Cost/Study \$5,552
Summary	Replacement Year 2017	Future Cost \$5,691

In 2016, the north and south parking lots are in need of sealing and restriping.

14,965 sq ft- south parking lot and maintenance yard  
12,797 sq ft- north parking lot

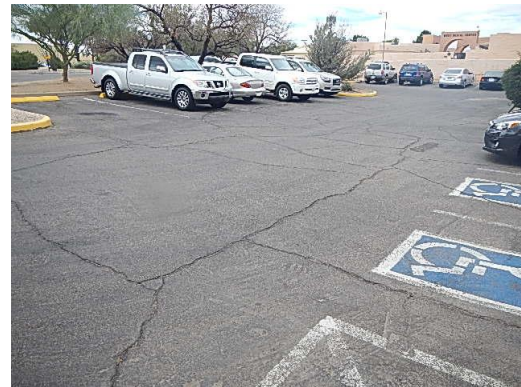
300 - Asphalt: Overlay w/ Interlayer	Useful Life 25	Remaining Life 6	
14,965 Sq. Ft. South Parking & Maintenance	Quantity 14,965	Unit of Measure Square Feet	
	Cost /SqFt \$1.60	Total Cost/Study \$23,944	
	% Included 100.00%	Future Cost \$27,768	
Summary	Replacement Year 2022

This is to apply a paving fabric interlayer to the existing asphalt surface and overlay with a minimum of 1.5" of new hot mix asphalt. Generally this includes edge grinding and utility box extensions.

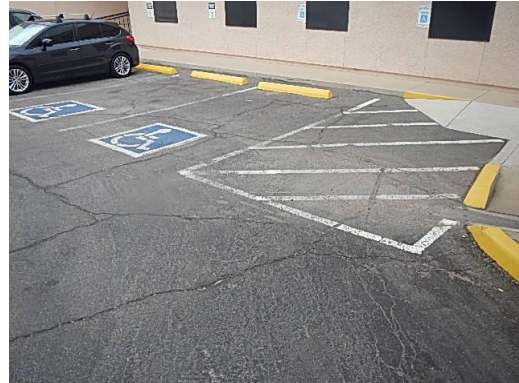
348 - Asphalt: Overlay w/ Interlayer	Useful Life 25	Remaining Life 11
12,797 Sq. Ft. North Parking Lot (50%)	Quantity 12,797	Unit of Measure Square Feet
	Cost /SqFt \$1.60	Qty * \$/SqFt \$20,475
	% Included 50.00%	Total Cost/Study \$10,238
Summary	Replacement Year 2027	Future Cost \$13,433

This is to apply a paving fabric interlayer to the existing asphalt surface and overlay with a minimum of 1.5" of new hot mix asphalt. Generally this includes edge grinding and utility box extensions.

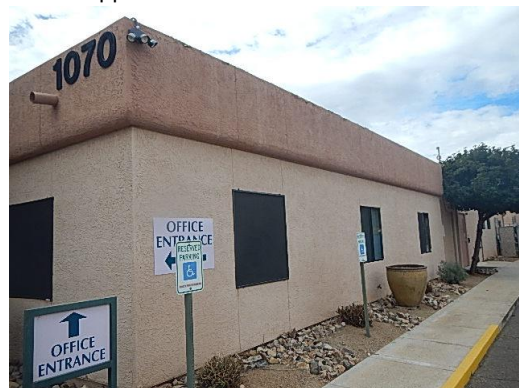
100 - Stucco	Useful Life 10	Remaining Life 1
9,085 Sq. Ft. Building Exterior & Wall Surfaces	Quantity 9,085	Unit of Measure Square Feet
	Cost /SqFt \$1.00	
	% Included 100.00%	Total Cost/Study \$9,085
Summary	Replacement Year 2017	Future Cost \$9,312

In 2016, the paint is faded, peeling and rust stained around the scuppers.

This is to prepare, power wash, sand, scrape, caulk and paint the stucco surfaces with a premium paint.

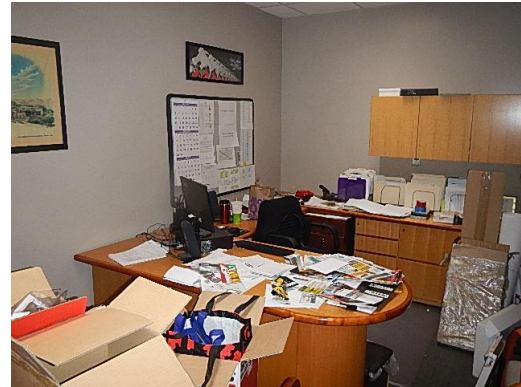
2016- Building was undergoing renovation during the reserve site visit, so this component assumes that painting was performed in conjunction with renovation.

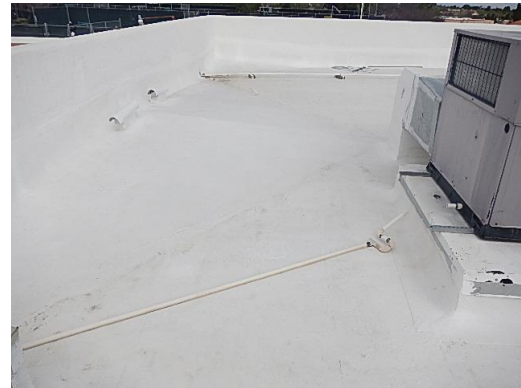
**05000 - Roofing**

This is to replace the low slope single-ply vinyl roofing system. All roofs should be regularly inspected and repaired as indicated to ensure maximum life.

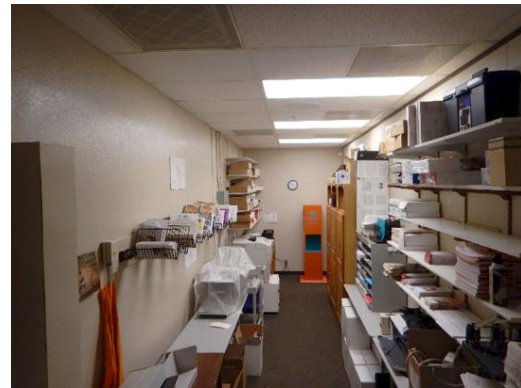
100 - Miscellaneous	Useful Life 8	Remaining Life 4	
Printers & Copiers	Quantity 1	Unit of Measure Lump Sum	
	Cost /LS \$14,000		
	% Included 100.00%	Total Cost/Study \$14,000	
Summary	Replacement Year 2020	Future Cost \$15,453

This is to replace miscellaneous office equipment.

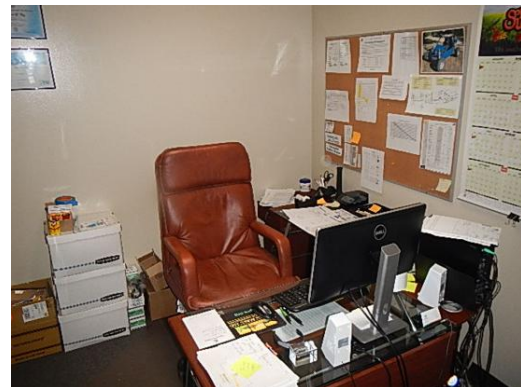
240 - Computers, Misc.	Useful Life 5	Remaining Life 2	
Office Computer Work Stations	Quantity 1	Unit of Measure	Lump Sum
	Cost /LS	\$36,000	
	% Included	100.00%	Total Cost/Study \$36,000
Summary	Replacement Year	2018	Future Cost \$37,823

This is to replace computers, printers, scanners and networking equipment as needed.

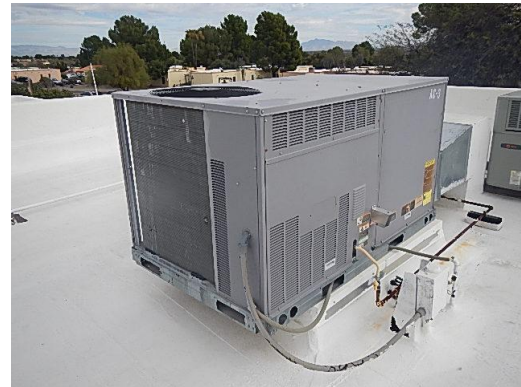
- Unit 1- Admin (S)- Carrier- 5T
- Unit 2- Admin (S)- Carrier- 5T
- Unit 3- Admin (Center)- Carrier- 5T

280 - HVAC	Useful Life 15	Remaining Life 1
Rooftop Carrier Unit- 2002	Quantity 1	Unit of Measure Items
	Cost /Itm \$5,000	
	% Included 100.00%	Total Cost/Study \$5,000
Summary	Replacement Year 2017	Future Cost \$5,125

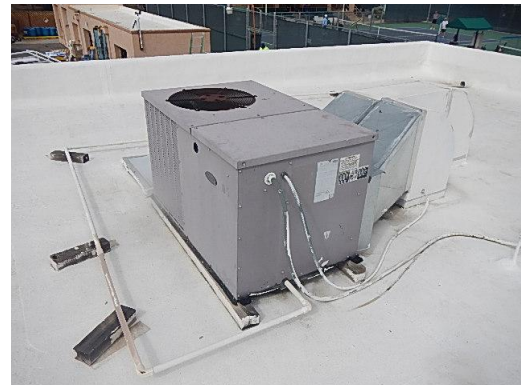
- Unit 5- Shop- Carrier- 4T

This is to replace the Carrier HVAC system. It is possible that sub-components of this system can be replaced or rebuilt to extend its life.

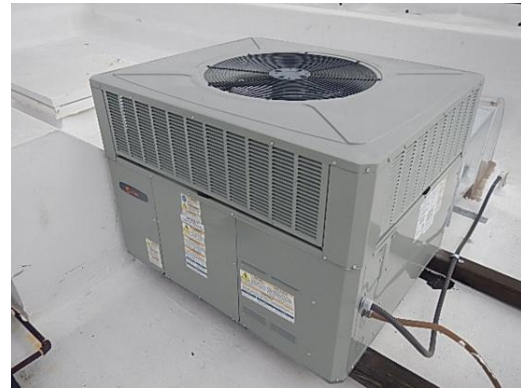
Unit 7- IT Room- Trane- 1.5T  
 Unit 9A & 9B- IT Server Room- Gree

376 - HVAC	Useful Life 15	Remaining Life 1
Bard Unit- 2002	Quantity 1	Unit of Measure Items
	Cost /Itm \$5,800	
	% Included 100.00%	Total Cost/Study \$5,800
Summary	Replacement Year 2017	Future Cost \$5,945

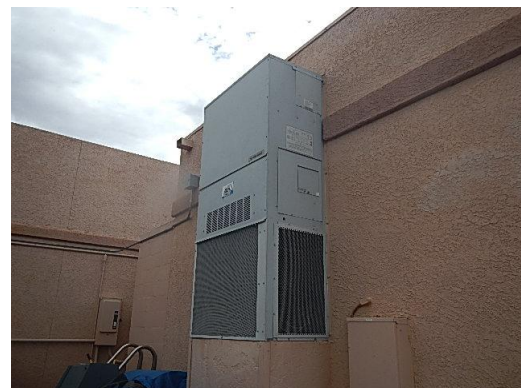
Unit 8- Annex- Bard- 5T

This is to replace the Bard HVAC system. It is possible that sub-components of this system can be replaced or rebuilt to extend its life.

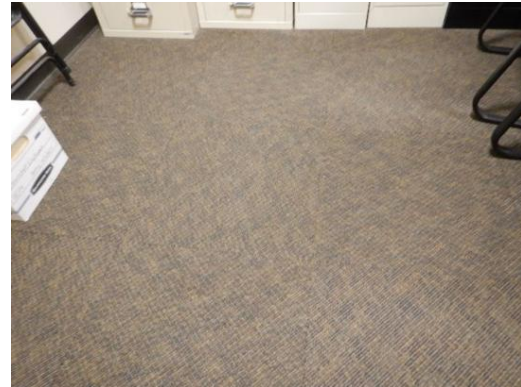
200 - Carpeting	Useful Life 10	Remaining Life 10	
475 Sq. Yds. Hallways, Lobby, Offices	Quantity 475	Unit of Measure Square Yard	
	Cost /SqYd \$32.00		
	% Included 100.00%	Total Cost/Study \$15,200	
Summary	Replacement Year 2026	Future Cost \$19,457

2016- The building was undergoing renovation during the reserve site visit, so this component assumes that flooring was replaced as part of the renovation.

This is to replace the carpeting.

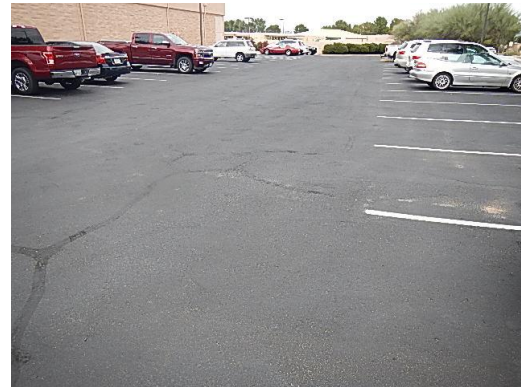
7,155 sq ft- loading dock driveway  
 23,812 sq ft- north parking lot  
 12,576 sq ft- south parking lot

112 - Asphalt: Sealing	Useful Life 5	Remaining Life 1	
75,321 Sq. Ft. West Parking Lot	Quantity 75,321	Unit of Measure Square Feet	
	Cost /SqFt \$0.200		
	% Included 100.00%	Total Cost/Study \$15,064	
Summary	Replacement Year 2017	Future Cost \$15,441

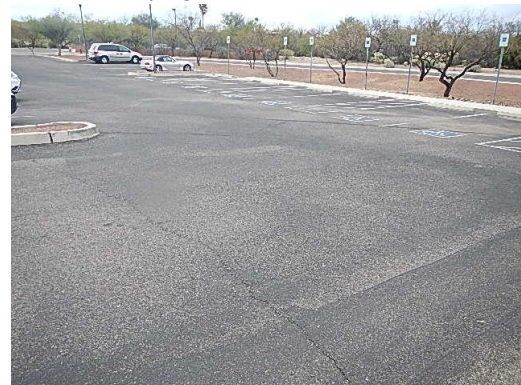
In 2016, the west parking lot is in need of sealing and crack fill. The striping is in fair condition.

This is to prepare the surface, apply a single coat asphalt emulsion product and restripe to match the existing layout. If a second coat is desired the cost is generally 10% to 20% higher.

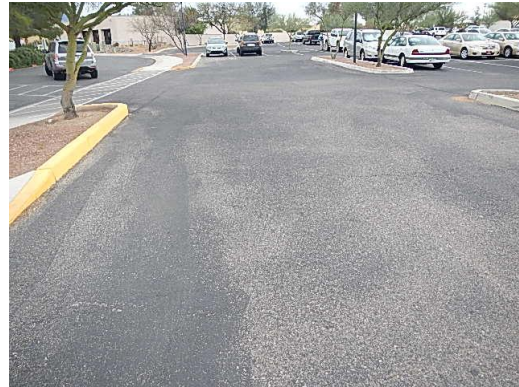
212 - Asphalt: Ongoing Repairs	Useful Life 5	Remaining Life 1	
75,321 Sq. Ft. West Parking Lot (3%)	Quantity 75,321	Unit of Measure Square Feet	
	Cost /SqFt \$3.25	Qty * \$/SqFt \$244,793	
	% Included 2.50%	Total Cost/Study \$6,120	
Summary	Replacement Year 2017	Future Cost \$6,273

In 2016, the west parking lot is in need of crack fill.

This is for miscellaneous repairs including crack fill, skin patching and minor dig out & fill. Cracks 1/4" or wider should be filled when observed.

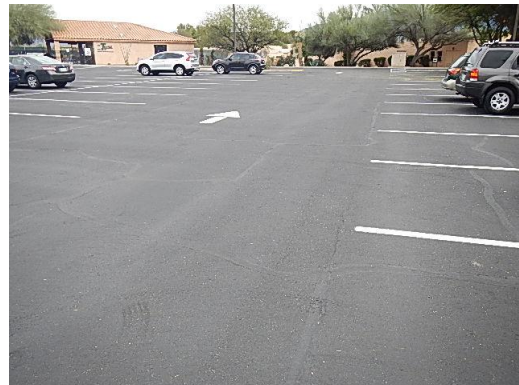
306 - Asphalt: Overlay w/ Interlayer	Useful Life 25	Remaining Life 8	
43,543 Sq. Ft. Drives, North & South Parking	Quantity 43,543	Unit of Measure Square Feet	
	Cost /SqFt \$1.60	Total Cost/Study \$69,669	
	% Included 100.00%	Future Cost \$84,885	
Summary	Replacement Year 2024

7,155 sq ft- loading dock driveway  
 23,812 sq ft- north parking lot  
 12,576 sq ft- south parking lot

This is to apply a paving fabric interlayer to the existing asphalt surface and overlay with a minimum of 1.5" of new hot mix asphalt. Generally this includes edge grinding and utility box extensions.

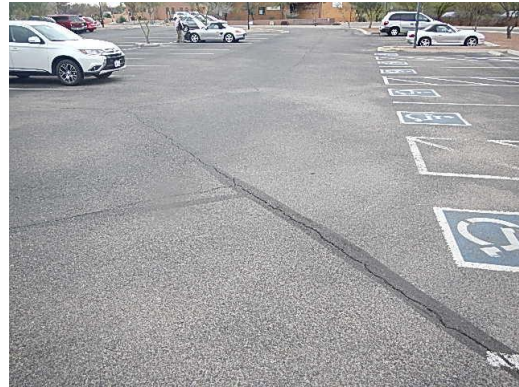
370 - Asphalt: Overlay w/ Interlayer 75,321 Sq. Ft. West Parking Lot	Useful Life 25    Remaining Life 15 Quantity 75,321    Unit of Measure Square Feet Cost /SqFt \$1.60 % Included 100.00% Replacement Year 2031	Total Cost/Study \$120,514 Future Cost \$174,540
-------------------------------------------------------------------------	-----------------------------------------------------------------------------------------------------------------------------------------------------------	-----------------------------------------------------

2006- parking lot installed

This is to apply a paving fabric interlayer to the existing asphalt surface and overlay with a minimum of 1.5" of new hot mix asphalt. Generally this includes edge grinding and utility box extensions.

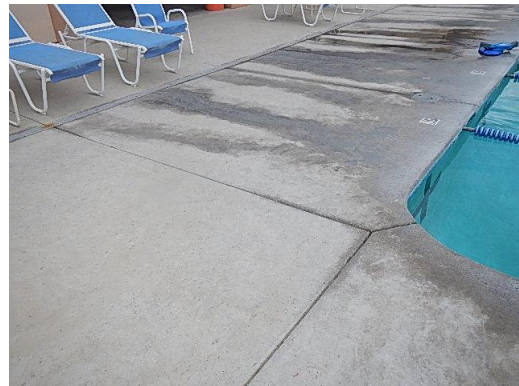
400 - Pool Deck 5,313 Sq. Ft. Pool Area Concrete (6%)	Useful Life 5    Remaining Life 4 Quantity 5,313    Unit of Measure Square Feet Cost /SqFt \$20.00    Qty * \$/SqFt \$106,260 % Included 6.00% Replacement Year 2020	Total Cost/Study \$6,376 Future Cost \$7,037
----------------------------------------------------------	----------------------------------------------------------------------------------------------------------------------------------------------------------------------------------	-------------------------------------------------

This is to repair and replace deck drains and concrete pool deck to remove abrupt elevation changes and maintain functionality. Since the concrete useful life exceeds the scope of this study, this component provides for repair only and not full replacement.

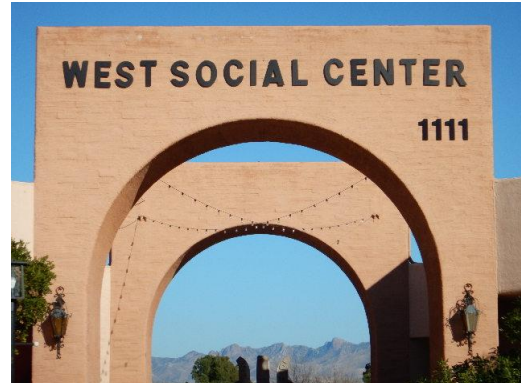
106 - Stucco	Useful Life 10	Remaining Life 6
53,060 Sq. Ft. Building & Wall Exterior Surfaces	Quantity 53,060	Unit of Measure Square Feet
	Cost /SqFt \$1.00	
	% Included 100.00%	Total Cost/Study \$53,060
Summary	Replacement Year 2022	Future Cost \$61,533

This is to prepare, power wash, sand, scrape, caulk and paint the stucco surfaces with a premium paint.

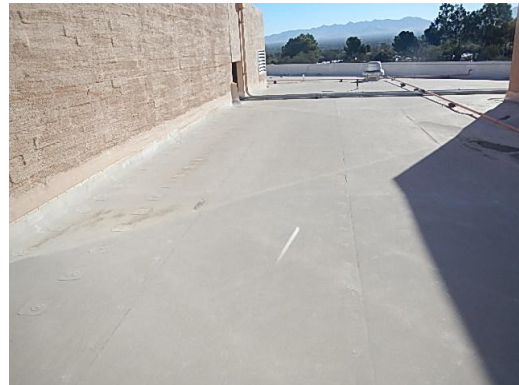
306 - Low Slope: Vinyl	Useful Life 10	Remaining Life 3
339 Squares- Building Flat Roofs (50%)	Quantity 339	Unit of Measure Squares
	Cost /Sqrs \$500	Qty * \$/Sqrs \$169,500
	% Included 50.00%	Total Cost/Study \$84,750
Summary	Replacement Year 2019	Future Cost \$91,266

This is to replace the low slope single-ply vinyl roofing system. All roofs should be regularly inspected and repaired as indicated to ensure maximum life.

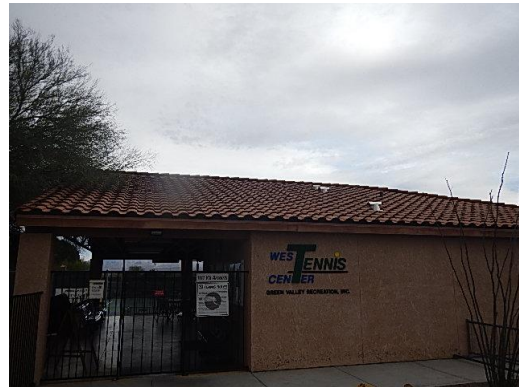
600 - Pitched: Tile	Useful Life 30	Remaining Life 20
24 Squares- Tennis Ramada Roof	Quantity 24	Unit of Measure Squares
	Cost /Sqrs \$600	
	% Included 100.00%	Total Cost/Study \$14,400
Summary	Replacement Year 2036	Future Cost \$23,596

This is to replace the tile roofing system. Tile roofs should be regularly inspected and repaired as indicated to ensure maximum life.

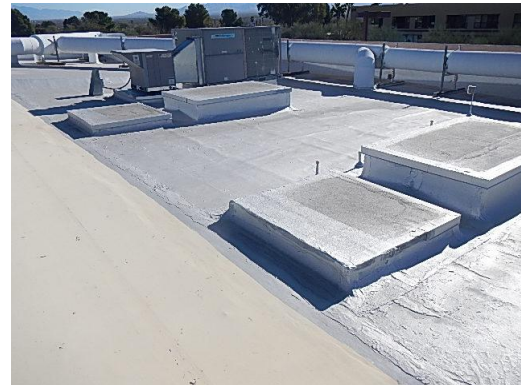
900 - Miscellaneous	Useful Life 5	Remaining Life 3
339 Squares- Roof Recoating	Quantity 339	Unit of Measure Squares
	Cost /Sqrs \$40.00	
	% Included 100.00%	Total Cost/Study \$13,560
Summary	Replacement Year 2019	Future Cost \$14,603

This is to prepare and recoat the low slope roofs. All roof should be regularly inspected and repaired as indicated to ensure full life.

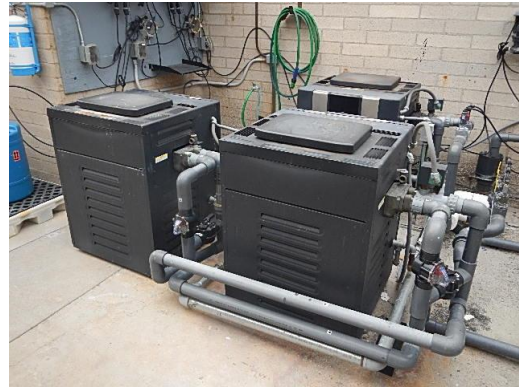
700 - Equipment: Replacement	Useful Life 5	Remaining Life 2	
Pool & Spa Equipment (50%)	Quantity 1	Unit of Measure Lump Sum	
	Cost /LS \$37,560	Qty * \$/LS \$37,560	
	% Included 50.00%	Total Cost/Study \$18,780	
Summary	Replacement Year 2018	Future Cost \$19,731

- 4- Pentair Triton II Commercial filters
- 3- Pentair Intelliflo Variable Speed pumps
- 2- additional spa pumps
- 4- Raypak Professional heaters (3- pool, 1- spa)
- 2- Aquasol chemical control systems
- Assorted- pipes, fittings, controls, lights, etc
- Carbon dioxide tank is not provided for within reserves.

This is to replace the pool equipment. Since not all equipment will fail simultaneously, this component provides for one half replacement every five years.

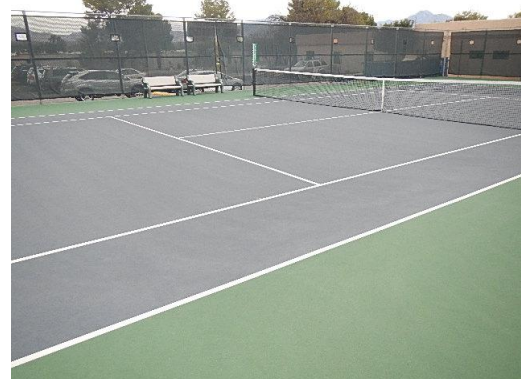
100 - Reseal	Useful Life 7	Remaining Life 4	
43,200 Sq. Ft. [6] Tennis Courts	Quantity 43,200	Unit of Measure Square Feet	
	Cost /SqFt \$0.900		
	% Included 100.00%	Total Cost/Study \$38,880	
Summary	Replacement Year 2020	Future Cost \$42,916

This is to crack fill, seal and stripe the tennis courts.

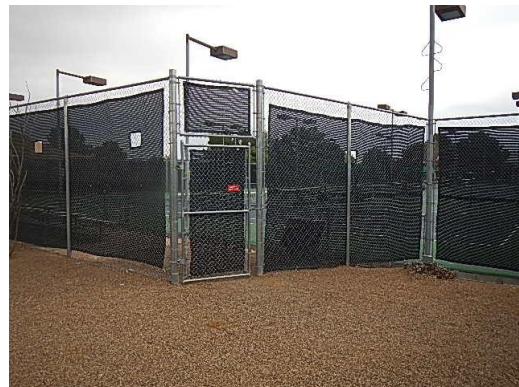
600 - Lighting	Useful Life 30	Remaining Life 7
20 Court Lights	Quantity 20	Unit of Measure Items
	Cost /Itm \$2,800	
	% Included 100.00%	Total Cost/Study \$56,000
Summary	Replacement Year 2023	Future Cost \$66,566

This is to replace the tennis court light poles and fixtures.

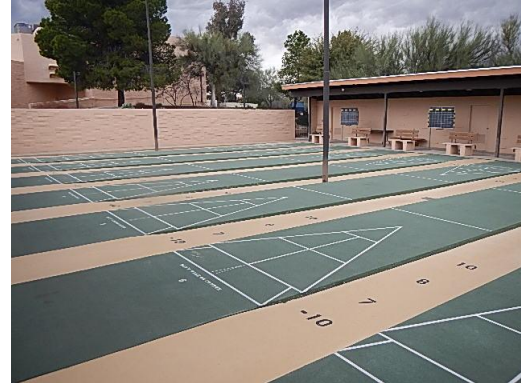
200 - Seal & Striping	Useful Life 8	Remaining Life 4	
3,744 Sq. Ft. [12] Shuffleboard Courts	Quantity 3,744	Unit of Measure Square Feet	
	Cost /SqFt \$2.50		
	% Included 100.00%	Total Cost/Study \$9,360	
Summary	Replacement Year 2020	Future Cost \$10,332

This is to seal and re-stripe the surface on an ongoing basis.

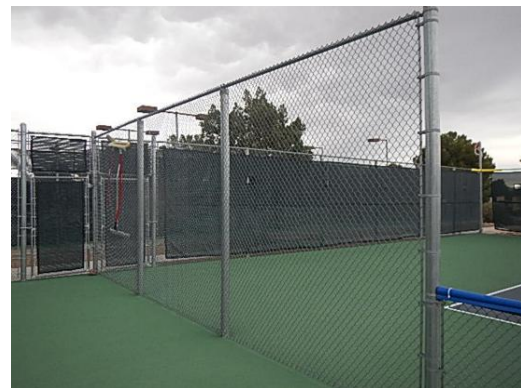
120 - Chain Link: 10'	Useful Life 30	Remaining Life 11	
1,710 Lin. Ft. Tennis Court Fence	Quantity 1,710	Unit of Measure Linear Feet	
	Cost /l.f. \$35.00		
	% Included 100.00%	Total Cost/Study \$59,850	
Summary	Replacement Year 2027	Future Cost \$78,528

This is to replace the 10' chain link fencing.

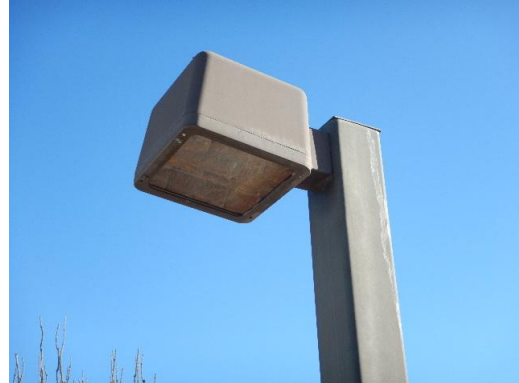
200 - Pole Lights	Useful Life 20	Remaining Life 10	
15 Walkway Lights	Quantity 15	Unit of Measure Items	
	Cost /Itm \$600		
	% Included 100.00%	Total Cost/Study \$9,000	
Summary	Replacement Year 2026	Future Cost \$11,521

This is to replace the walkway pole lights reusing the existing wiring and conduits.

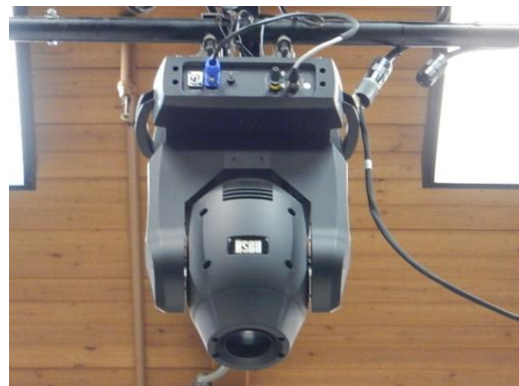
400 - Interior	Useful Life 20	Remaining Life 5	
Stage Lighting	Quantity 1	Unit of Measure Lump Sum	
	Cost /LS \$9,000		
	% Included 100.00%	Total Cost/Study \$9,000	
Summary	Replacement Year 2021	Future Cost \$10,183

This is to replace various stage lighting fixtures.

- 1- Martin Rush moving head
- 5- light bars
- 6- scoop lights
- 10- LED panels
- 29- fixed spot lights
- assorted others

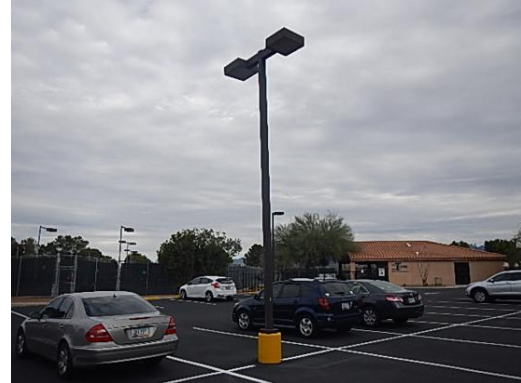
500 - Parking Lot	Useful Life 5	Remaining Life 4	
25 Parking Lot Lights (20%)	Quantity 25	Unit of Measure Items	
	Cost /Itm \$2,500	Qty * \$/Itm \$62,500	
	% Included 20.00%	Total Cost/Study \$12,500	
Summary	Replacement Year 2020	Future Cost \$13,798

This is to replace the parking lot lights.

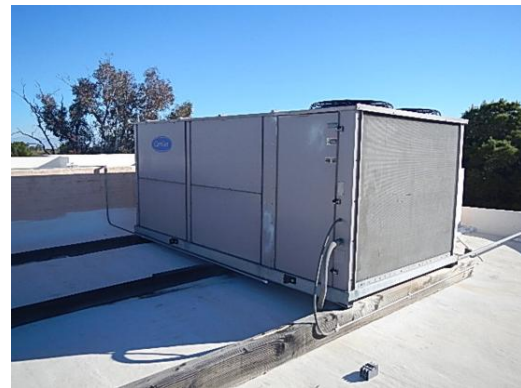
204 - HVAC	Useful Life 15	Remaining Life 5	
2 Rooftop Carrier Units- 2006	Quantity 2	Unit of Measure Items	
	Cost /Itm \$22,000	Total Cost/Study \$44,000	
	% Included 100.00%	Future Cost \$49,782	
Summary	Replacement Year 2021

This is to replace the Carrier HVAC systems. It is possible that sub-components of these systems can be replaced or rebuilt to extend their lives.

- Unit 1- Auditorium (W)- Carrier- 20T
- Unit 2- Auditorium (E)- Carrier 20T

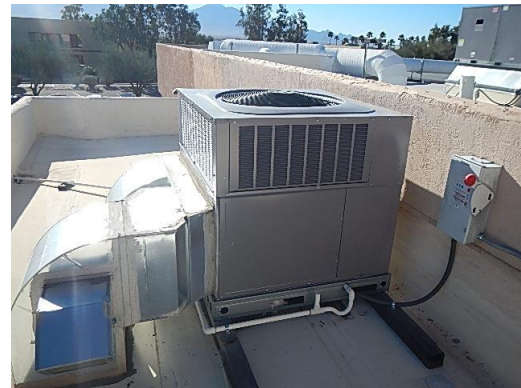
Unit 3- Auditorium Main- Carrier- 10T  
 Unit 6- Woodshop- Carrier- 3T

320 - HVAC	Useful Life 15	Remaining Life 3
2 Rooftop Carrier Units- 2004	Quantity 2	Unit of Measure Items
	Cost /Itm \$11,650	
	% Included 100.00%	Total Cost/Study \$23,300
Summary	Replacement Year 2019	Future Cost \$25,092

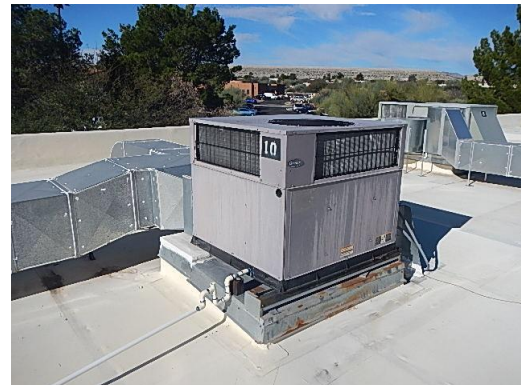
This is to replace the Carrier HVAC systems. It is possible that sub-components of these systems can be replaced or rebuilt to extend their lives.

Unit 4- Lobby (E)- Carrier- 15T  
 Unit 10- Woodshop- Carrier- 5T

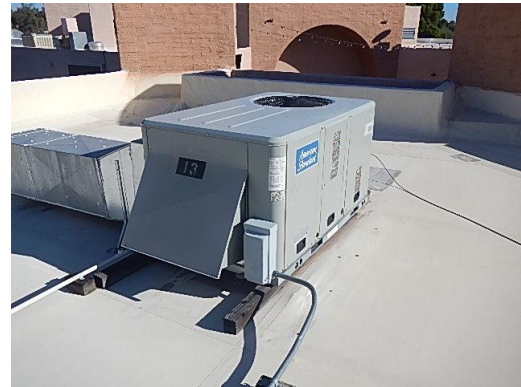
- Unit 5- Lobby (W)- Carrier- 10T
- Unit 12- Billiard Room- American Standard- 4T
- Unit 13- La Tienda- American Standard- 3.5T

380 - HVAC	Useful Life 15	Remaining Life 9	
Rooftop Carrier Unit- 2010	Quantity 1	Unit of Measure	Items
	Cost /Itm \$12,000		
	% Included 100.00%	Total Cost/Study	\$12,000
Summary	Replacement Year 2025	Future Cost	\$14,986

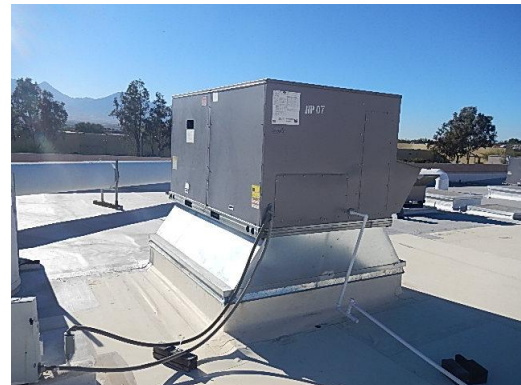
This is to replace the Carrier HVAC system. It is possible that sub-components of this system can be replaced or rebuilt to extend its life.

- Unit 7- Woodshop- Carrier- 10T

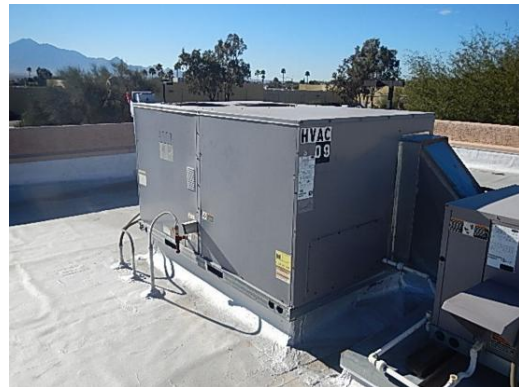
404 - HVAC	Useful Life 15	Remaining Life 7
4 Rooftop Carrier/American Units- 2008	Quantity 4	Unit of Measure Items
	Cost /Itm \$8,750	
	% Included 100.00%	Total Cost/Study \$35,000
Summary	Replacement Year 2023	Future Cost \$41,604

This is to replace the Carrier and American Standard HVAC systems. It is possible that sub-components of these systems can be replaced or rebuilt to extend their lives.

- Unit 8- Woodshop- Carrier- 10T
- Unit 9- Woodshop- Carrier- 10T
- Unit 11- Lapidary- American Standard- 7.5T
- Unit 14A-& B- Sound/Light Off- Carrier- 1T (mini split system)

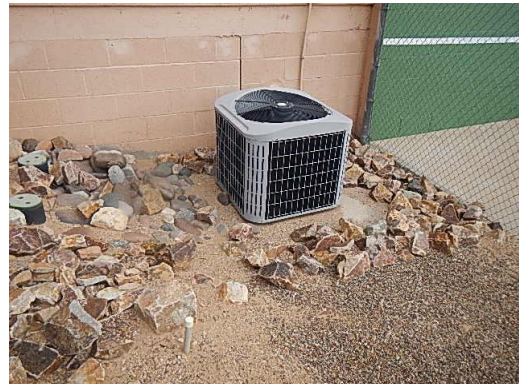
420 - HVAC	Useful Life 15	Remaining Life 6
Tennis Ramada Carrier Unit- 2007	Quantity 1	Unit of Measure Items
	Cost /Itm \$5,000	
	% Included 100.00%	Total Cost/Study \$5,000
Summary	Replacement Year 2022	Future Cost \$5,798

This is to replace the Carrier HVAC systems. It is possible that sub-components of these systems can be replaced or rebuilt to extend their lives.

- Unit 15- Tennis Ramada- Carrier- heat pump and furnace

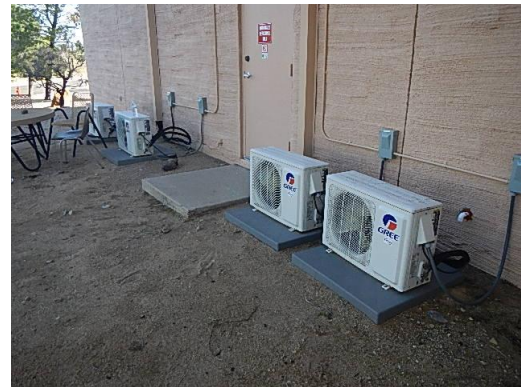
440 - HVAC	Useful Life 15	Remaining Life 11
4 Gree HVAC Units- 2012	Quantity 4	Unit of Measure Items
	Cost /Itm \$2,000	
	% Included 100.00%	Total Cost/Study \$8,000
Summary	Replacement Year 2027	Future Cost \$10,497

This is to replace the Gree HVAC systems. It is possible that sub-components of these systems can be replaced or rebuilt to extend their lives.

- Unit 16- Green Room Lobby- Gree Indoor & Outdoor
- Unit 17- Green Room- Gree Indoor & Outdoor
- Unit 18- Green Room Men's Dressing Room- Gree Indoor & Outdoor
- Unit 19- Green Room- Women's Dressing Room- Gree Indoor & Outdoor

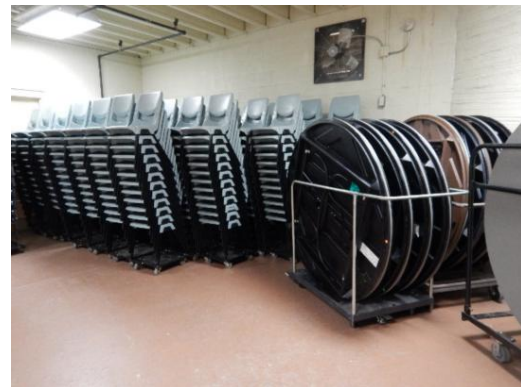
500 - Miscellaneous	Useful Life 10	Remaining Life 5
Auditorium Tables & Chairs	Quantity 1	Unit of Measure Lump Sum
	Cost /LS \$54,625	
	% Included 100.00%	Total Cost/Study \$54,625
Summary	Replacement Year 2021	Future Cost \$61,803

This is to replace miscellaneous furnishings.

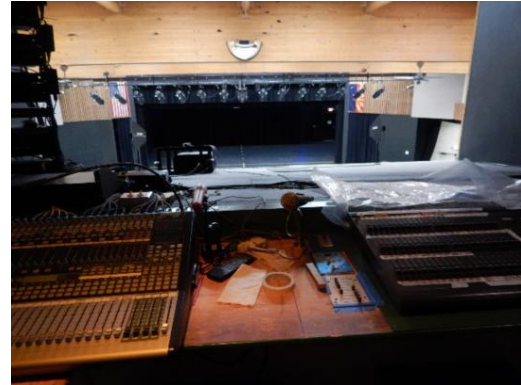
220 - Entertainment System	Useful Life 10	Remaining Life 10	
Auditorium Bldg	Quantity 1	Unit of Measure	Lump Sum
	Cost /LS \$50,000		
	% Included 100.00%	Total Cost/Study	\$50,000
Summary	Replacement Year 2026	Future Cost	\$64,004

This is to replace the audio visual and lighting systems. Not all items will be replaced at one time.

Stage back: 2x portable Anchor PA's, LG TV, Mackie PPM1008 mixer, 2x speakers w/ stands, 2x LED theater lights

Lighting closet: DLP projector, scoops/gels

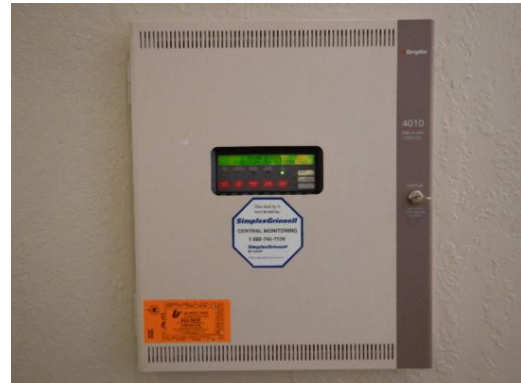
200 - Fire Control Misc	Useful Life 20	Remaining Life 4	
Fire Alarm System	Quantity 1	Unit of Measure	Lump Sum
	Cost /LS \$37,250		
	% Included 100.00%	Total Cost/Study	\$37,250
Summary	Replacement Year 2020	Future Cost	\$41,117

This is to repair and replace the fire alarm control panel, fire suppression system, alarms, sensors, pull stations, etc.

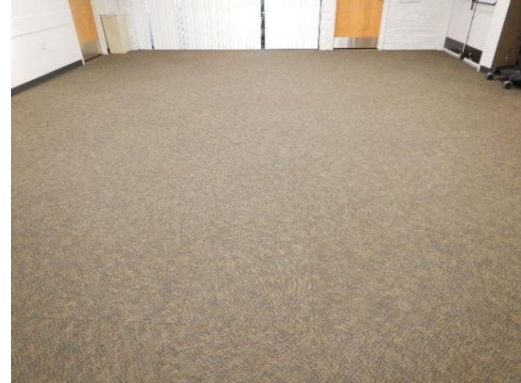
210 - Carpeting	Useful Life 10	Remaining Life 5
565 Sq. Yds. West Center Carpet	Quantity 565	Unit of Measure Square Yard
	Cost /SqYd \$32.00	
	% Included 100.00%	Total Cost/Study \$18,080
Summary	Replacement Year 2021	Future Cost \$20,456

This is to replace the carpeting.

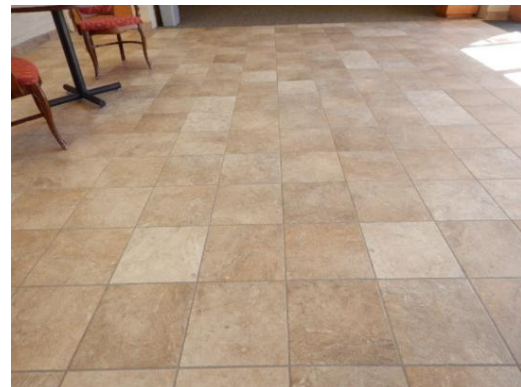
410 - Tile	Useful Life 20	Remaining Life 5
2,300 Sq. Ft. Clubhouse Walls & Floors	Quantity 2,300	Unit of Measure Square Feet
	Cost /SqFt \$10.00	
	% Included 100.00%	Total Cost/Study \$23,000
Summary	Replacement Year 2021	Future Cost \$26,022

This is to replace the wall and floor tile.

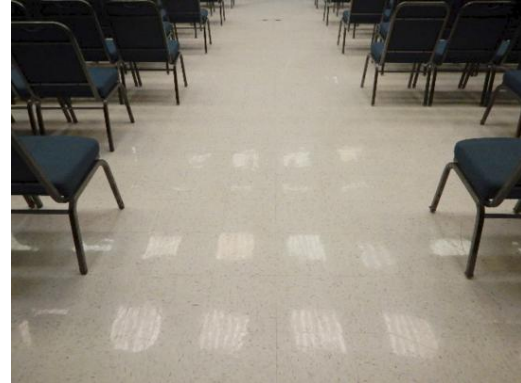
600 - Vinyl	Useful Life 15	Remaining Life 7
1,100 Sq. Yds. West Center Vinyl	Quantity 1,100	Unit of Measure Square Yard
	Cost /SqYd \$35.00	
	% Included 100.00%	Total Cost/Study \$38,500
Summary	Replacement Year 2023	Future Cost \$45,764

This is to replace the vinyl flooring.

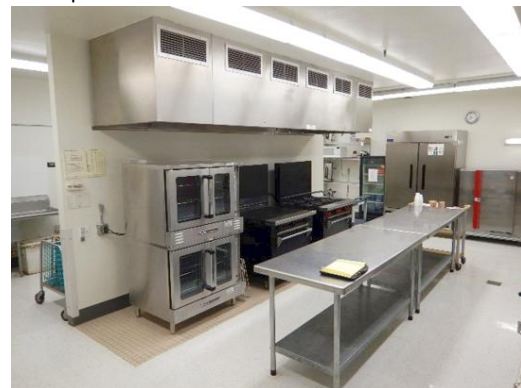
2016- Southbend CGS/28SC dbl stack convection oven replaced prior oven.

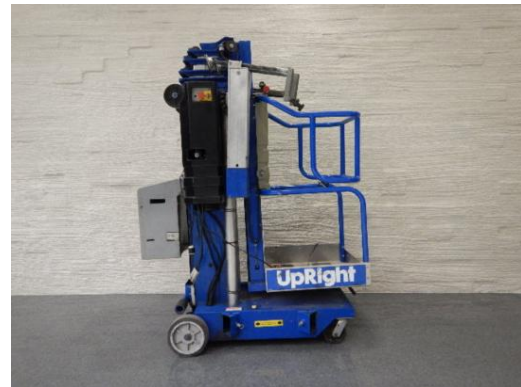
240 - Maintenance Equipment	Useful Life 20	Remaining Life 10	
3 Portable Lifts	Quantity 3	Unit of Measure	Items
	Cost /Itm \$10,000		
	% Included 100.00%	Total Cost/Study	\$30,000
Summary	Replacement Year 2026	Future Cost	\$38,403

This is to repair and replace the portable lifts.

In 2016, the units appear to have different ages. Unit replacement will likely be spread over several years.

- UpRight manlift, MN 068001-001M, SN 20642
- JLG manlift, MN SCR121097B1, SN 11292160
- Genie Industries 15' easy up lift, MN EU-15, SN 2785-354

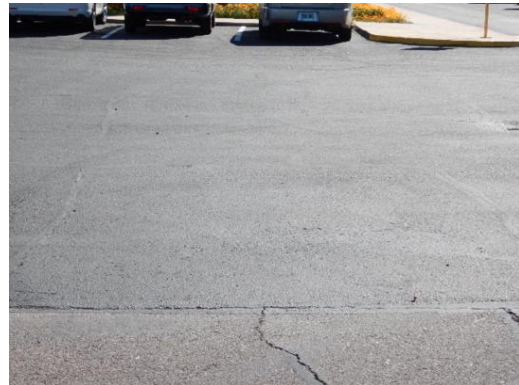
118 - Asphalt: Sealing	Useful Life 5	Remaining Life 3	
79,662 Sq. Ft. Parking Lot	Quantity 79,662	Unit of Measure Square Feet	
	Cost /SqFt \$0.200		
	% Included 100.00%	Total Cost/Study \$15,932	
Summary	Replacement Year 2019	Future Cost \$17,157

This is to prepare the surface, apply a single coat asphalt emulsion product and restripe to match existing layout. If a second coat is desired the cost is generally 10% to 20% higher.

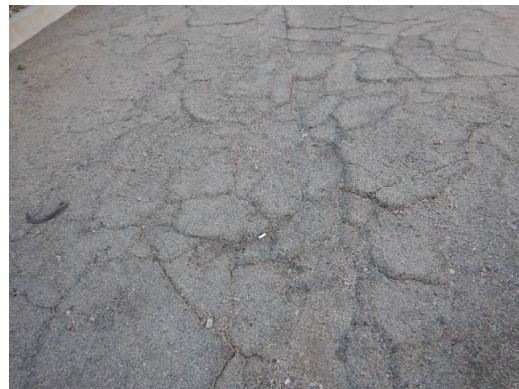
This is for miscellaneous repairs including crackfill, skin patching and minor dig out & fill. Cracks 1/4" or wider should be filled when observed.

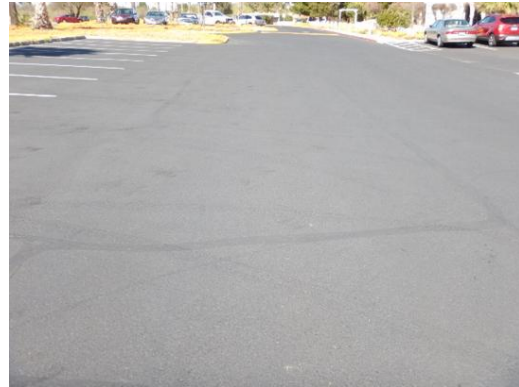
312 - Asphalt: Overlay w/ Interlayer	Useful Life 25	Remaining Life 23
51,762 Sq. Ft. West & North Parking Lots	Quantity 51,762	Unit of Measure Square Feet
	Cost /SqFt \$1.60	
	% Included 100.00%	Total Cost/Study \$82,819
Summary	Replacement Year 2039	Future Cost \$146,144

This is to apply a paving fabric interlayer to the existing asphalt surface and overlay with a minimum of 1.5" of new hot mix asphalt. Generally this includes edge grinding and utility box extensions.

2014- overlay work completed

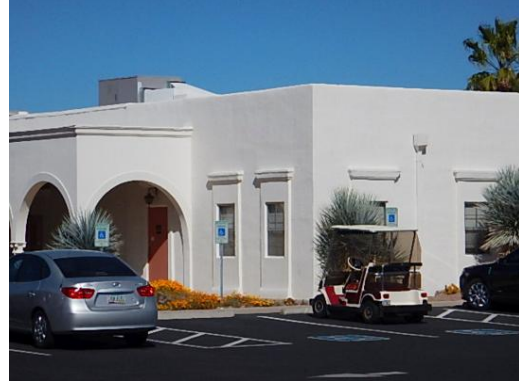
112 - Stucco	Useful Life 10	Remaining Life 7	
13,905 Sq. Ft. Building Exterior Painting	Quantity 13,905	Unit of Measure Square Feet	
	Cost /SqFt \$1.00		
	% Included 100.00%	Total Cost/Study \$13,905	
Summary	Replacement Year 2023	Future Cost \$16,529

This is to prepare, power wash, sand, scrape, caulk and paint the stucco surfaces with a premium paint.

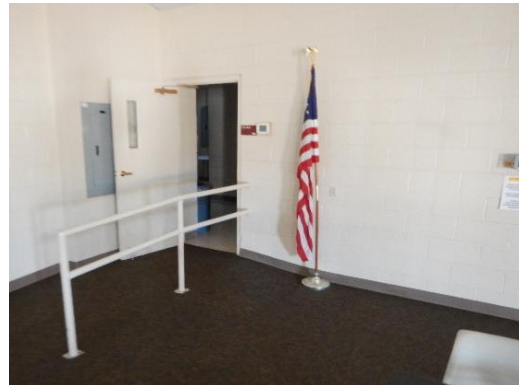
112 - Building	Useful Life 10	Remaining Life 5	
17,350 Sq. Ft. All Interior Spaces	Quantity 17,350	Unit of Measure Square Feet	
	Cost /SqFt \$0.750		
	% Included 100.00%	Total Cost/Study \$13,013	
Summary	Replacement Year 2021	Future Cost \$14,722

This is to prepare and paint all interior walls and ceilings.

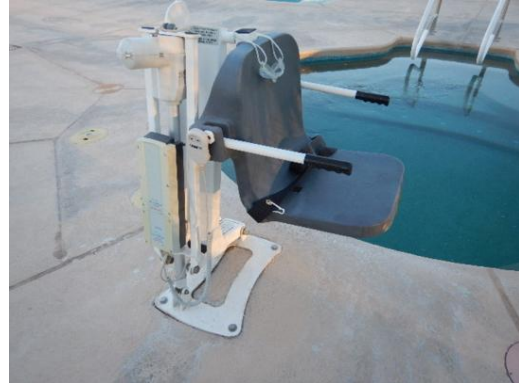
400 - ADA Chair Lift	Useful Life 10	Remaining Life 4	
2 Pool & Spa ADA Chairs	Quantity 2	Unit of Measure Items	
	Cost /Itm \$4,400		
	% Included 100.00%	Total Cost/Study \$8,800	
Summary	Replacement Year 2020	Future Cost \$9,714

This is to replace the pool and spa ADA compliant chair lifts.

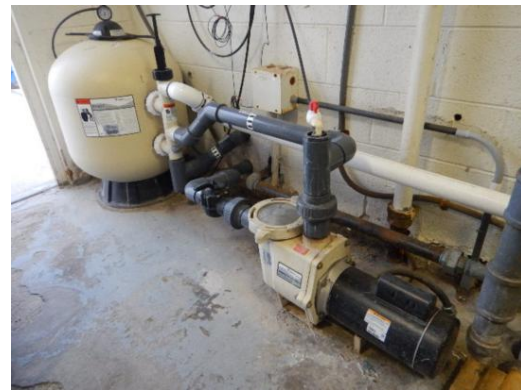
- 3- Pentair Triton II Commercial filters
- 2- Pentair Intelliflo Variable Speed pumps
- 1- additional spa pumps
- 3- Raypak Professional heaters (2- pool, 1- spa)
- 2- Aquasol chemical control systems
- Assorted- pipes, fittings, controls, lights, etc
- Carbon dioxide tank is not provided for within reserves.

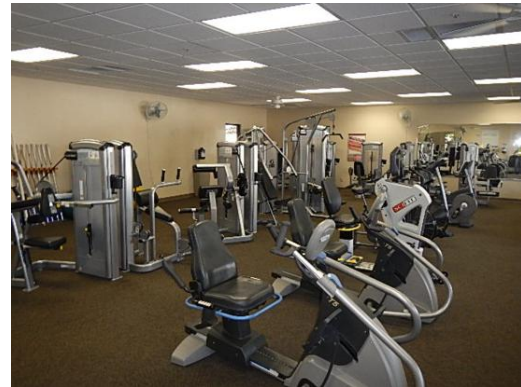
200 - Exercise: Cardio Equipment	Useful Life 1	Remaining Life 1	
17 Fitness Room Cardio Machines (20%)	Quantity 17	Unit of Measure Items	
	Cost /Itm \$6,000	Qty * \$/Itm \$102,000	
	% Included 20.00%	Total Cost/Study \$20,400	
Summary	Replacement Year 2017	Future Cost \$20,910

This is for as needed periodic replacement of the cardio equipment machines. Strength machines are provided for in another component.

Stepper (1)- Sci Fit

Treadmills (4)- 2 x Woodway, Life Fitness, Paramount

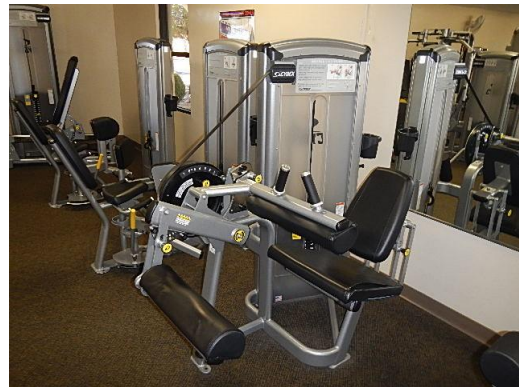
300 - Exercise: Strength Equipment	Useful Life 1	Remaining Life 1
13 Fitness Room Strength Machines (10%)	Quantity 13	Unit of Measure Items
	Cost /Itm \$4,000	Qty * \$/Itm \$52,000
	% Included 10.00%	Total Cost/Study \$5,200
Summary	Replacement Year 2017	Future Cost \$5,330

This is for as needed periodic replacement of the strength equipment machines. Cardio machines are provided for in another component.

Cybex (12)- Leg Extension, Seated Leg Curl, Hip Abduction, Hip Adduction, Leg Press, Fly/Rear Delt, Lat Pull, Row, Chest Press, Back Extension, Abdominal, Arm Extension

Precor (1)- Abdominal

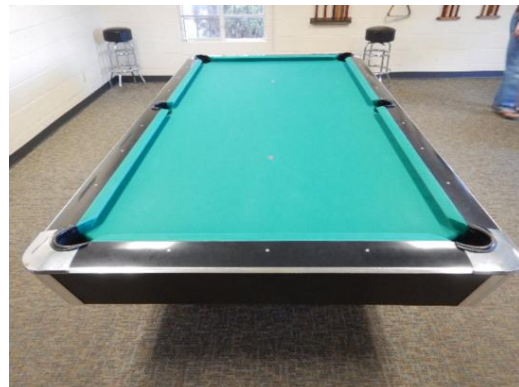
720 - Billiard Table	Useful Life 25	Remaining Life 13
2 Billiards Room	Quantity 2	Unit of Measure Items
	Cost /Itm \$5,750	
	% Included 100.00%	Total Cost/Study \$11,500
Summary	Replacement Year 2029	Future Cost \$15,853

This is to replace the billiard tables.

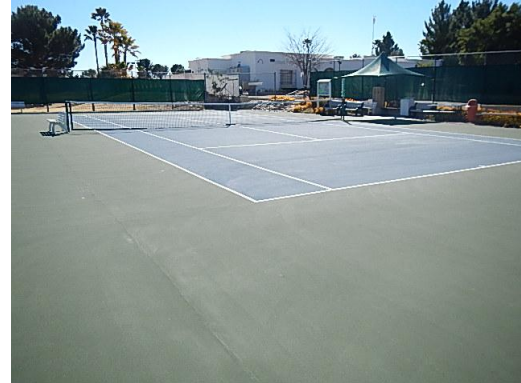
110 - Reseal	Useful Life 7	Remaining Life 4	
14,400 Sq. Ft. [2] Tennis Courts	Quantity 14,400	Unit of Measure Square Feet	
	Cost /SqFt \$0.900		
	% Included 100.00%	Total Cost/Study \$12,960	
Summary	Replacement Year 2020	Future Cost \$14,305

This is to crack fill, seal and stripe the tennis courts.

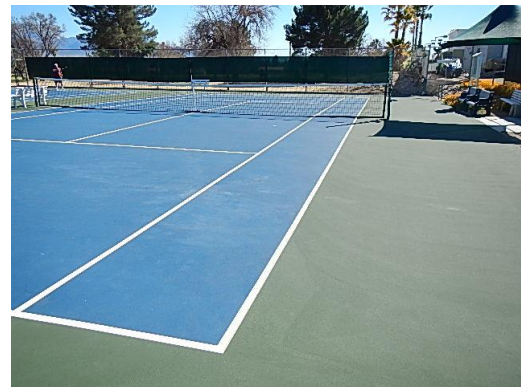
510 - Resurface	Useful Life 21	Remaining Life 11	
14,400 Sq. Ft. [2] Tennis Courts	Quantity 14,400	Unit of Measure Square Feet	
	Cost /SqFt \$2.75		
	% Included 100.00%	Total Cost/Study \$39,600	
Summary	Replacement Year 2027	Future Cost \$51,959

This is to resurface the tennis courts utilizing an overlay, color coat and striping.

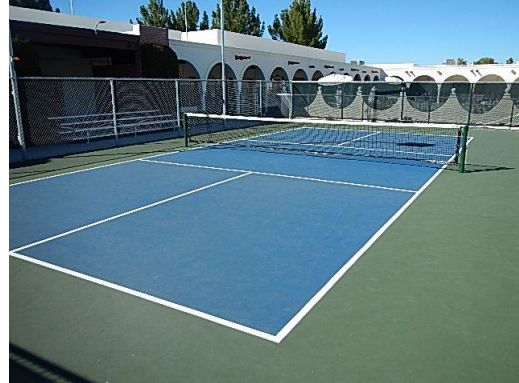
210 - Seal & Striping 15,330 Sq. Ft. [7] Pickleball Courts	Useful Life 7    Remaining Life 6 Quantity 15,330    Unit of Measure Square Feet Cost /SqFt \$0.900 % Included 100.00%    Total Cost/Study \$13,797 Replacement Year 2022    Future Cost \$16,000
Summary

This is to seal and re-stripe the Pickleball court surfaces on an ongoing basis.

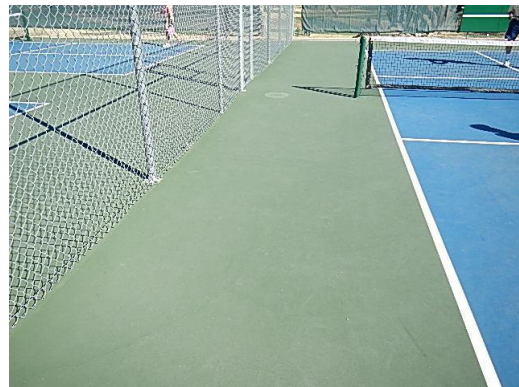
400 - Overlay 8,840 Sq. Ft. [4] Pickleball Courts	Useful Life 21    Remaining Life 20 Quantity 8,840    Unit of Measure Square Feet Cost /SqFt \$2.75 % Included 100.00%    Total Cost/Study \$24,310 Replacement Year 2036    Future Cost \$39,835
Summary

This is to resurface the northerly Pickleball courts utilizing an overlay, color coat and striping.

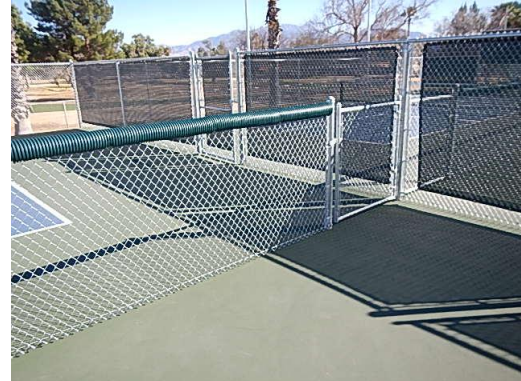
110 - Chain Link: 6'	Useful Life 30	Remaining Life 29
873 Lin. Ft. Pickleball Court Fencing	Quantity 873	Unit of Measure Linear Feet
	Cost /l.f. \$20.00	
	% Included 100.00%	Total Cost/Study \$17,460
Summary	Replacement Year 2045	Future Cost \$35,730

This is to replace the 6' and 4' chain link fencing.

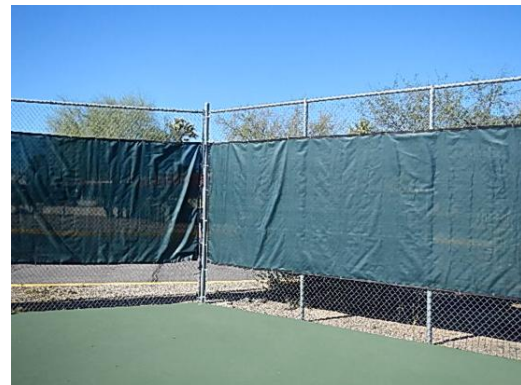
130 - Chain Link: 10'	Useful Life 30	Remaining Life 15
540 Lin. Ft. Tennis Court Fence	Quantity 540	Unit of Measure Linear Feet
	Cost /l.f. \$36.00	
	% Included 100.00%	Total Cost/Study \$19,440
Summary	Replacement Year 2031	Future Cost \$28,155

This is to replace the 10' chain link fencing.

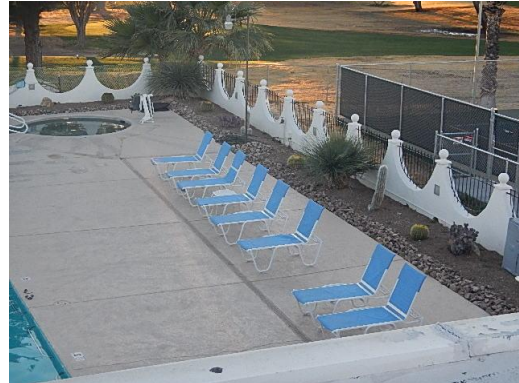
200 - Wrought Iron: 5'	Useful Life 30	Remaining Life 10	
415 Lin. Ft. Pool Perimeter Fence	Quantity 415	Unit of Measure Linear Feet	
	Cost /l.f. \$34.00		
	% Included 100.00%	Total Cost/Study \$14,110	
Summary	Replacement Year 2026	Future Cost \$18,062

This is to replace the 5' wrought iron fencing. With aggressive paint maintenance, this component's life may be extended. Painting is provided for within another component.

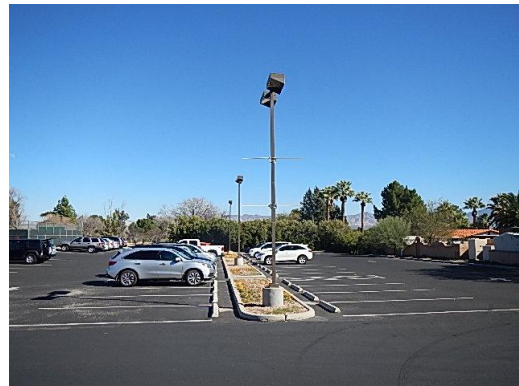
510 - Parking Lot	Useful Life 30	Remaining Life 5	
7 Parking Lot Lights	Quantity 7	Unit of Measure Items	
	Cost /Itm \$2,500		
	% Included 100.00%	Total Cost/Study \$17,500	
Summary	Replacement Year 2021	Future Cost \$19,800

This is to replace the parking lot lights.

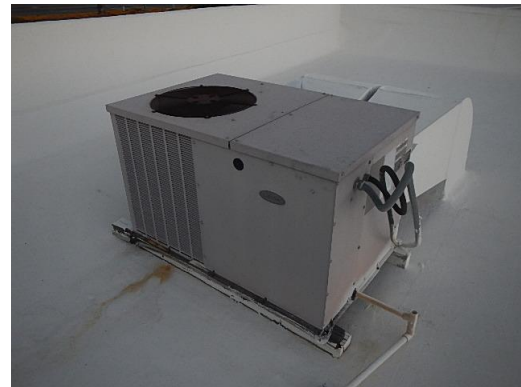
288 - HVAC	Useful Life 15	Remaining Life 1
4 Rooftop Carrier Units- 2001	Quantity 4	Unit of Measure Items
	Cost /Itm \$5,075	
	% Included 100.00%	Total Cost/Study \$20,300
Summary	Replacement Year 2017	Future Cost \$20,808

This is to replace the Carrier HVAC systems. It is possible that sub-components of these systems can be replaced or rebuilt to extend their lives.

- Unit 2- Art Room- Carrier- 3.5T
- Unit 6- Locker Room- Carrier- 4T
- Unit 7- Office- Carrier- 4T
- Unit 11- Fitness- Carrier- 5T

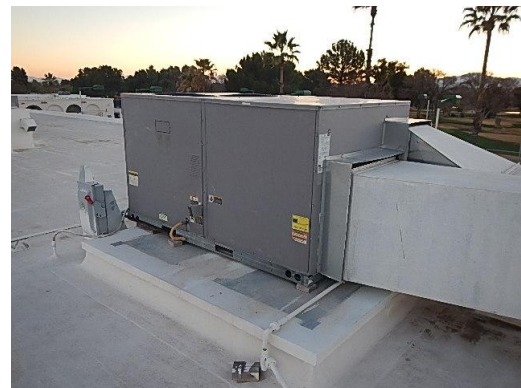
324 - HVAC	Useful Life 15	Remaining Life 8
Rooftop Carrier Unit- 2009	Quantity 1	Unit of Measure Items
	Cost /Itm \$12,000	
	% Included 100.00%	Total Cost/Study \$12,000
Summary	Replacement Year 2024	Future Cost \$14,621

This is to replace the Carrier HVAC system. It is possible that sub-components of this system can be replaced or rebuilt to extend its life.

- Unit 3- Auditorium- Carrier- 10T

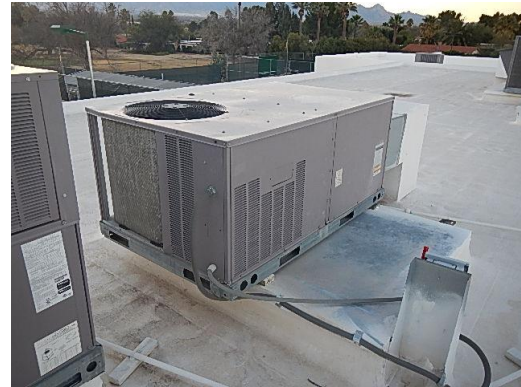
Useful Life	15	Remaining Life	5
Quantity	1	Unit of Measure	Items
Cost /Itm	\$12,000		
% Included	100.00%	Total Cost/Study	\$12,000
Replacement Year	2021	Future Cost	\$13,577

This is to replace the Carrier HVAC system. It is possible that sub-components of this system can be replaced or rebuilt to extend its life.

Unit 4- Auditorium- Carrier- 10T

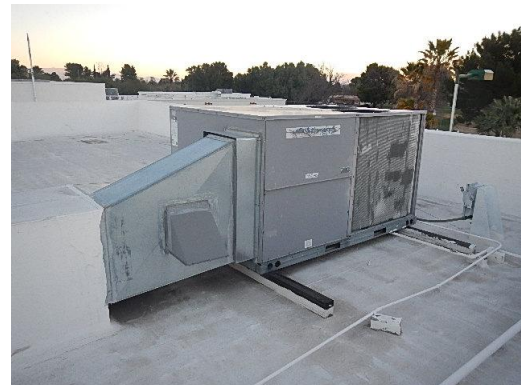
384 - HVAC

Rooftop Carrier Unit- 2008

Useful Life	15	Remaining Life	7
Quantity	1	Unit of Measure	Items
Cost /Itm	\$12,000		
% Included	100.00%	Total Cost/Study	\$12,000
Replacement Year	2023	Future Cost	\$14,264

This is to replace the Carrier HVAC system. It is possible that sub-components of this system can be replaced or rebuilt to extend its life.

Unit 8- Lounge- Carrier- 10T

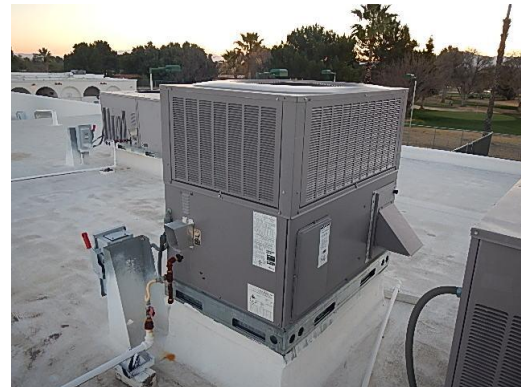
408 - HVAC	Useful Life 15	Remaining Life 10
5 Rooftop Carrier Units- 2011	Quantity 5	Unit of Measure Items
	Cost /Itm \$4,960	
	% Included 100.00%	Total Cost/Study \$24,800
Summary	Replacement Year 2026	Future Cost \$31,746

This is to replace the Carrier HVAC systems. It is possible that sub-components of these systems can be replaced or rebuilt to extend their lives.

- Unit 5- Lobby- Carrier- 3T
- Unit 12- Fitness- Carrier- 5T
- Unit 13- Billiard Room- Carrier- 4T
- Unit 14- Lapidary Annex- Carrier- 4T
- Unit 15- Lapidary- Carrier- 4T

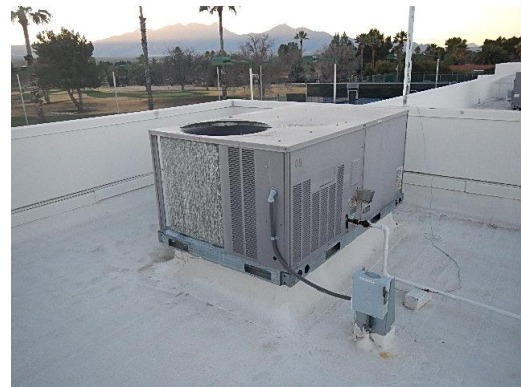
424 - HVAC	Useful Life 15	Remaining Life 1
2 Rooftop Carrier Units- 2002	Quantity 2	Unit of Measure Items
	Cost /Itm \$4,000	
	% Included 100.00%	Total Cost/Study \$8,000
Summary	Replacement Year 2017	Future Cost \$8,200

This is to replace the Carrier HVAC systems. It is possible that sub-components of these systems can be replaced or rebuilt to extend their lives.

- Unit 9- Women's Locker Room- Carrier- 3T
- Unit 10- Men's Locker Room- Carrier 3T

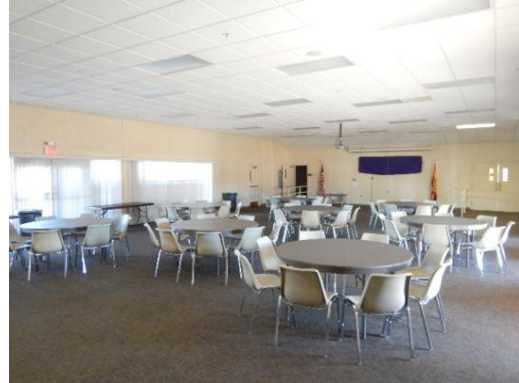
520 - Miscellaneous	Useful Life 10	Remaining Life 5	
Folding Tables & Chairs	Quantity 1	Unit of Measure Lump Sum	
	Cost /LS \$26,500		
	% Included 100.00%	Total Cost/Study \$26,500	
Summary	Replacement Year 2021	Future Cost \$29,982

This is to replace the auditorium folding tables and chairs.

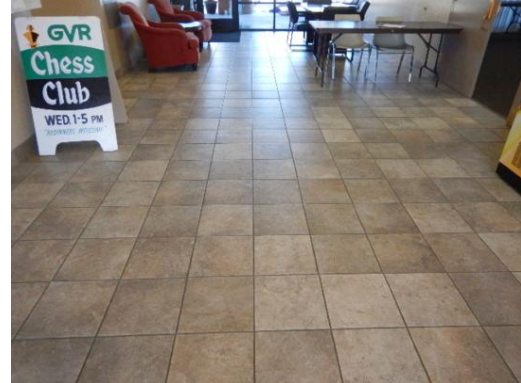
420 - Tile	Useful Life 20	Remaining Life 5
4,000 Sq. Ft. Clubhouse Walls & Floors	Quantity 4,000	Unit of Measure Square Feet
	Cost /SqFt \$10.00	
	% Included 100.00%	Total Cost/Study \$40,000
Summary	Replacement Year 2021	Future Cost \$45,256

This is to replace the wall and floor tile.

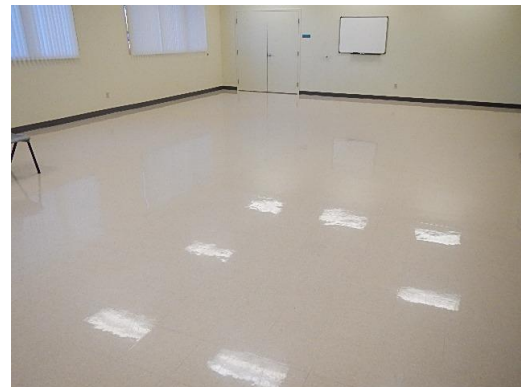
610 - Vinyl	Useful Life 15	Remaining Life 5
160 Sq. Yds. Art Room, Lobby, Kitchen	Quantity 160	Unit of Measure Square Yard
	Cost /SqYd \$35.00	
	% Included 100.00%	Total Cost/Study \$5,600
Summary	Replacement Year 2021	Future Cost \$6,336

This is to replace the vinyl flooring.
