**RESERVE STUDY**

Full Study

**Green Valley Recreation Inc**

Published - June 28, 2016

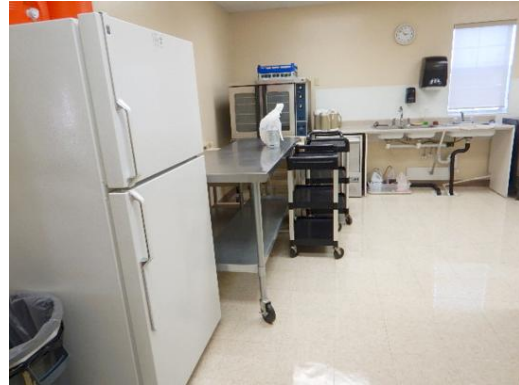
720 - Miscellaneous	Useful Life 12	Remaining Life 6
8 Kitchen Appliances	Quantity 8	Unit of Measure Items
	Cost /Itm \$1,835	
	% Included 100.00%	Total Cost/Study \$14,680
Summary	Replacement Year 2022	Future Cost \$17,024

This is to repair or replace miscellaneous appliances.

Bunn Coffee snl brewer, Amana Distinctions range, Maytag microwave, Manitowoc UY0140A-161B SN 310283308 ice maker, Moyer Diebel 401LT SN W6128 under counter commercial dishwasher, Duke E101-E dbl door convection oven, GE 22 CF refer, Vollrath 38710 4-pan buffet cart

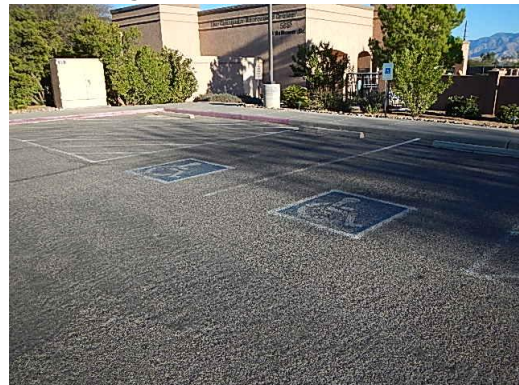
124 - Asphalt: Sealing	Useful Life 5	Remaining Life 1
70,468 Sq. Ft. Parking Lot	Quantity 70,468	Unit of Measure Square Feet
	Cost /SqFt \$0.200	
	% Included 100.00%	Total Cost/Study \$14,094
Summary	Replacement Year 2017	Future Cost \$14,446

This is to prepare the surface, apply a single coat asphalt emulsion product and restripe to match the existing layout. If a second coat is desired the cost is generally 10% to 20% higher.

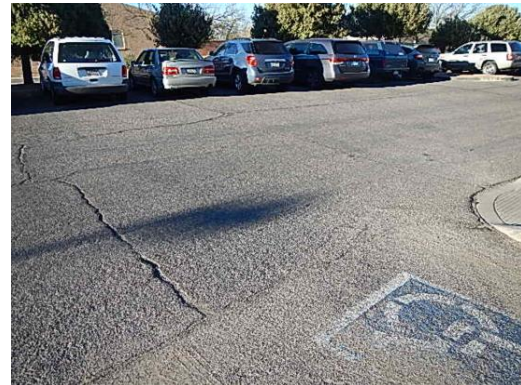
224 - Asphalt: Ongoing Repairs 70,468 Sq. Ft. Parking Lot (3%)	Useful Life 5    Remaining Life 1 Quantity 70,468 Cost /SqFt \$3.25 % Included 2.50%	Unit of Measure Square Feet Qty * \$/SqFt \$229,021 Total Cost/Study \$5,726 Future Cost \$5,869
Summary	Replacement Year 2017

This is for miscellaneous repairs including crackfill, skin patching and minor dig out & fill. Cracks 1/4" or wider should be filled when observed.

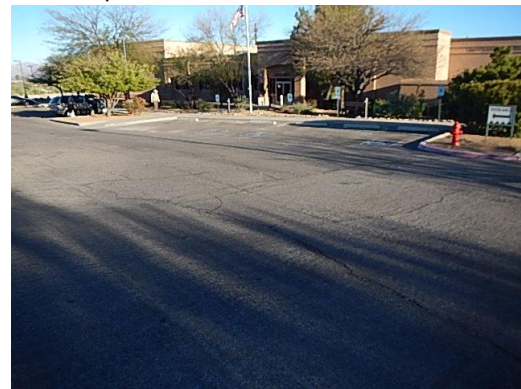
318 - Asphalt: Overlay w/ Interlayer 26,000 Sq. Ft. North Parking Lot	Useful Life 25    Remaining Life 5 Quantity 26,000 Cost /SqFt \$1.60 % Included 100.00%	Unit of Measure Square Feet Total Cost/Study \$41,600 Future Cost \$47,067
Summary	Replacement Year 2021

This is to apply a paving fabric interlayer to the existing asphalt surface and overlay with a minimum of 1.5" of new hot mix asphalt. Generally this includes edge grinding and utility box extensions.

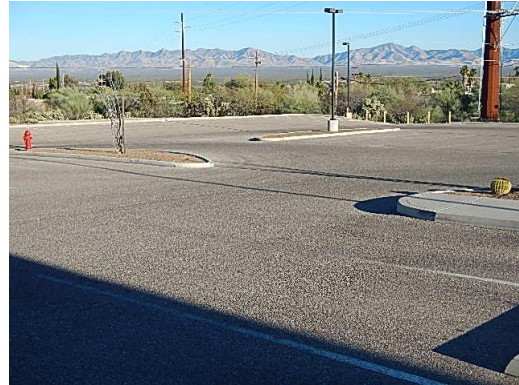
364 - Asphalt: Overlay w/ Interlayer 44,468 Sq. Ft. East Parking Lot	Useful Life 25    Remaining Life 19 Quantity 44,468    Unit of Measure Square Feet Cost /SqFt \$1.60 % Included 100.00%    Total Cost/Study \$71,149 Replacement Year 2035    Future Cost \$113,742
Summary

This is to apply a paving fabric interlayer to the existing asphalt surface and overlay with a minimum of 1.5" of new hot mix asphalt. Generally this includes edge grinding and utility box extensions.

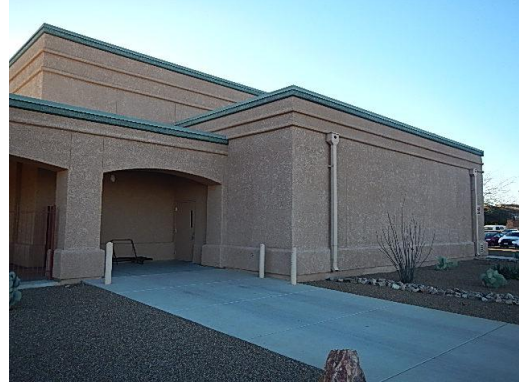
118 - Stucco	Useful Life 10	Remaining Life 5
18,180 Sq. Ft. Exterior Building Surfaces	Quantity 18,180	Unit of Measure Square Feet
	Cost /SqFt \$1.00	
	% Included 100.00%	Total Cost/Study \$18,180
Summary	Replacement Year 2021	Future Cost \$20,569

This is to prepare, power wash, sand, scrape, caulk and paint the stucco surfaces with a premium paint.

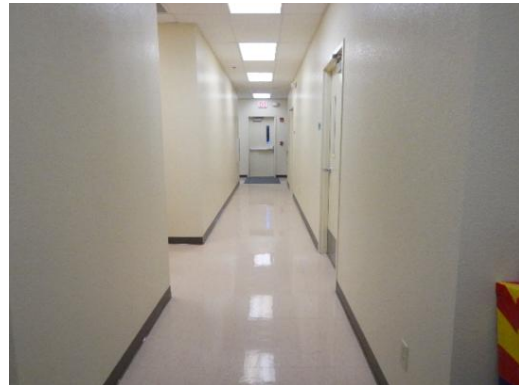
118 - Building	Useful Life 10	Remaining Life 5
21,900 Sq. Ft. All Interior Spaces	Quantity 21,900	Unit of Measure Square Feet
	Cost /SqFt \$0.750	
	% Included 100.00%	Total Cost/Study \$16,425
Summary	Replacement Year 2021	Future Cost \$18,583

This is to prepare and paint all interior walls and ceilings.

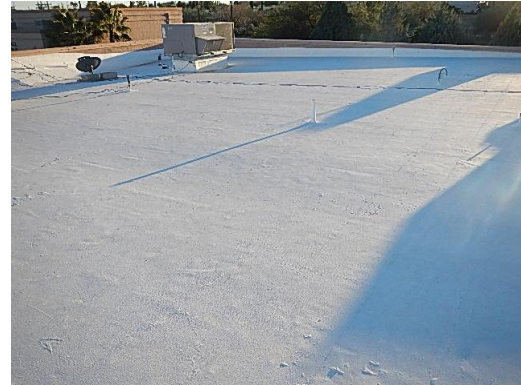
318 - Low Slope: Vinyl 198 Squares- Clubhouse & Racquetball Roof	Useful Life 20 Quantity 198 Cost /Sqrs \$500 % Included 100.00%	Remaining Life 5 Unit of Measure Squares Total Cost/Study \$99,000 Replacement Year 2021 Future Cost \$112,009
Summary

This is to replace the low slope single-ply vinyl roofing system. All roofs should be regularly inspected and repaired as indicated to ensure maximum life.

Clubhouse- 193 squares  
 Racquetball Building- 5 squares

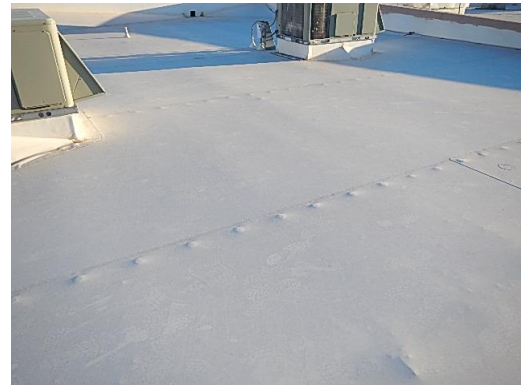
912 - Miscellaneous 198 Squares- Roof Recoating	Useful Life 5 Quantity 198 Cost /Sqrs \$40.00 % Included 100.00%	Remaining Life 3 Unit of Measure Squares Total Cost/Study \$7,920 Replacement Year 2019 Future Cost \$8,529
Summary

This is to prepare and recoat the low slope roofs. All roof should be regularly inspected and repaired as indicated to ensure full life.

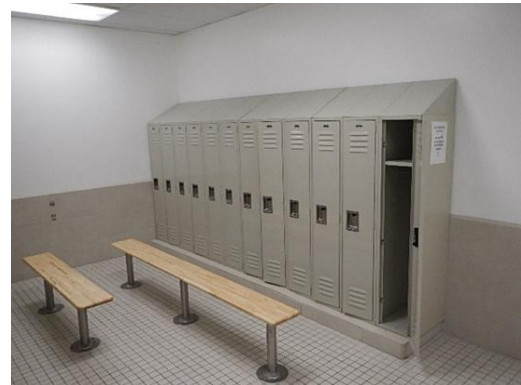
212 - Bathrooms 2 Locker Rooms	Useful Life 20 Quantity 2 Cost /Rm \$23,500 % Included 100.00%	Remaining Life 5 Unit of Measure Room Total Cost/Study \$47,000 Future Cost \$53,176
Summary	Replacement Year 2021

This is to rehab and redecorate the bathrooms including items such as partitions, fixtures, lighting, tile, etc. Client input will further define this component.

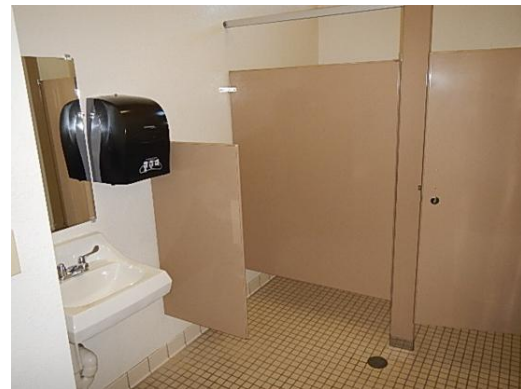
318 - Restrooms 2 Racquetball Court Restrooms	Useful Life 20 Quantity 2 Cost /Rm \$6,125 % Included 100.00%	Remaining Life 3 Unit of Measure Room Total Cost/Study \$12,250 Future Cost \$13,192
Summary	Replacement Year 2019

This is to rehab and redecorate the restrooms including items such as partitions, fixtures, lighting, tile, etc. Client input will further define this component.

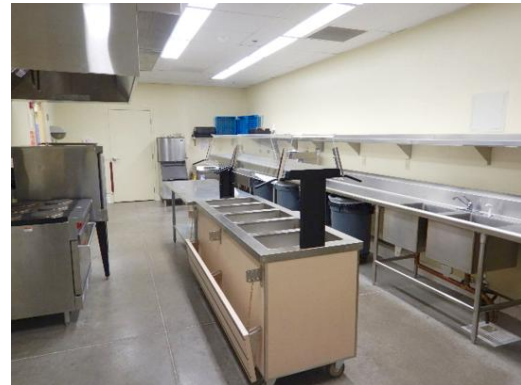
406 - Kitchen	Useful Life 1	Remaining Life 0
Clubhouse Kitchen	Quantity 1	Unit of Measure Room
	Cost /Rm \$7,000	
	% Included 100.00%	Total Cost/Study \$7,000
Summary	Replacement Year 2016	Future Cost \$7,000

This is to rehab and redecorate the kitchen including items such as cabinets, countertops, fixtures, lighting, etc. Client input will further define this component. Appliances are provided for within other components.

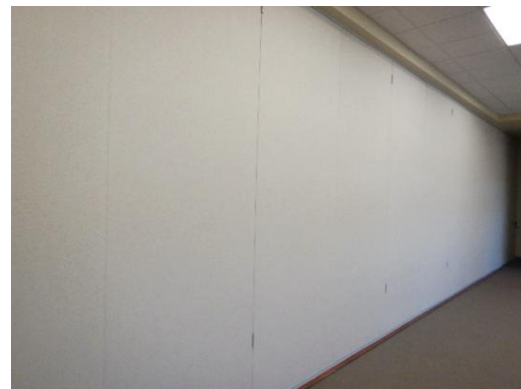
560 - Operable Wall/Partition	Useful Life 25	Remaining Life 17
1,296 Sq. Ft. [2] Agave	Quantity 1,296	Unit of Measure Square Feet
	Cost /SqFt \$35.00	
	% Included 100.00%	Total Cost/Study \$45,360
Summary	Replacement Year 2033	Future Cost \$69,021

This is to repair and replace the operable panel walls.

2- 12x54

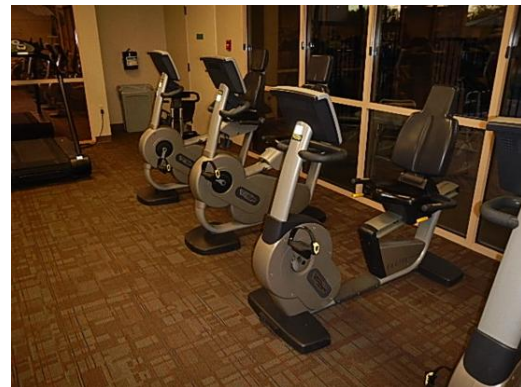
210 - Exercise: Cardio Equipment	Useful Life 1	Remaining Life 1	
19 Fitness Center Cardio Machines (20%)	Quantity 19	Unit of Measure Items	
	Cost /Itm \$6,000	Qty * \$/Itm \$114,000	
	% Included 20.00%	Total Cost/Study \$22,800	
Summary	Replacement Year 2017	Future Cost \$23,370

This is for as needed periodic replacement of the cardio equipment machines. Strength machines are provided for in another component.

Stepper (1)- 1 Cybex

Treadmills (4)- 3 Woodway, 1 Techno Gym

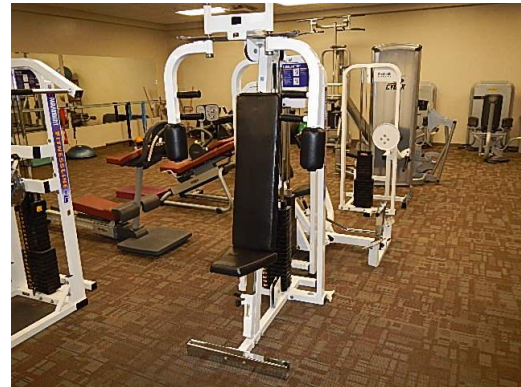
310 - Exercise: Strength Equipment	Useful Life 1	Remaining Life 1	
17 Fitness Center Strength Machines (10%)	Quantity 17	Unit of Measure Items	
	Cost /Itm \$4,000	Qty * \$/Itm \$68,000	
	% Included 10.00%	Total Cost/Study \$6,800	
Summary	Replacement Year 2017	Future Cost \$6,970

This is for as needed periodic replacement of the strength equipment machines. Cardio machines are provided for in another component.

Precor (1)- Abdominal

Techno Gym (6)- Low Row, Abductor, Adductor, 3 set Stair Machine, Posterior Flexibility, Anterior Flexibility

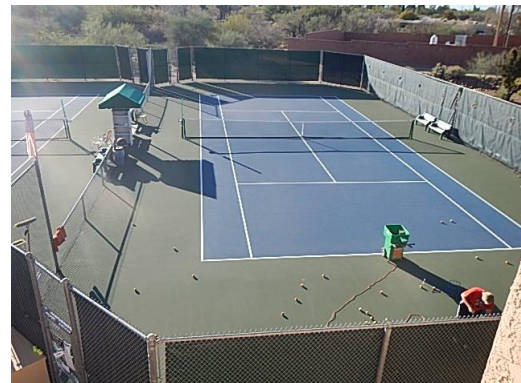
120 - Reseal	Useful Life 7	Remaining Life 3	
14,000 Sq. Ft. [2] Tennis Courts	Quantity 14,000	Unit of Measure Square Feet	
	Cost /SqFt \$0.900		
	% Included 100.00%	Total Cost/Study \$12,600	
Summary	Replacement Year 2019	Future Cost \$13,569

This is to crack fill, seal and stripe the tennis courts.

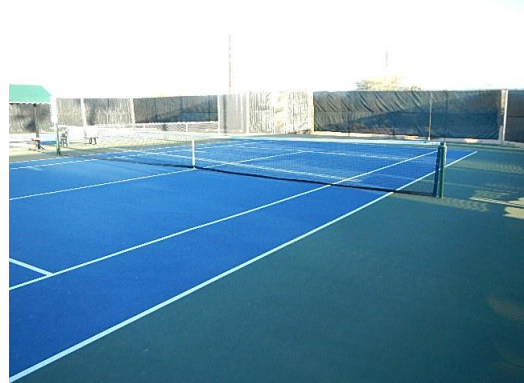
520 - Resurface	Useful Life 21	Remaining Life 10
14,000 Sq. Ft. [2] Tennis Courts	Quantity 14,000	Unit of Measure Square Feet
	Cost /SqFt \$2.75	
	% Included 100.00%	Total Cost/Study \$38,500
Summary	Replacement Year 2026	Future Cost \$49,283

This is to resurface the tennis courts utilizing an overlay, color coat and striping.

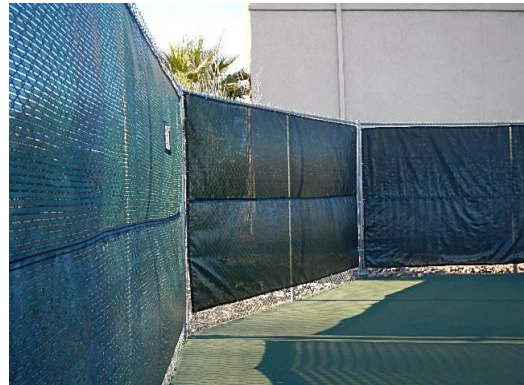
140 - Chain Link: 10'	Useful Life 30	Remaining Life 15
540 Lin. Ft. Tennis Court Fence	Quantity 540	Unit of Measure Linear Feet
	Cost /l.f. \$35.00	
	% Included 100.00%	Total Cost/Study \$18,900
Summary	Replacement Year 2031	Future Cost \$27,373

This is to replace the 10' chain link fencing.

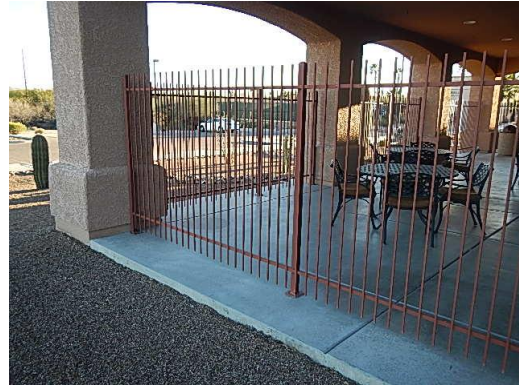
210 - Wrought Iron: 5'	Useful Life 30	Remaining Life 11
315 Lin. Ft. Pool Area Fencing	Quantity 315	Unit of Measure Linear Feet
	Cost /l.f. \$34.00	
	% Included 100.00%	Total Cost/Study \$10,710
Summary	Replacement Year 2027	Future Cost \$14,052

This is to replace the 5' wrought iron fencing. With aggressive paint maintenance, this component's life may be extended. Painting is provided for within another component.

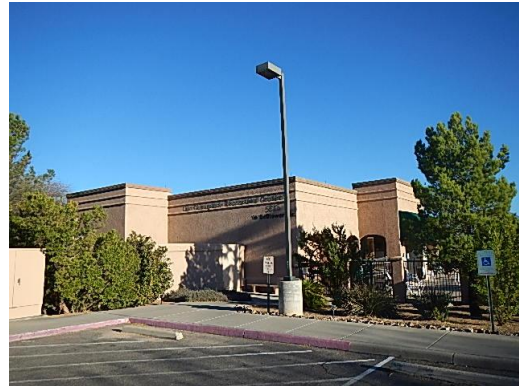
520 - Parking Lot	Useful Life 30	Remaining Life 11
8 North Parking Lot Lights	Quantity 8	Unit of Measure Items
	Cost /itm \$2,500	
	% Included 100.00%	Total Cost/Study \$20,000
Summary	Replacement Year 2027	Future Cost \$26,242

This is to replace the parking lot lights.

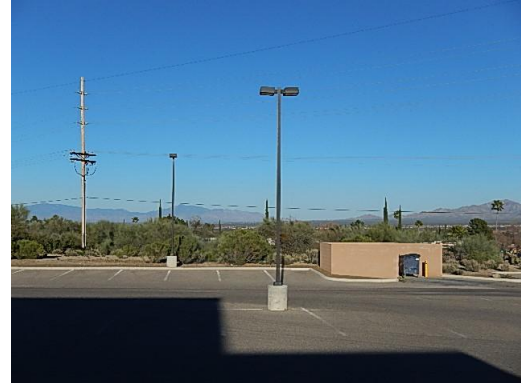
560 - Parking Lot	Useful Life 30	Remaining Life 24
13 East Parking Lot Lights	Quantity 13	Unit of Measure Items
	Cost /Itm \$2,500	
	% Included 100.00%	Total Cost/Study \$32,500
Summary	Replacement Year 2040	Future Cost \$58,784

This is to replace the parking lot lights.

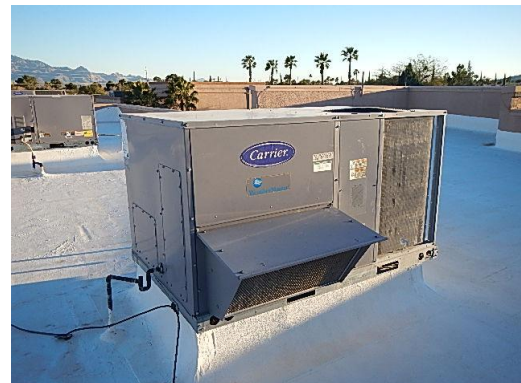
212 - HVAC	Useful Life 15	Remaining Life 7
11 Rooftop Trane Units- 2008	Quantity 11	Unit of Measure Items
	Cost /Itm \$7,923	
	% Included 100.00%	Total Cost/Study \$87,150
Summary	Replacement Year 2023	Future Cost \$103,594

This is to replace the Trane HVAC systems. It is possible that sub-components of these systems can be replaced or rebuilt to extend their lives.

- Unit 1- Acacia- Trane- 3.5T
- Unit 2- Cypress- Trane- 3.5T
- Unit 3- Lobby- Trane- 3.5T
- Unit 4- Cottonwood- Trane 4.5T
- Unit 5- Iron Wood- Trane- 5T
- Unit 6- Kitchen- Trane- 5T
- Unit 7- Bathrooms- Trane- 2.5T
- Unit 8- Ocotillo- Trane- 12.5T
- Unit 9- Agave- Trane 10T
- Unit 10- Juniper- Trane- 12.5T
- Unit 11- Fitness- Trane- 10T

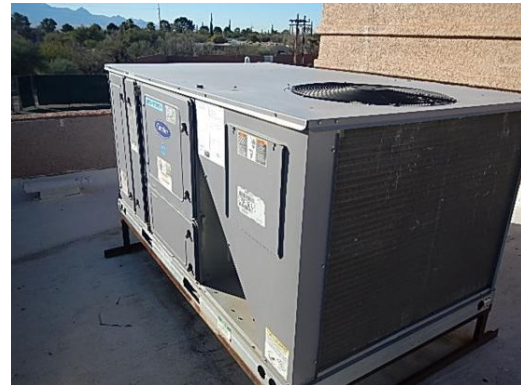
292 - HVAC 4 Rooftop Carrier Units- 2010	Useful Life 15 Quantity 4 Cost /Itm \$7,225 % Included 100.00%	Remaining Life 9 Unit of Measure Items Total Cost/Study \$28,900 Replacement Year 2025 Future Cost \$36,092
Summary

This is to replace the Carrier HVAC systems. It is possible that sub-components of these systems can be replaced or rebuilt to extend their lives.

- Unit 12- Fitness- Carrier- 6T
- Unit 13- Lobby- Carrier- 3T
- Unit 14- Locker Room- Carrier- 5T
- Unit 15- Racquetball Courts 1 & 2- Carrier- 5T

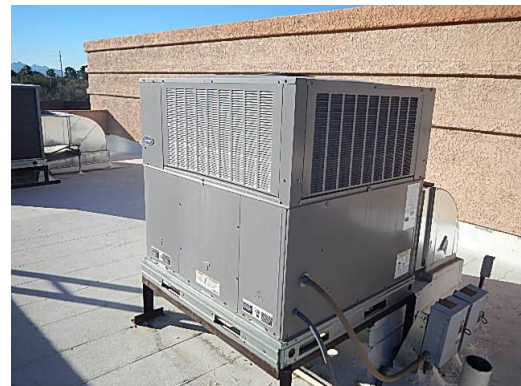
328 - HVAC Rooftop Carrier Unit- 2014	Useful Life 15 Quantity 1 Cost /Itm \$5,000 % Included 100.00%	Remaining Life 13 Unit of Measure Items Total Cost/Study \$5,000 Replacement Year 2029 Future Cost \$6,893
Summary

This is to replace the Carrier HVAC system. It is possible that sub-components of this system can be replaced or rebuilt to extend its life.

- Unit 16- Racquetball Lobby, men's & women's restrooms- Carrier- 4T

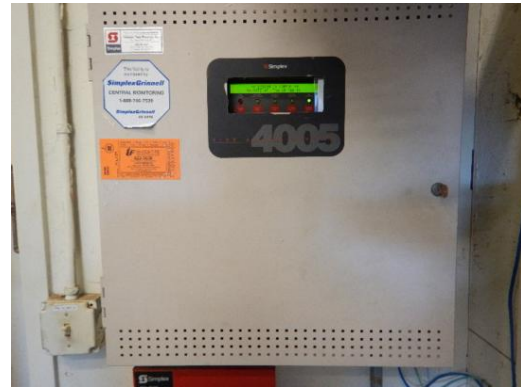
210 - Fire Control Misc	Useful Life 20	Remaining Life 5	
Fire Alarm System	Quantity 1	Unit of Measure Lump Sum	
	Cost /LS \$15,875		
	% Included 100.00%	Total Cost/Study \$15,875	
Summary	Replacement Year 2021	Future Cost \$17,961

This is to repair and replace the fire alarm control panel, fire suppression system, alarms, sensors, pull stations, etc.

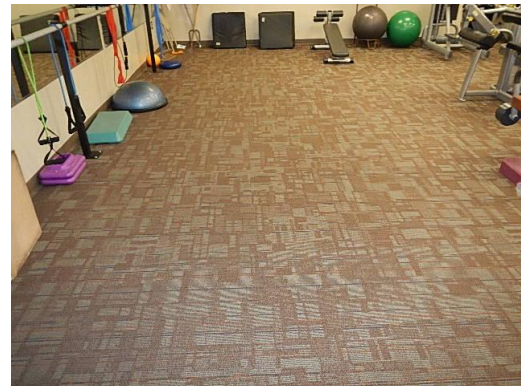
230 - Carpeting	Useful Life 10	Remaining Life 5	
580 Sq. Yds. Clubhouse Carpet	Quantity 580	Unit of Measure Square Yard	
	Cost /SqYd \$32.00		
	% Included 100.00%	Total Cost/Study \$18,560	
Summary	Replacement Year 2021	Future Cost \$20,999

This is to replace the carpeting.

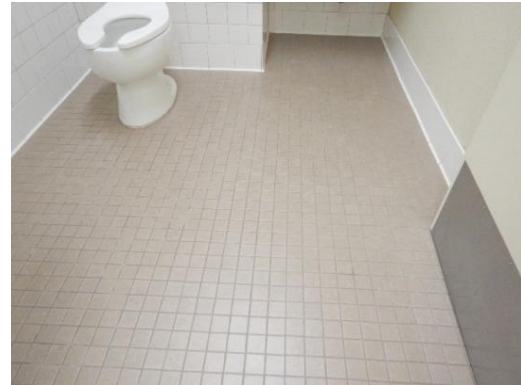
430 - Tile	Useful Life 20	Remaining Life 5	
3,050 Sq. Ft. Clubhouse Walls & Floors	Quantity 3,050	Unit of Measure Square Feet	
	Cost /SqFt \$10.00		
	% Included 100.00%	Total Cost/Study \$30,500	
Summary	Replacement Year 2021	Future Cost \$34,508

This is to replace the wall and floor tile.

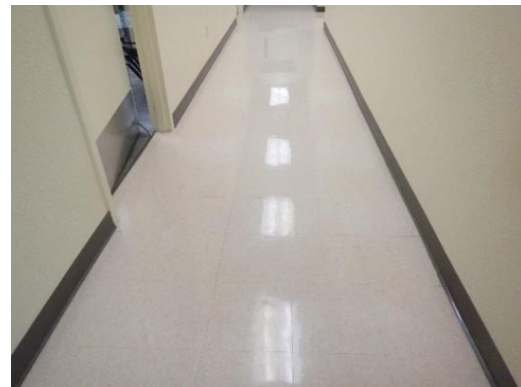
620 - Vinyl	Useful Life 15	Remaining Life 5	
540 Sq. Yds. Clubhouse	Quantity 540	Unit of Measure Square Yard	
	Cost /SqYd \$35.00		
	% Included 100.00%	Total Cost/Study \$18,900	
Summary	Replacement Year 2021	Future Cost \$21,384

This is to replace the vinyl flooring.

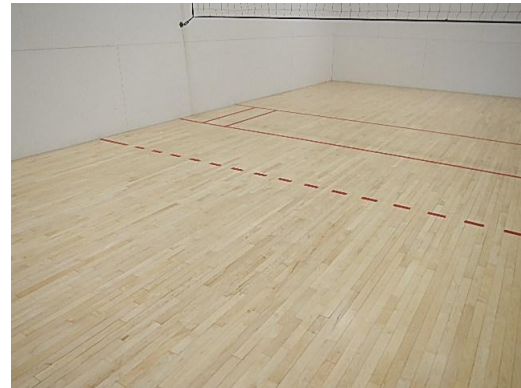
700 - Hardwood Floors	Useful Life 25	Remaining Life 13	
1,600 Sq. Ft. Racquetball Court- Replace	Quantity 1,600	Unit of Measure Square Feet	
	Cost /SqFt \$14.00		
	% Included 100.00%	Total Cost/Study \$22,400	
Summary	Replacement Year 2029	Future Cost \$30,879

This is to replace the racquetball court hardwood flooring. Refinishing and restriping is from operating.

2- 20' x 40' racquetball courts

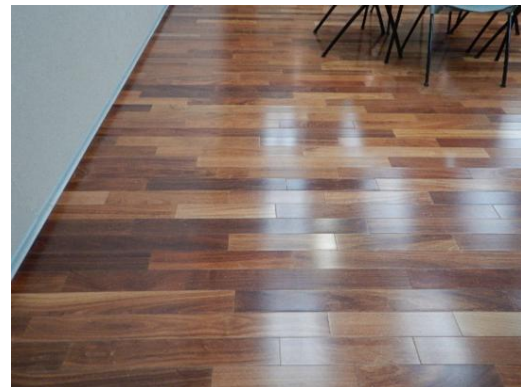
740 - Hardwood Floors	Useful Life 40	Remaining Life 32	
2,925 Sq. Ft. Agave & Ocotillo Floor- Replace	Quantity 2,925	Unit of Measure Square Feet	
	Cost /SqFt \$15.00		
	% Included 100.00%	Total Cost/Study \$43,875	
Summary	Replacement Year 2048	Future Cost \$96,690

This is to replace the Agave & Ocotillo room hardwood flooring. Refinishing is provided for within another component.

2008- Approximate new installation year.

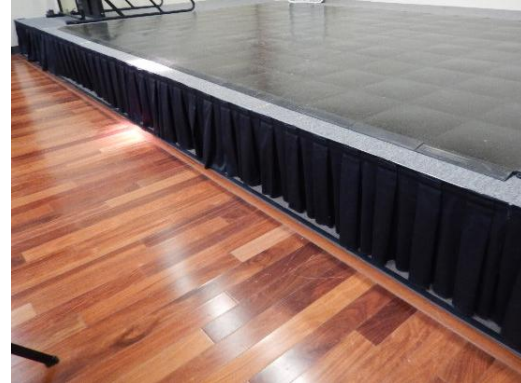
770 - Hardwood Floors	Useful Life 10	Remaining Life 5	
2,925 Sq. Ft. Agave & Ocotillo Floor-Refinish	Quantity 2,925	Unit of Measure Square Feet	
	Cost /SqFt \$6.00		
	% Included 100.00%	Total Cost/Study \$17,550	
Summary	Replacement Year 2021	Future Cost \$19,856

This is to refinish the hardwood flooring.

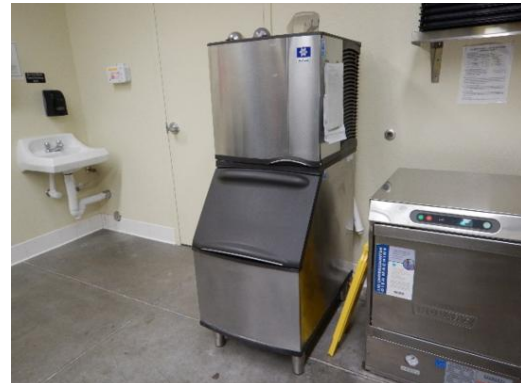
800 - Miscellaneous	Useful Life 12	Remaining Life 6	
14 Kitchen Appliances	Quantity 14	Unit of Measure Items	
	Cost /Itm \$3,075		
	% Included 100.00%	Total Cost/Study \$43,050	
Summary	Replacement Year 2022	Future Cost \$49,925

This is to repair or replace miscellaneous appliances.

Porcelain sink, Manitowoc ice machine w/ B320 bin, Hobart LXIH under counter commercial dishwasher, SS counter w/ 5 sinks, Bunn coffee, True TS-23 sngl door refer, True T-19F sngl door freezer, Vulcan 6-burner 36" range, Vulcan VC4ED convection oven, Captive Aire 5424 ND-2 hood, Ansul fire, GE microwave, SS table, Duke HB5HFM 5-pan portable buffet

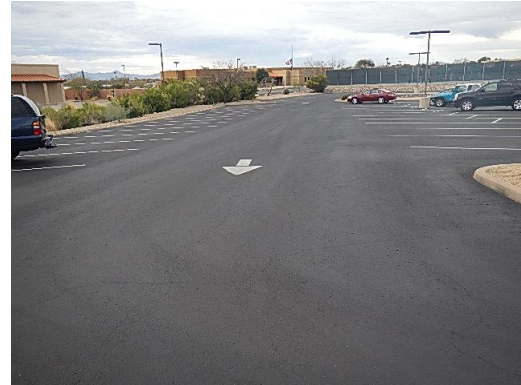
130 - Asphalt: Sealing	Useful Life 5	Remaining Life 4
104,016 Sq. Ft. Drives & Parking	Quantity 104,016	Unit of Measure Square Feet
	Cost /SqFt \$0.200	
	% Included 100.00%	Total Cost/Study \$20,803
Summary	Replacement Year 2020	Future Cost \$22,963

This is to prepare the surface, apply a single coat asphalt emulsion product and restripe to match the existing layout. If a second coat is desired the cost is generally 10% to 20% higher.

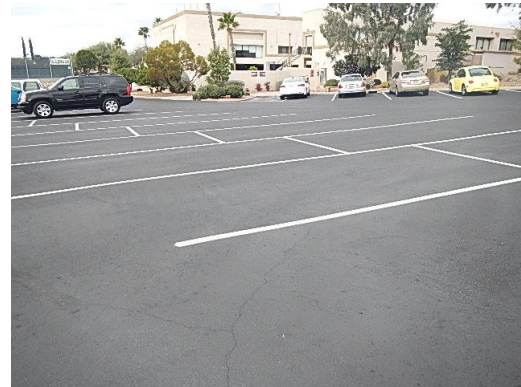
230 - Asphalt: Ongoing Repairs	Useful Life 5	Remaining Life 4
104,016 Sq. Ft. Drives & Parking (3%)	Quantity 104,016	Unit of Measure Square Feet
	Cost /SqFt \$3.25	Qty * \$/SqFt \$338,052
	% Included 2.50%	Total Cost/Study \$8,451
Summary	Replacement Year 2020	Future Cost \$9,329

This is for miscellaneous repairs including crackfill, skin patching and minor dig out & fill. Cracks 1/4" or wider should be filled when observed.

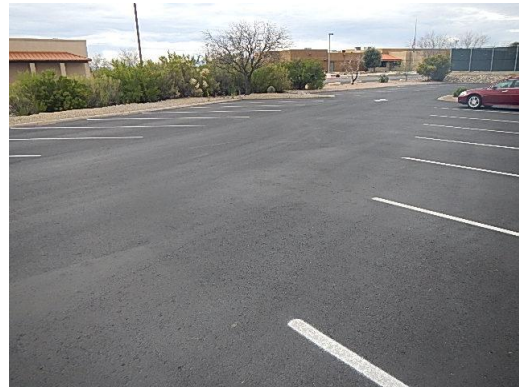
324 - Asphalt: Overlay w/ Interlayer 104,016 Sq. Ft. Drives & Parking	Useful Life 25    Remaining Life 8 Quantity 104,016    Unit of Measure Square Feet Cost /SqFt \$1.60 % Included 100.00%    Total Cost/Study \$166,426 Replacement Year 2024    Future Cost \$202,773
Summary

This is to apply a paving fabric interlayer to the existing asphalt surface and overlay with a minimum of 1.5" of new hot mix asphalt. Generally this includes edge grinding and utility box extensions.

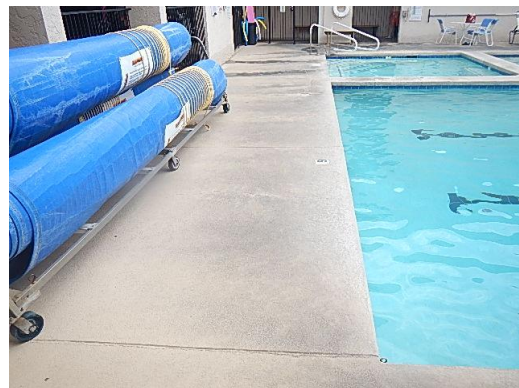
418 - Pool Deck 5,981 Sq. Ft. Pool Area Concrete (6%)	Useful Life 5    Remaining Life 2 Quantity 5,981    Unit of Measure Square Feet Cost /SqFt \$20.00    Qty * \$/SqFt \$119,620 % Included 6.00%    Total Cost/Study \$7,177 Replacement Year 2018    Future Cost \$7,541
Summary

This is to repair and replace concrete pool deck to remove abrupt elevation changes and maintain functionality. Since the concrete useful life exceeds the scope of this study, this component provides for repair only and not full replacement.

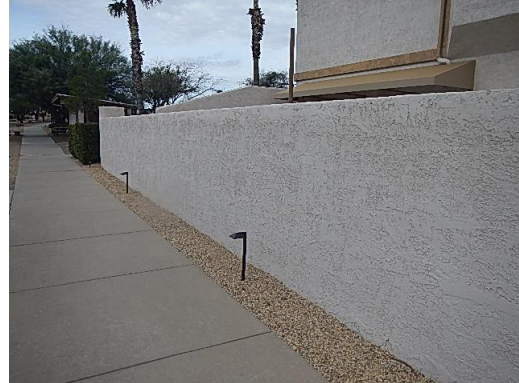
124 - Stucco	Useful Life 10	Remaining Life 5
30,135 Sq. Ft. Exterior Building Surfaces	Quantity 30,135	Unit of Measure Square Feet
	Cost /SqFt \$1.00	
	% Included 100.00%	Total Cost/Study \$30,135
Summary	Replacement Year 2021	Future Cost \$34,095

This is to prepare, power wash, sand, scrape, caulk and paint the stucco surfaces with a premium paint.

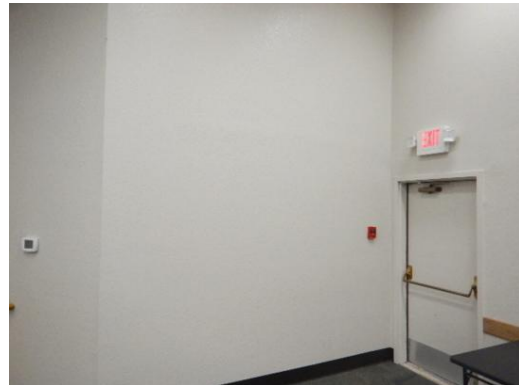
124 - Building	Useful Life 10	Remaining Life 5
26,950 Sq. Ft. All Interior Spaces	Quantity 26,950	Unit of Measure Square Feet
	Cost /SqFt \$0.750	
	% Included 100.00%	Total Cost/Study \$20,213
Summary	Replacement Year 2021	Future Cost \$22,869

This is to prepare and paint all interior walls and ceilings.

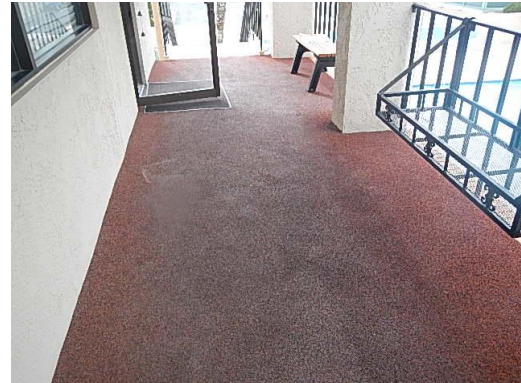
200 - Resurface 1,778 Sq. Ft. Second Floor Deck	Useful Life 20 Quantity 1,778 Cost /SqFt \$6.00	Remaining Life 9 Unit of Measure Square Feet
Summary	% Included 100.00% Replacement Year 2025	Total Cost/Study \$10,668 Future Cost \$13,323

This is to resurface the deck.

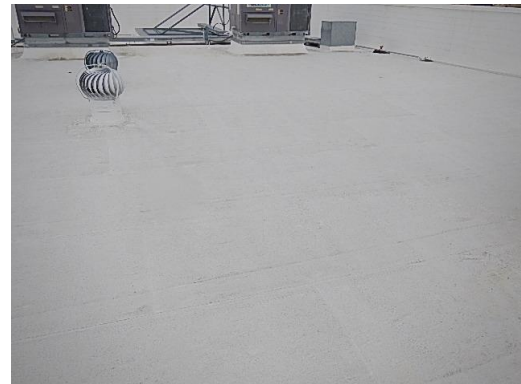
324 - Low Slope: Vinyl 137 Squares- Roof Replacement	Useful Life 20 Quantity 137 Cost /Sqrs \$500	Remaining Life 10 Unit of Measure Squares
Summary	% Included 100.00% Replacement Year 2026	Total Cost/Study \$68,500 Future Cost \$87,686

This is to replace the low slope single-ply vinyl roofing system. All roofs should be regularly inspected and repaired as indicated to ensure maximum life.

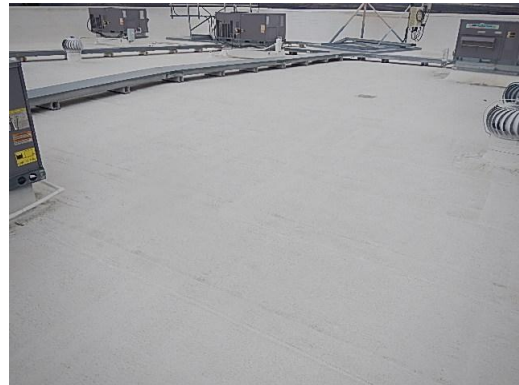
918 - Miscellaneous 137 Squares- Roof Recoating	Useful Life 5    Remaining Life 2 Quantity 137            Unit of Measure Squares Cost /Sqrs \$40.00 % Included 100.00%    Total Cost/Study \$5,480 Replacement Year 2018            Future Cost \$5,757
Summary

This is to prepare and recoat the low slope roofs. All roof should be regularly inspected and repaired as indicated to ensure full life.

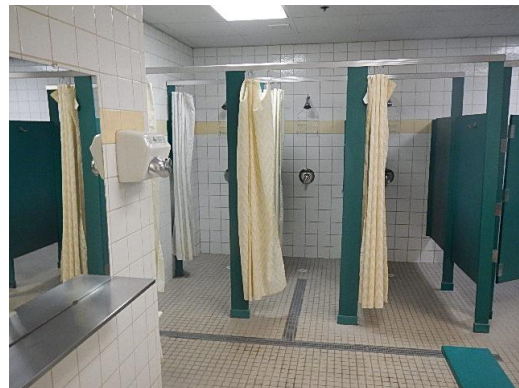
218 - Bathrooms 2 Locker Rooms	Useful Life 20    Remaining Life 7 Quantity 2            Unit of Measure Room Cost /Rm \$17,500 % Included 100.00%    Total Cost/Study \$35,000 Replacement Year 2023            Future Cost \$41,604
Summary

This is to rehab and redecorate the bathrooms including items such as partitions, fixtures, lighting, tile, etc. Client input will further define this component.

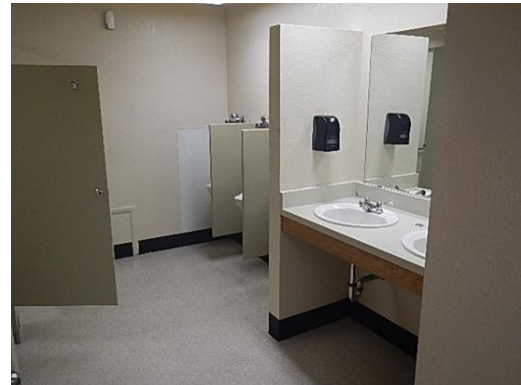
324 - Restrooms	Useful Life 20	Remaining Life 5
2 Auditorium Lobby Restrooms	Quantity 2	Unit of Measure Room
	Cost /Rm \$5,900	
	% Included 100.00%	Total Cost/Study \$11,800
Summary	Replacement Year 2021	Future Cost \$13,351

This is to rehab and redecorate the restrooms including items such as partitions, fixtures, lighting, tile, etc. Client input will further define this component.

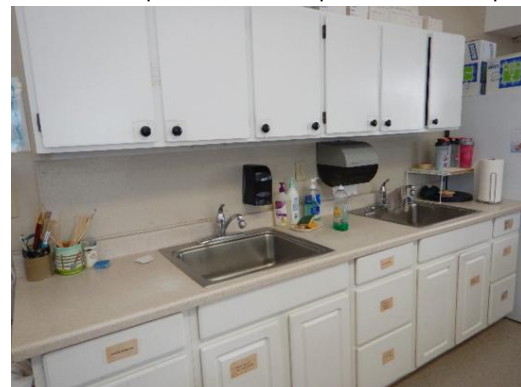
466 - Cabinets	Useful Life 20	Remaining Life 10
40 Lin. Ft. Countertops & Cabinets	Quantity 40	Unit of Measure Linear Feet
	Cost /l.f. \$640	
	% Included 100.00%	Total Cost/Study \$25,600
Summary	Replacement Year 2026	Future Cost \$32,770

This is for replacing the cabinets per existing. Replacement costs will depend on the scope of work at replacement.

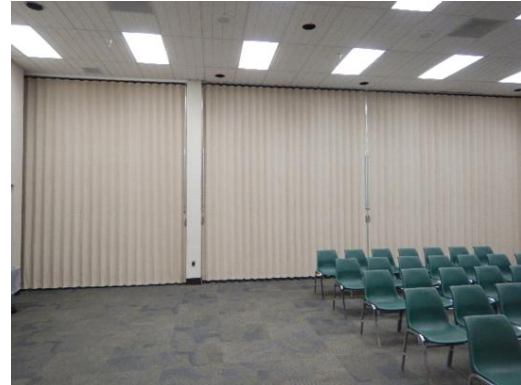
570 - Operable Wall/Partition	Useful Life 25	Remaining Life 6	
770 Sq. Ft. [4] Room Dividers	Quantity 770	Unit of Measure Square Feet	
	Cost /SqFt \$40.00		
	% Included 100.00%	Total Cost/Study \$30,800	
Summary	Replacement Year 2022	Future Cost \$35,719

This is to repair and replace the operable walls/partitions.

- 1- 18x14 dining area divider
- 1- 12x14 kitchen/auditorium divider
- 2- 12.5x14 dining/auditorium dividers (pair)

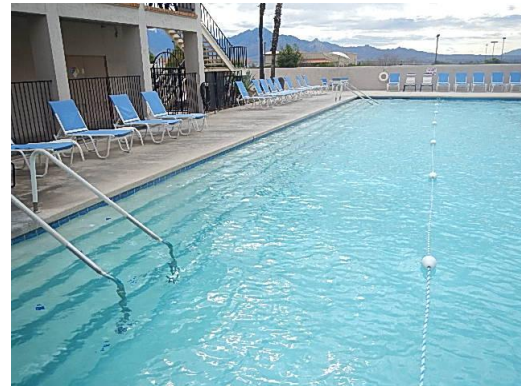
118 - Resurface	Useful Life 12	Remaining Life 7	
260 Lin. Ft. Pool	Quantity 260	Unit of Measure Linear Feet	
	Cost /l.f. \$140		
	% Included 100.00%	Total Cost/Study \$36,400	
Summary	Replacement Year 2023	Future Cost \$43,268

This is to resurface the pool including start-up costs.

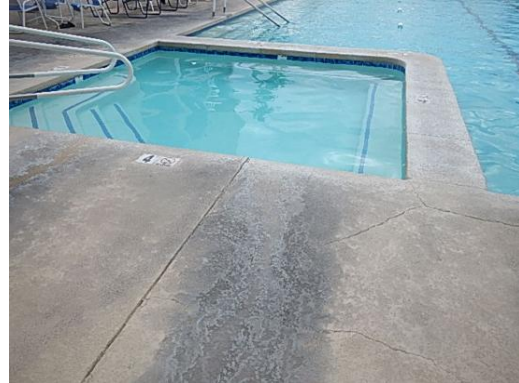
618 - Deck: Re-Surface	Useful Life 15	Remaining Life 12
5,981 Sq. Ft. Pool Area Decking	Quantity 5,981	Unit of Measure Square Feet
	Cost /SqFt \$7.50	
	% Included 100.00%	Total Cost/Study \$44,858
Summary	Replacement Year 2028	Future Cost \$60,328

This is to prepare and resurface the coated deck with Kool Deck or similar product.

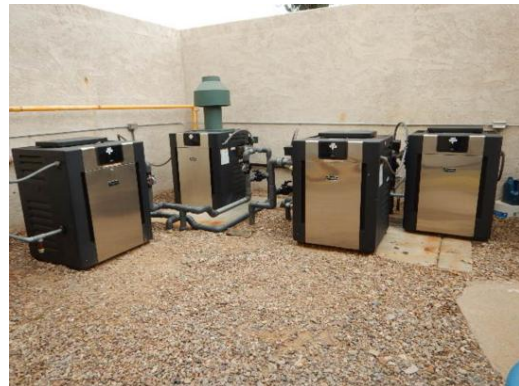
718 - Equipment: Replacement	Useful Life 5	Remaining Life 2
Pool & Spa Equipment (50%)	Quantity 1	Unit of Measure Lump Sum
	Cost /LS \$42,960	Qty * \$/LS \$42,960
	% Included 50.00%	Total Cost/Study \$21,480
Summary	Replacement Year 2018	Future Cost \$22,567

This is to replace the pool equipment. Since not all equipment will fail simultaneously, this component provides for one half replacement every five years.

- 4- Pentair Triton II Commercial filters
- 4- Pentair Intelliflo Variable Speed pumps
- 2- additional spa pumps
- 5- Raypak Professional heaters (4- pool, 1- spa)
- 2- Aquasol chemical control systems
- Assorted- pipes, fittings, controls, lights, etc
- Carbon dioxide tank is not provided for within reserves.

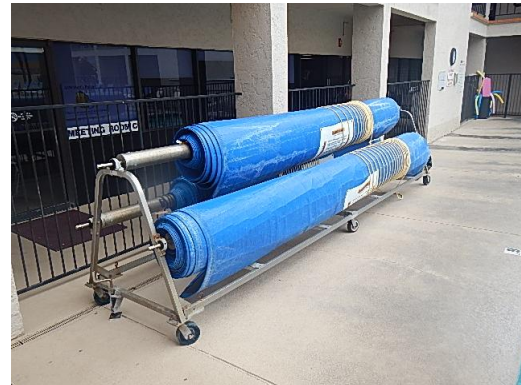
812 - Cover	Useful Life 6	Remaining Life 3
3,870 Sq. Ft. Pool Cover	Quantity 3,870	Unit of Measure Square Feet
	Cost /SqFt \$1.65	
	% Included 100.00%	Total Cost/Study \$6,386
Summary	Replacement Year 2019	Future Cost \$6,876

This is to replace the pool cover. The cover should be properly cleaned and stored during non-use to ensure maximum life.

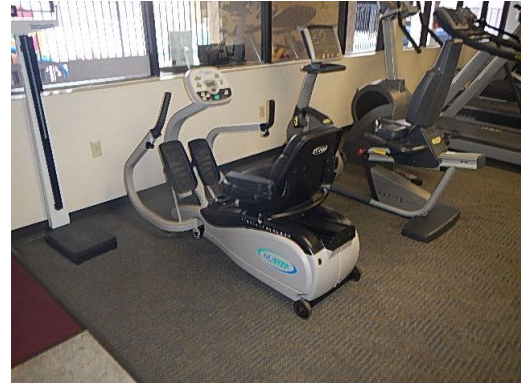
220 - Exercise: Cardio Equipment	Useful Life 1	Remaining Life 1
13 Fitness Center Cardio Machines (20%)	Quantity 13	Unit of Measure Items
	Cost /Itm \$6,000	Qty * \$/Itm \$78,000
	% Included 20.00%	Total Cost/Study \$15,600
Summary	Replacement Year 2017	Future Cost \$15,990

This is for as needed periodic replacement of the cardio equipment machines. Strength machines are provided for in another component.

Steppers (2)- Nu Step Recumbent, Sci Fit

Treadmills (3)- Techno Gym, Woodway, Precor

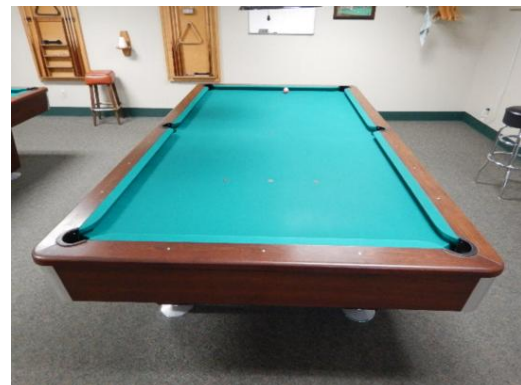
740 - Billiard Table	Useful Life 25	Remaining Life 5
5 Billiards Room	Quantity 5	Unit of Measure Items
	Cost /Itm \$4,500	
	% Included 100.00%	Total Cost/Study \$22,500
Summary	Replacement Year 2021	Future Cost \$25,457

This is to replace the billiard table.

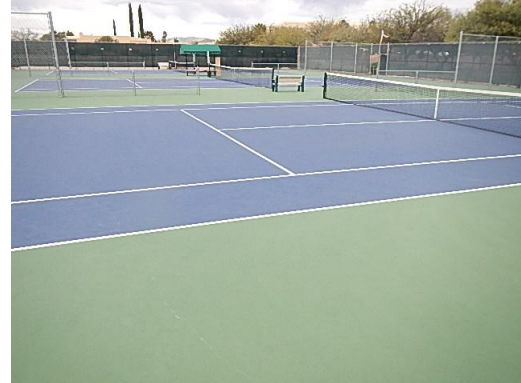
130 - Reseal	Useful Life 7	Remaining Life 5	
28,800 Sq. Ft. [4] Tennis Courts	Quantity 28,800	Unit of Measure Square Feet	
	Cost /SqFt \$0.900		
	% Included 100.00%	Total Cost/Study \$25,920	
Summary	Replacement Year 2021	Future Cost \$29,326

This is to crack fill, seal and stripe the tennis courts.

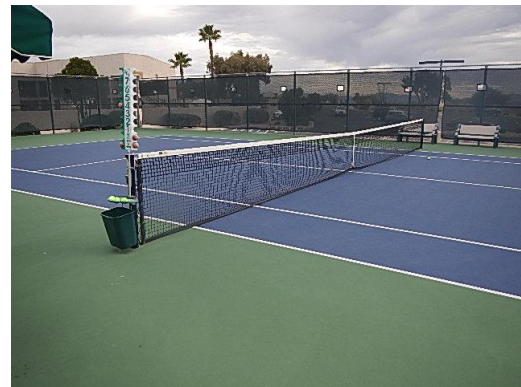
530 - Resurface	Useful Life 21	Remaining Life 15	
28,800 Sq. Ft. [4] Tennis Courts	Quantity 28,800	Unit of Measure Square Feet	
	Cost /SqFt \$2.75		
	% Included 100.00%	Total Cost/Study \$79,200	
Summary	Replacement Year 2031	Future Cost \$114,705

This is to resurface the tennis courts utilizing an overlay, color coat and striping.

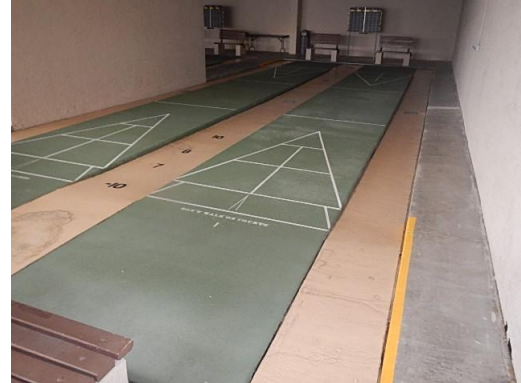
410 - Overlay	Useful Life 8	Remaining Life 4	
2,496 Sq. Ft. [8] Shuffleboard Courts- Resurfacing	Quantity 2,496	Unit of Measure Square Feet	
	Cost /SqFt \$2.50		
	% Included 100.00%	Total Cost/Study \$6,240	
Summary	Replacement Year 2020	Future Cost \$6,888

This is to resurface the shuffleboard court.

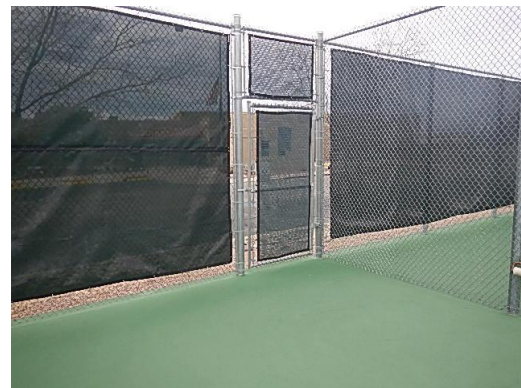
150 - Chain Link: 10'	Useful Life 30	Remaining Life 15	
960 Lin. Ft. Tennis Court Fence	Quantity 960	Unit of Measure Linear Feet	
	Cost /l.f. \$35.00		
	% Included 100.00%	Total Cost/Study \$33,600	
Summary	Replacement Year 2031	Future Cost \$48,663

This is to replace the 10' chain link fencing.

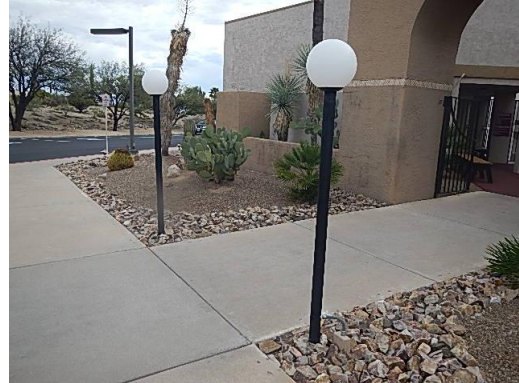
210 - Pole Lights	Useful Life 20	Remaining Life 10	
7 Walkway Lights	Quantity 7	Unit of Measure	Items
	Cost /Itm \$1,000		
	% Included 100.00%	Total Cost/Study	\$7,000
Summary	Replacement Year 2026	Future Cost	\$8,961

This is to replace the walkway lights reusing the existing wiring and conduits.

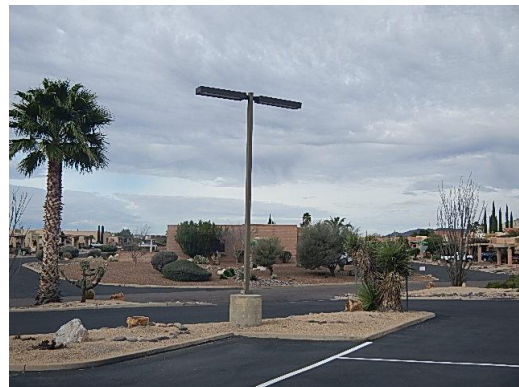
530 - Parking Lot	Useful Life 30	Remaining Life 10	
11 Parking Lot Lights	Quantity 11	Unit of Measure	Items
	Cost /Itm \$2,250		
	% Included 100.00%	Total Cost/Study	\$24,750
Summary	Replacement Year 2026	Future Cost	\$31,682

This is to replace the parking lot lights.

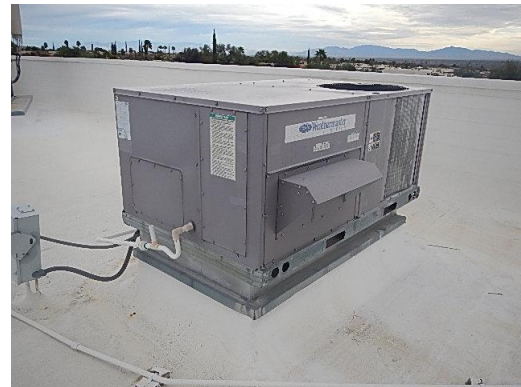
216 - HVAC	Useful Life 15	Remaining Life 4
4 Rooftop Carrier Units- 2005	Quantity 4	Unit of Measure Items
	Cost /Itm \$5,800	
	% Included 100.00%	Total Cost/Study \$23,200
Summary	Replacement Year 2020	Future Cost \$25,608

This is to replace the Carrier HVAC systems. It is possible that sub-components of these systems can be replaced or rebuilt to extend their lives.

- Unit 1- Auditorium- Carrier- 5T
- Unit 2- Auditorium- Carrier- 5T
- Unit 3- Auditorium- Carrier- 5T
- Unit 4- Auditorium- Carrier- 5T

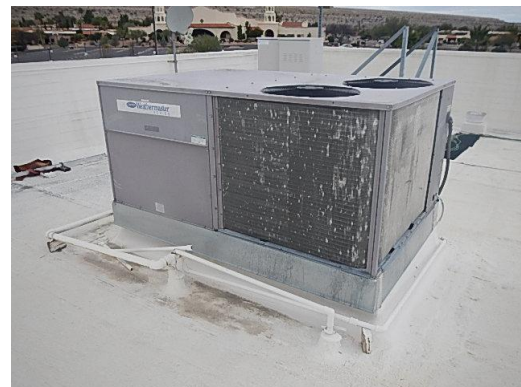
296 - HVAC	Useful Life 15	Remaining Life 6
3 Rooftop Carrier Units- 2007	Quantity 3	Unit of Measure Items
	Cost /Itm \$5,200	
	% Included 100.00%	Total Cost/Study \$15,600
Summary	Replacement Year 2022	Future Cost \$18,091

This is to replace the Carrier HVAC systems. It is possible that sub-components of these systems can be replaced or rebuilt to extend their lives.

- Unit 5- Room B- Carrier- 5T
- Unit 12- Fitness- Carrier- 3T
- Unit 15- Lapidary- Carrier- 5T

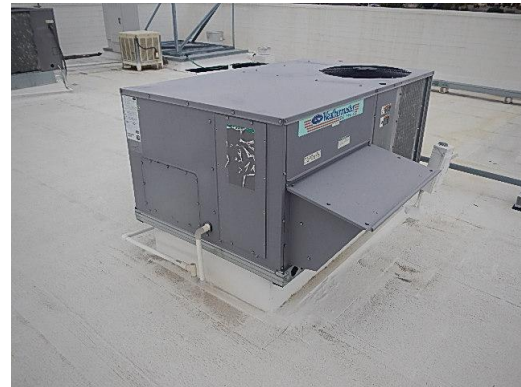
332 - HVAC	Useful Life 15	Remaining Life 8
3 Rooftop Carrier Units- 2009	Quantity 3	Unit of Measure Items
	Cost /Itm \$6,333	
	% Included 100.00%	Total Cost/Study \$19,000
Summary	Replacement Year 2024	Future Cost \$23,150

This is to replace the Carrier HVAC systems. It is possible that sub-components of these systems can be replaced or rebuilt to extend their lives.

- Unit 6- Lobby- Carrier- 4T
- Unit 7- Room A- Carrier- 7.5T
- Unit 9- Locker Room- Carrier- 4T

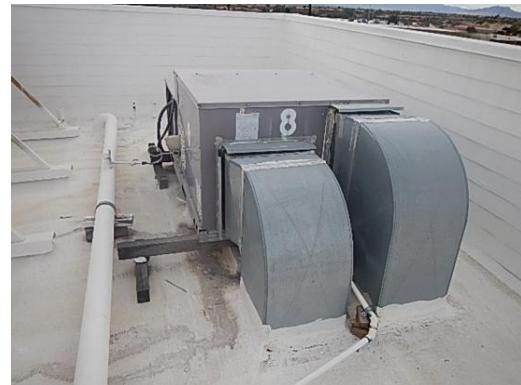
360 - HVAC	Useful Life 15	Remaining Life 1
Rooftop Carrier Unit- 2000	Quantity 1	Unit of Measure Items
	Cost /Itm \$5,000	
	% Included 100.00%	Total Cost/Study \$5,000
Summary	Replacement Year 2017	Future Cost \$5,125

This is to replace the Carrier HVAC system. It is possible that sub-components of this system can be replaced or rebuilt to extend its life.

- Unit 8- Ceramics Class- Carrier- 4T

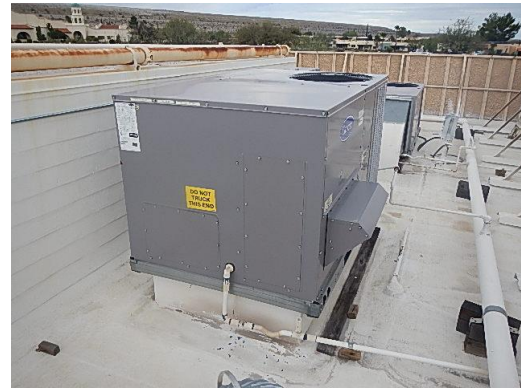
388 - HVAC	Useful Life 15	Remaining Life 12
3 Rooftop Carrier Units- 2013	Quantity 3	Unit of Measure Items
	Cost /Itm \$5,533	
	% Included 100.00%	Total Cost/Study \$16,600
Summary	Replacement Year 2028	Future Cost \$22,325

This is to replace the Carrier HVAC systems. It is possible that sub-components of these systems can be replaced or rebuilt to extend their lives.

- Unit 10- Ceramics- Carrier- 5T
- Unit 13- Art Room- Carrier- 5T
- Unit 14- Room C- Carrier- 4T

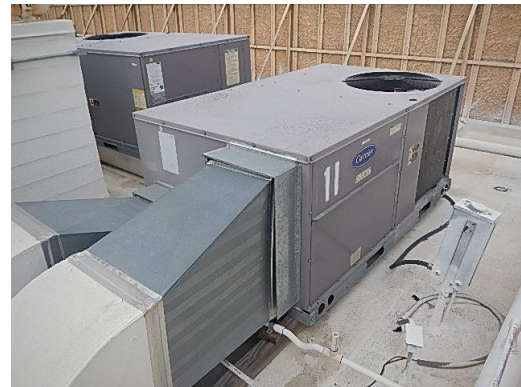
412 - HVAC	Useful Life 15	Remaining Life 3
Rooftop Carrier Unit- 2004	Quantity 1	Unit of Measure Items
	Cost /Itm \$5,000	
	% Included 100.00%	Total Cost/Study \$5,000
Summary	Replacement Year 2019	Future Cost \$5,384

This is to replace the Carrier HVAC system. It is possible that sub-components of this system can be replaced or rebuilt to extend its life.

- Unit 11- Fitness- Carrier- 4T

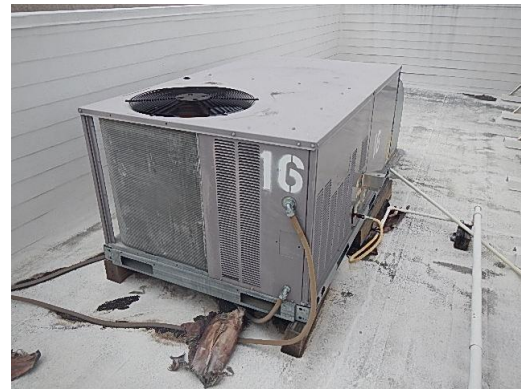
428 - HVAC	Useful Life 15	Remaining Life 1	
Rooftop Carrier Unit- 2002	Quantity 1	Unit of Measure	Items
	Cost /Itm \$9,000		
	% Included 100.00%	Total Cost/Study	\$9,000
Summary	Replacement Year 2017	Future Cost	\$9,225

This is to replace the Carrier HVAC system. It is possible that sub-components of this system can be replaced or rebuilt to extend its life.

Unit 16- Blueprint Room- Carrier- 7.5T

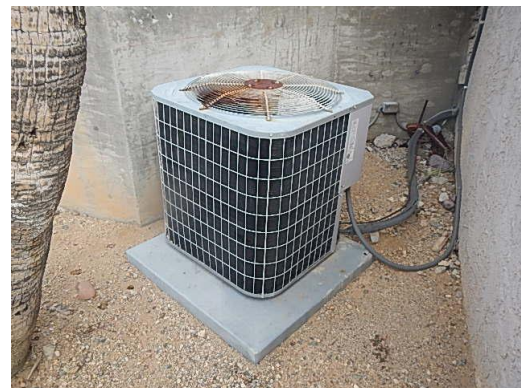
444 - HVAC	Useful Life 15	Remaining Life 2	
Rooftop Carrier Unit- 2002	Quantity 1	Unit of Measure	Items
	Cost /Itm \$5,000		
	% Included 100.00%	Total Cost/Study	\$5,000
Summary	Replacement Year 2018	Future Cost	\$5,253

This is to replace the Carrier HVAC systems. It is possible that sub-components of these systems can be replaced or rebuilt to extend their lives.

Unit 17A- Billiards Room- Carrier- 4T  
 Unit 17B- Billiards Room- Carrier- 4T

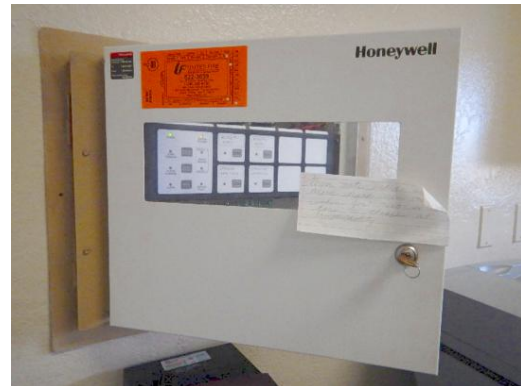
220 - Fire Control Misc	Useful Life 20	Remaining Life 5	
Fire Alarm System	Quantity 1	Unit of Measure	Lump Sum
	Cost /LS	\$15,500	
	% Included	100.00%	Total Cost/Study \$15,500
Summary	Replacement Year	2021	Future Cost \$17,537

This is to repair and replace the fire alarm control panel, fire suppression system, alarms, sensors, pull stations, etc.

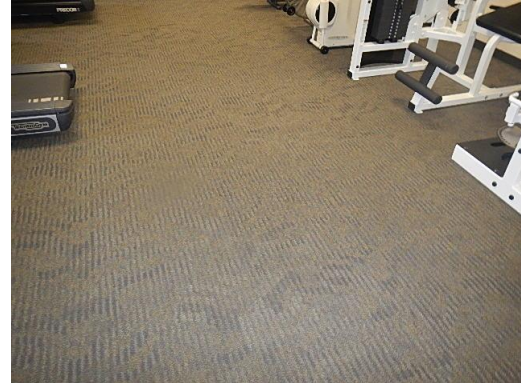
240 - Carpeting 970 Sq. Yds. Clubhouse Carpet	Useful Life 10 Remaining Life 5 Quantity 970 Unit of Measure Square Yard Cost /SqYd \$32.00 % Included 100.00% Total Cost/Study \$31,040 Replacement Year 2021 Future Cost \$35,119
--------------------------------------------------	-------------------------------------------------------------------------------------------------------------------------------------------------------------------------------------------------

This is to replace the carpeting.

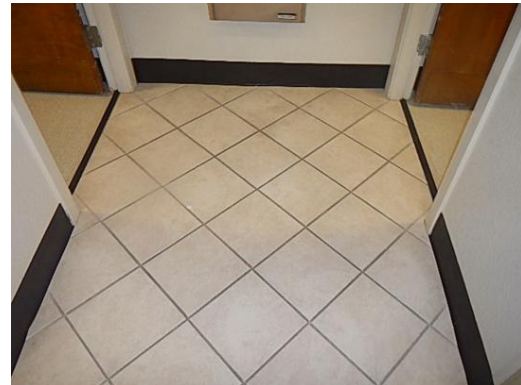
440 - Tile 975 Sq. Ft. Clubhouse Walls & Floors	Useful Life 20 Remaining Life 5 Quantity 975 Unit of Measure Square Feet Cost /SqFt \$10.00 % Included 100.00% Total Cost/Study \$9,750 Replacement Year 2021 Future Cost \$11,031
----------------------------------------------------	------------------------------------------------------------------------------------------------------------------------------------------------------------------------------------------------

This is to replace the wall and floor tile.

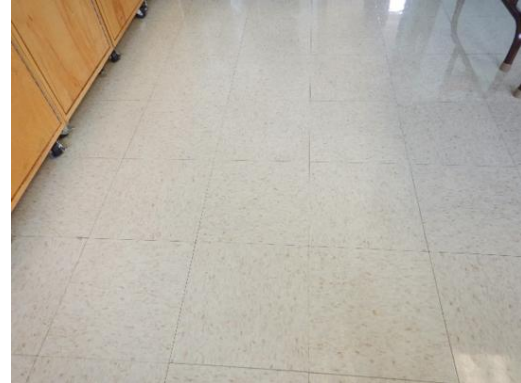
Useful Life	15	Remaining Life	7
Quantity	650	Unit of Measure	Square Yard
Cost /SqYd	\$26.00	Qty * \$/SqYd	\$16,900
% Included	33.33%	Total Cost/Study	\$5,633
Replacement Year	2023	Future Cost	\$6,696

This is to replace the vinyl flooring.

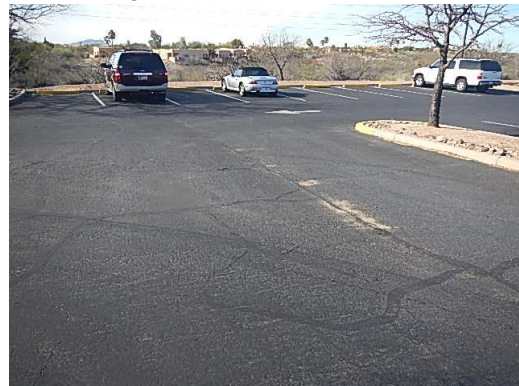
136 - Asphalt: Sealing	Useful Life 5	Remaining Life 3	
67,354 Sq. Ft. Parking Lot	Quantity 67,354	Unit of Measure Square Feet	
	Cost /SqFt \$0.200		
	% Included 100.00%	Total Cost/Study \$13,471	
Summary	Replacement Year 2019	Future Cost \$14,507

This is to prepare the surface, apply a single coat asphalt emulsion product and restripe to match the existing layout. If a second coat is desired the cost is generally 10% to 20% higher.

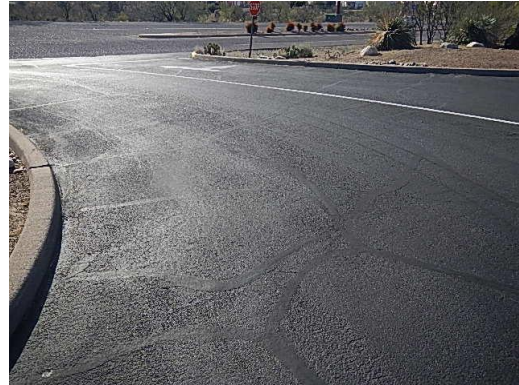
236 - Asphalt: Ongoing Repairs 67,354 Sq. Ft. Parking Lot (3%)	Useful Life 5    Remaining Life 3 Quantity 67,354 Cost /SqFt \$3.25 % Included 2.50%	Unit of Measure Square Feet Qty * \$/SqFt \$218,901 Total Cost/Study \$5,473 Future Cost \$5,893
Summary	Replacement Year 2019

This is for miscellaneous repairs including crackfill, skin patching and minor dig out & fill. Cracks 1/4" or wider should be filled when observed.
