**RESERVE STUDY**

Full Study

**Green Valley Recreation Inc**

Published - June 28, 2016

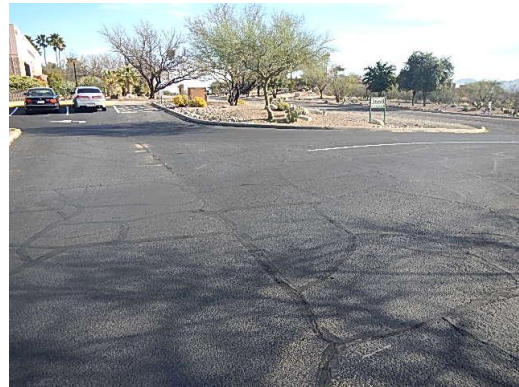
330 - Asphalt: Overlay w/ Interlayer 67,354 Sq. Ft. Parking Lot	Useful Life 25    Remaining Life 2 Quantity 67,354 Cost /SqFt \$1.60 % Included 100.00%	Unit of Measure Square Feet Total Cost/Study \$107,766 Future Cost \$113,222
Summary	Replacement Year 2018

This is to apply a paving fabric interlayer to the existing asphalt surface and overlay with a minimum of 1.5" of new hot mix asphalt. Generally this includes edge grinding and utility box extensions.

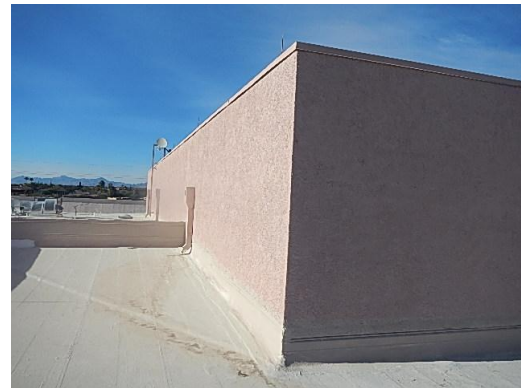
130 - Stucco	Useful Life 10	Remaining Life 5	
10,940 Sq. Ft. Clubhouse Exterior	Quantity 10,940	Unit of Measure Square Feet	
	Cost /SqFt \$2.00		
	% Included 100.00%	Total Cost/Study \$21,880	
Summary	Replacement Year 2021	Future Cost \$24,755

This is to prepare, power wash, sand, scrape, caulk and paint the stucco surfaces with a premium paint.

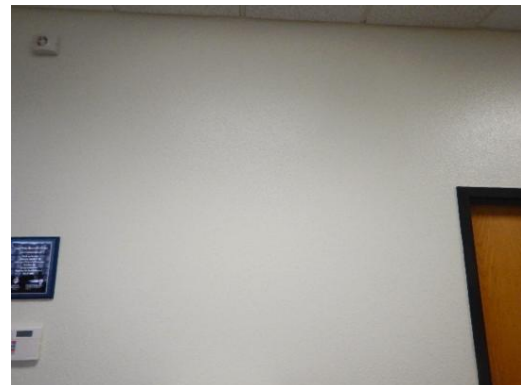
130 - Building	Useful Life 10	Remaining Life 5	
22,750 Sq. Ft. All Interior Spaces	Quantity 22,750	Unit of Measure Square Feet	
	Cost /SqFt \$0.750		
	% Included 100.00%	Total Cost/Study \$17,063	
Summary	Replacement Year 2021	Future Cost \$19,305

This is to prepare and paint all interior walls and ceilings.

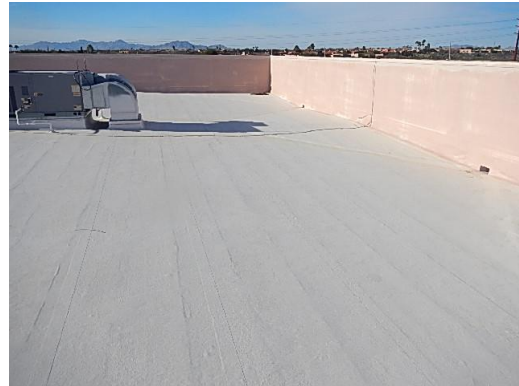
330 - Low Slope: Vinyl 227 Squares- Building Roof	Useful Life 20    Remaining Life 14 Quantity 227                      Unit of Measure Squares Cost /Sqrs \$500 % Included 100.00%              Total Cost/Study \$113,500 Replacement Year 2030              Future Cost \$160,373
Summary

This is to replace the low slope single-ply vinyl roofing system. All roofs should be regularly inspected and repaired as indicated to ensure maximum life.

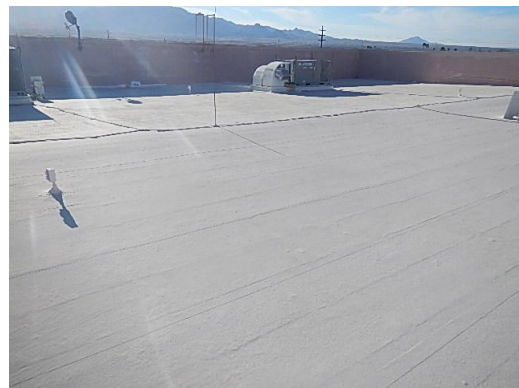
924 - Miscellaneous 227 Squares- Roof Recoating	Useful Life 5    Remaining Life 4 Quantity 227                      Unit of Measure Squares Cost /Sqrs \$40.00 % Included 100.00%              Total Cost/Study \$9,080 Replacement Year 2020              Future Cost \$10,023
Summary

This is to prepare and recoat the low slope roofs. All roof should be regularly inspected and repaired as indicated to ensure full life.

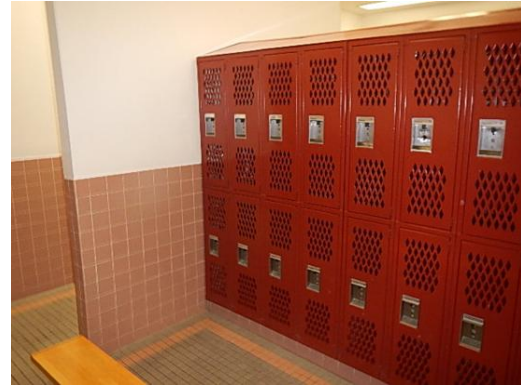
224 - Bathrooms	Useful Life 20	Remaining Life 10
2 Locker Rooms	Quantity 2	Unit of Measure Room
	Cost /Rm \$40,750	
	% Included 100.00%	Total Cost/Study \$81,500
Summary	Replacement Year 2026	Future Cost \$104,327

This is to rehab and redecorate the bathrooms including items such as partitions, fixtures, lighting, tile, etc. Client input will further define this component.

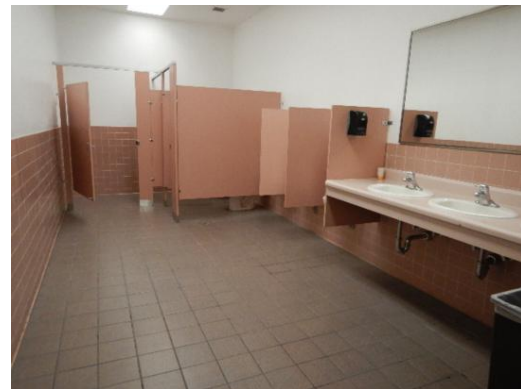
330 - Restrooms	Useful Life 20	Remaining Life 10
2 Clubhouse Restrooms	Quantity 2	Unit of Measure Room
	Cost /Rm \$20,500	
	% Included 100.00%	Total Cost/Study \$41,000
Summary	Replacement Year 2026	Future Cost \$52,483

This is to rehab and redecorate the restrooms including items such as partitions, fixtures, lighting, tile, etc. Client input will further define this component.

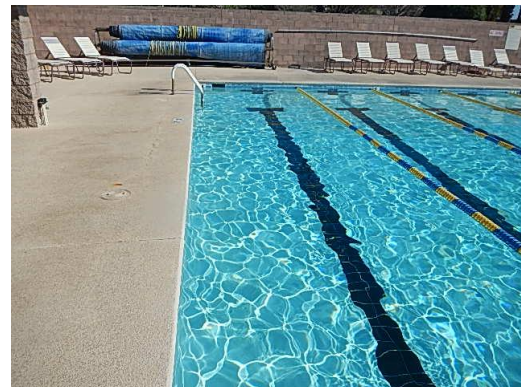
124 - Resurface	Useful Life 12	Remaining Life 8
274 Lin. Ft. Pool	Quantity 274	Unit of Measure Linear Feet
	Cost /l.f. \$160	
	% Included 100.00%	Total Cost/Study \$43,840
Summary	Replacement Year 2024	Future Cost \$53,415

This is to resurface the pool including start-up costs.

2012- Pool resurfaced.

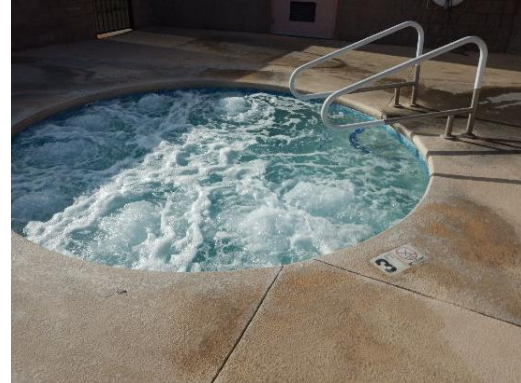
624 - Deck: Re-Surface	Useful Life 15	Remaining Life 11
5,950 Sq. Ft. Pool Area Decking	Quantity 5,950	Unit of Measure Square Feet
	Cost /SqFt \$7.50	
	% Included 100.00%	Total Cost/Study \$44,625
Summary	Replacement Year 2027	Future Cost \$58,552

This is to prepare and resurface the coated deck with Kool Deck or similar product.

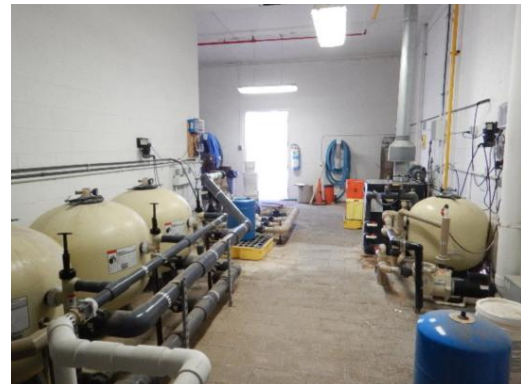
724 - Equipment: Replacement	Useful Life 5	Remaining Life 2
Pool & Spa Equipment (50%)	Quantity 1	Unit of Measure Lump Sum
	Cost /LS \$26,160	Qty * \$/LS \$26,160
	% Included 50.00%	Total Cost/Study \$13,080
Summary	Replacement Year 2018	Future Cost \$13,742

This is to replace the pool equipment. Since not all equipment will fail simultaneously, this component provides for one half replacement every five years.

- 4- Pentair Triton II Commercial filters
- 4- Pentair Intelliflo Variable Speed pumps
- 2- additional spa pumps
- 1- Raypak Professional heater (spa only)
- 2- Aquasol chemical control systems
- Assorted- pipes, fittings, controls, lights, etc
- Carbon dioxide tank is not provided for within reserves.

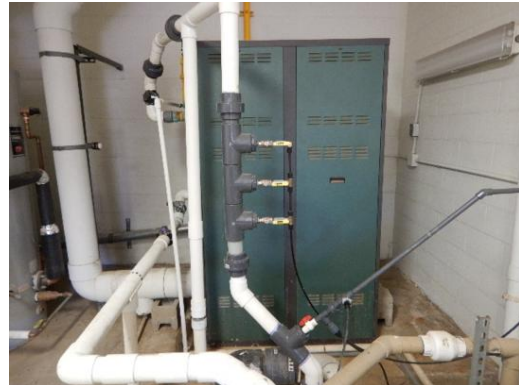
790 - Heater	Useful Life 10	Remaining Life 0	
Pool XTherm Heater	Quantity 1	Unit of Measure	Items
	Cost /Itm \$25,000		
	% Included 100.00%	Total Cost/Study	\$25,000
Summary	Replacement Year 2016	Future Cost	\$25,000

This is to replace the pool water heater.

Raypak  
 WHP-2005 XTherm condensing pool heater 1999k BTU, SN 1105325025  
 mfg 5/2011

2016- In June, cost revised from BRG projection of \$37,650 to an association provided number of \$25,000. In addition the remaining life was reduced from 2021 to 2016 per association.

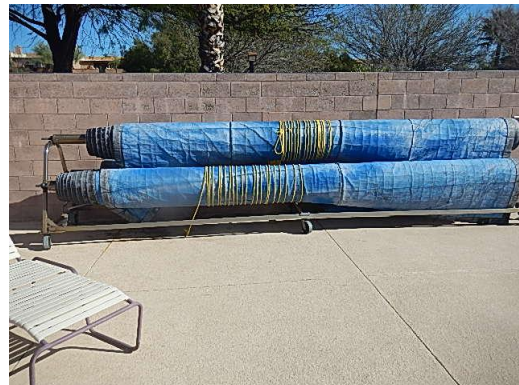
818 - Cover	Useful Life 6	Remaining Life 3	
4,800 Sq. Ft. Pool Cover	Quantity 4,800	Unit of Measure	Square Feet
	Cost /SqFt \$1.65		
	% Included 100.00%	Total Cost/Study	\$7,920
Summary	Replacement Year 2019	Future Cost	\$8,529

This is to replace the pool cover. The cover should be properly cleaned and stored during non-use to ensure maximum life.

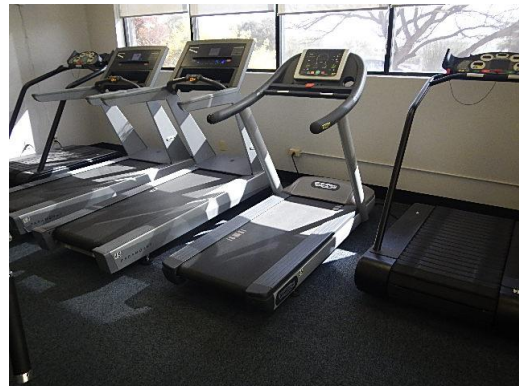
230 - Exercise: Cardio Equipment	Useful Life 1	Remaining Life 1	
16 Fitness Center Cardio Machines (20%)	Quantity 16	Unit of Measure Items	
	Cost /Itm \$6,000	Qty * \$/Itm \$96,000	
	% Included 20.00%	Total Cost/Study \$19,200	
Summary	Replacement Year 2017	Future Cost \$19,680

This is for as needed periodic replacement of the cardio equipment machines. Strength machines are provided for in another component.

Stepper (1)- Sci Fit

Treadmills (5)- 2 x Woodway, Techno Gym, 2 x Paramount

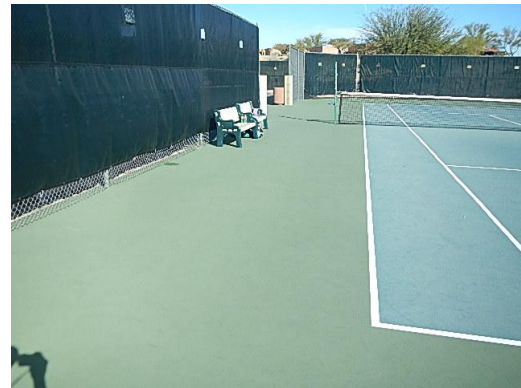
140 - Reseal	Useful Life 7	Remaining Life 5	
14,000 Sq. Ft. [2] Tennis Courts	Quantity 14,000	Unit of Measure Square Feet	
	Cost /SqFt \$0.900		
	% Included 100.00%	Total Cost/Study \$12,600	
Summary	Replacement Year 2021	Future Cost \$14,256

This is to crack fill, seal and stripe the tennis courts.

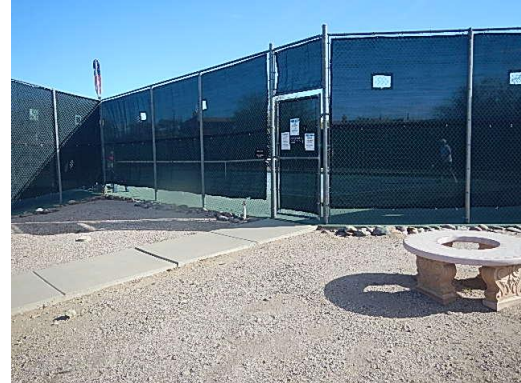
160 - Chain Link: 10'	Useful Life 30	Remaining Life 15
580 Lin. Ft. Tennis Court Fence	Quantity 580	Unit of Measure Linear Feet
	Cost /l.f. \$35.00	
	% Included 100.00%	Total Cost/Study \$20,300
Summary	Replacement Year 2031	Future Cost \$29,400

This is to replace the 10' chain link fencing.

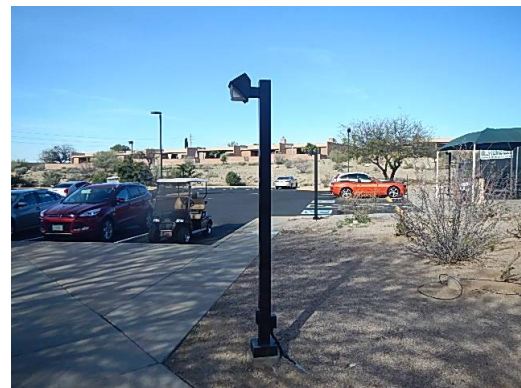
220 - Pole Lights	Useful Life 30	Remaining Life 10
24 Parking Lot & Walkway Lights	Quantity 24	Unit of Measure Items
	Cost /Itm \$2,500	
	% Included 100.00%	Total Cost/Study \$60,000
Summary	Replacement Year 2026	Future Cost \$76,805

This is to replace the pole lights reusing the existing wiring and conduits.

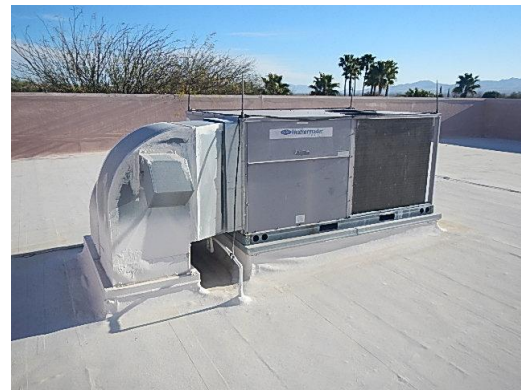
220 - HVAC	Useful Life 15	Remaining Life 6
7 Rooftop Carrier Units- 2007	Quantity 7	Unit of Measure Items
	Cost /Itm \$6,600	
	% Included 100.00%	Total Cost/Study \$46,200
Summary	Replacement Year 2022	Future Cost \$53,578

This is to replace the Carrier HVAC systems. It is possible that sub-components of these systems can be replaced or rebuilt to extend their lives.

- Unit 1- Fitness- Carrier- 7.5T
- Unit 2- Locker Room-Carrier- 5T
- Unit 4- Bath- Carrier- 5T
- Unit 6- Saguaro Room- Carrier- 5T
- Unit 7- Saguaro Room- Carrier- 7.5T
- Unit 8- Palo Verde Room- Carrier- 4T
- Unit 9- Palo Verde Room- Carrier- 5T

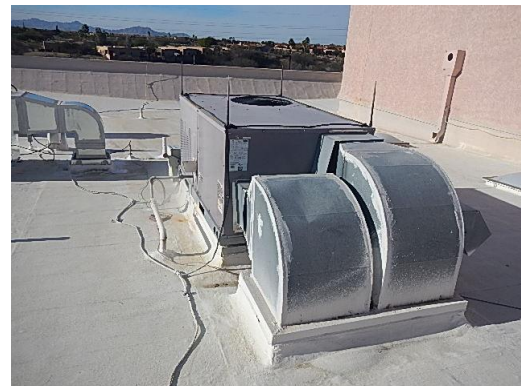
340 - HVAC	Useful Life 15	Remaining Life 4
Rooftop Carrier Unit- 2005	Quantity 1	Unit of Measure Items
	Cost /Itm \$5,800	
	% Included 100.00%	Total Cost/Study \$5,800
Summary	Replacement Year 2020	Future Cost \$6,402

This is to replace the Carrier HVAC system. It is possible that sub-components of this system can be replaced or rebuilt to extend it's life.

- Unit 5- Kitchen- Carrier- 5T

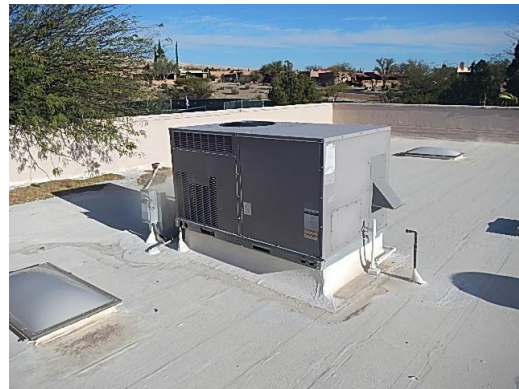
364 - HVAC Rooftop Carrier Unit- 2006	Useful Life 15 Quantity 1 Cost /Itm \$5,800 % Included 100.00%	Remaining Life 5 Unit of Measure Items Total Cost/Study \$5,800 Replacement Year 2021 Future Cost \$6,562
------------------------------------------	-------------------------------------------------------------------------	-----------------------------------------------------------------------------------------------------------------------

This is to replace the Carrier HVAC system. It is possible that sub-components of this system can be replaced or rebuilt to extend it's life.

Unit 10- Mesquite Room- Carrier- 5T

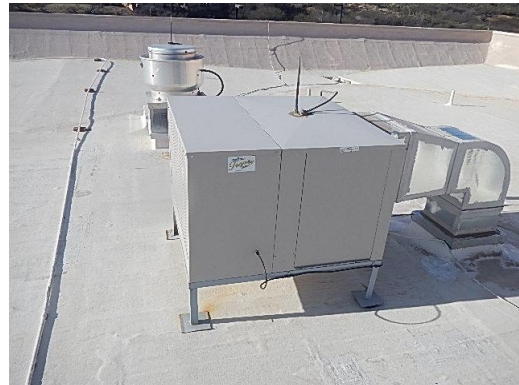
500 - Swamp Cooler Evaporative Cooler- 2014	Useful Life 20 Quantity 1 Cost /Itm \$2,000 % Included 100.00%	Remaining Life 18 Unit of Measure Items Total Cost/Study \$2,000 Replacement Year 2034 Future Cost \$3,119
------------------------------------------------	-------------------------------------------------------------------------	------------------------------------------------------------------------------------------------------------------------

This is to replace the evaporative cooler.

Kitchen- Champion

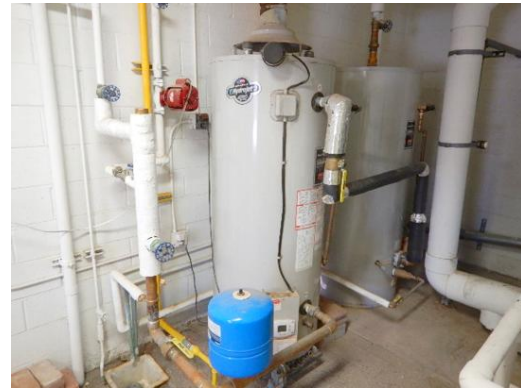
600 - Water Heater	Useful Life 12	Remaining Life 9	
Pool Eq Room Heater & Tank	Quantity 1	Unit of Measure	Items
	Cost /Itm \$12,000		
	% Included 100.00%	Total Cost/Study	\$12,000
Summary	Replacement Year 2025	Future Cost	\$14,986

This is to replace the commercial water heater, storage tank and recirculation pump. Includes disposal of old unit.

- 1- Bradford White D100T1993N, gas, 100 gal, water heater, SN KD18209360, mfg 4/2013
- 1- Bradford White M3ST200R5A, 200 gal storage tank, SN JL 17416073, mfg 2012
- 1- B/G recirculation pump
- 1- expansion tank

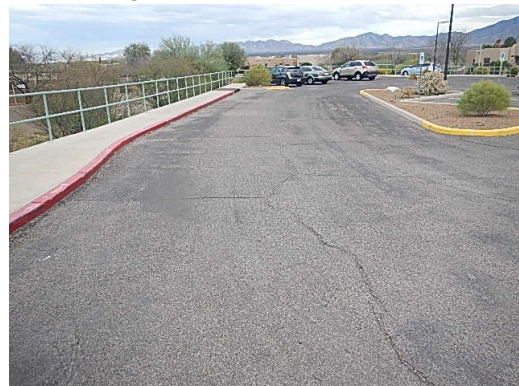
142 - Asphalt: Sealing	Useful Life 5	Remaining Life 1	
80,636 Sq. Ft. Parking Lots	Quantity 80,636	Unit of Measure Square Feet	
	Cost /SqFt \$0.200		
	% Included 100.00%	Total Cost/Study \$16,127	
Summary	Replacement Year 2017	Future Cost \$16,530

This is to prepare the surface, apply a single coat asphalt emulsion product and restripe to match the existing layout. If a second coat is desired the cost is generally 10% to 20% higher.

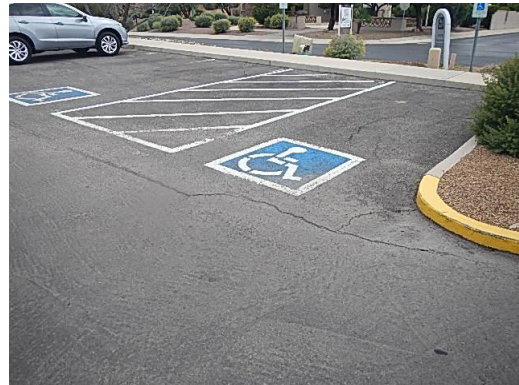
242 - Asphalt: Ongoing Repairs 80,636 Sq. Ft. Parking Lots (3%)	Useful Life 5    Remaining Life 1 Quantity 80,636 Cost /SqFt \$3.25 % Included 2.50%	Unit of Measure Square Feet Qty * \$/SqFt \$262,067 Total Cost/Study \$6,552 Future Cost \$6,715
Summary	Replacement Year 2017

This is for miscellaneous repairs including crackfill, skin patching and minor dig out & fill. Cracks 1/4" or wider should be filled when observed.

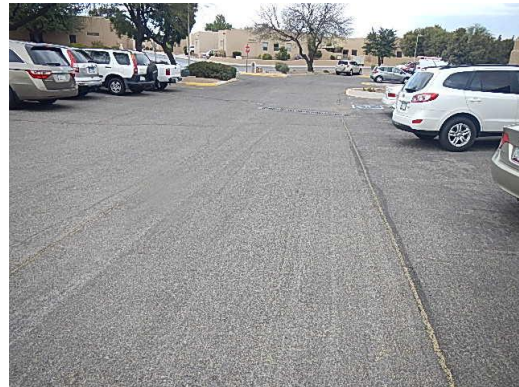
336 - Asphalt: Overlay w/ Interlayer 58,386 Sq. Ft. North & East Parking Lots	Useful Life 25    Remaining Life 1 Quantity 58,386 Cost /SqFt \$1.60 % Included 100.00%	Unit of Measure Square Feet Total Cost/Study \$93,418 Future Cost \$95,753
Summary	Replacement Year 2017

This is to apply a geotextile interlayer to the existing asphalt surface and overlay with a minimum of 1.5" of new hot mix asphalt. Generally this includes edge grinding and utility box extensions.

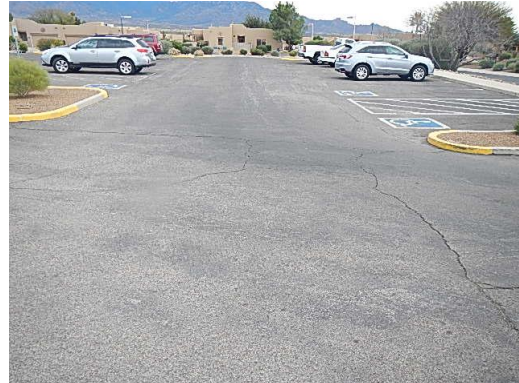
360 - Asphalt: Overlay w/ Interlayer 22,250 Sq. Ft. South Parking Lot	Useful Life 25    Remaining Life 12 Quantity 22,250    Unit of Measure Square Feet Cost /SqFt \$1.60 % Included 100.00%    Total Cost/Study \$35,600 Replacement Year 2028    Future Cost \$47,878
Summary

This is to apply a paving fabric interlayer to the existing asphalt surface and overlay with a minimum of 1.5" of new hot mix asphalt. Generally this includes edge grinding and utility box extensions.

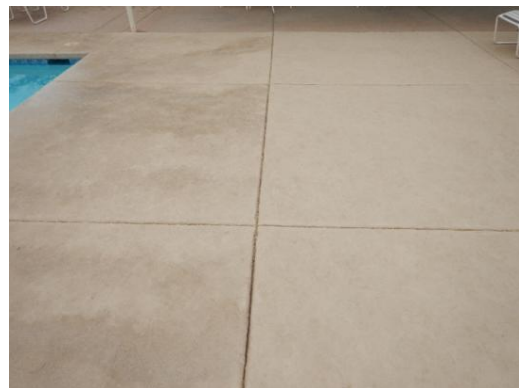
430 - Pool Deck 5,975 Sq. Ft. Pool Area Concrete (6%)	Useful Life 5    Remaining Life 3 Quantity 5,975    Unit of Measure Square Feet Cost /SqFt \$20.00    Qty * \$/SqFt \$119,500 % Included 6.00%    Total Cost/Study \$7,170 Replacement Year 2019    Future Cost \$7,721
Summary

This is to repair and replace concrete pool deck to remove abrupt elevation changes and maintain functionality. Since the concrete useful life exceeds the scope of this study, this component provides for repair only and not full replacement.

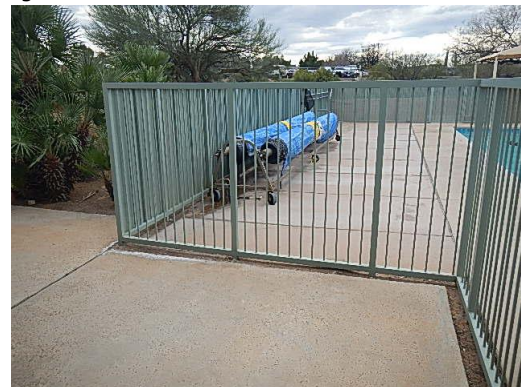
400 - Wrought Iron	Useful Life 4	Remaining Life 2
1,758 Lin. Ft. Pool Fence, Metal Railings	Quantity 1,758	Unit of Measure Linear Feet
	Cost /l.f. \$6.40	
	% Included 100.00%	Total Cost/Study \$11,251
Summary	Replacement Year 2018	Future Cost \$11,821

This is to prepare, power wash, sand, scrape, spot prime and paint the wrought iron.

348 lf- pool perimeter 5' wrought iron fence  
 1,410 lf- bridge, deck, stair, walkway, south perimeter railings

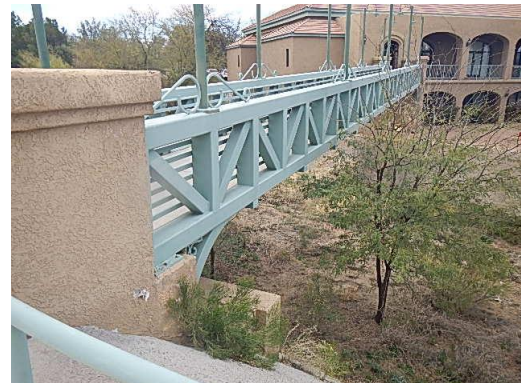
600 - Metal Railings	Useful Life 10	Remaining Life 5	
1,410 Lin. Ft. Deck, Stair & Bridge Railings (50%)	Quantity 1,410	Unit of Measure Linear Feet	
	Cost /l.f. \$30.00	Qty * \$/l.f. \$42,300	
	% Included 50.00%	Total Cost/Study \$21,150	
Summary	Replacement Year 2021	Future Cost \$23,929

This is to replace the metal railings.

- 486 lf- upper level 4' metal railing
- 28 lf- upper level 2' metal railing
- 176 lf- bridge
- 120 lf- walkway
- 65 lf- stairwell
- 535 lf- south side property near wash canal and parking lot

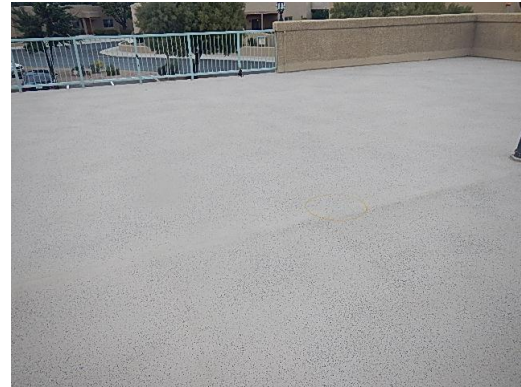
206 - Resurface	Useful Life 20	Remaining Life 1
12,664 Sq. Ft. Elastomeric Deck- Resurface	Quantity 12,664	Unit of Measure Square Feet
	Cost /SqFt \$7.70	
	% Included 100.00%	Total Cost/Study \$97,513
Summary	Replacement Year 2017	Future Cost \$99,951

This is to resurface the deck. Deck seal coat is provided for within another component.

In 2016, client indicated that deck membrane leak issues are being investigated and that repairs are needed. Some ceilings below the deck exhibited water stains.

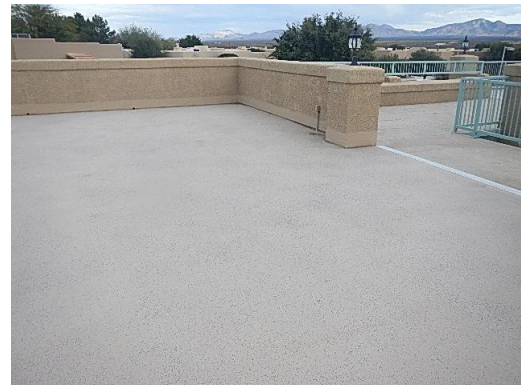
300 - Repairs	Useful Life 5	Remaining Life 1
12,664 Sq. Ft. Elastomeric Deck- Seal/Repair	Quantity 12,664	Unit of Measure Square Feet
	Cost /SqFt \$1.80	
	% Included 100.00%	Total Cost/Study \$22,795
Summary	Replacement Year 2017	Future Cost \$23,365

This is seal and repair the rooftop decking of the Fiesta and Santa Cruz buildings.

In 2016, client indicated that deck membrane leak issues are being investigated and that repairs are needed. Some ceilings below the deck exhibited water stains.

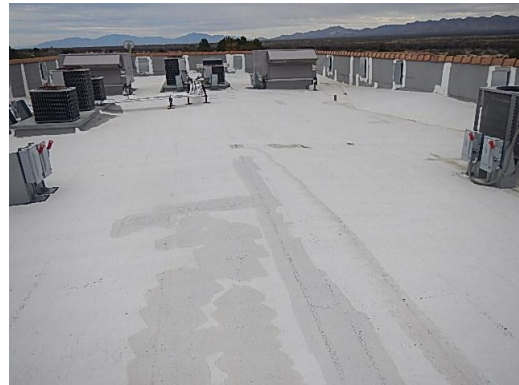
336 - Low Slope: Vinyl 68 Squares- Building Roof	Useful Life 20 Remaining Life 5 Quantity 68 Unit of Measure Squares Cost /Sqrs \$500 % Included 100.00% Total Cost/Study \$34,000 Replacement Year 2021 Future Cost \$38,468
Summary

This is to replace the low slope single-ply vinyl roofing system. All roofs should be regularly inspected and repaired as indicated to ensure maximum life.

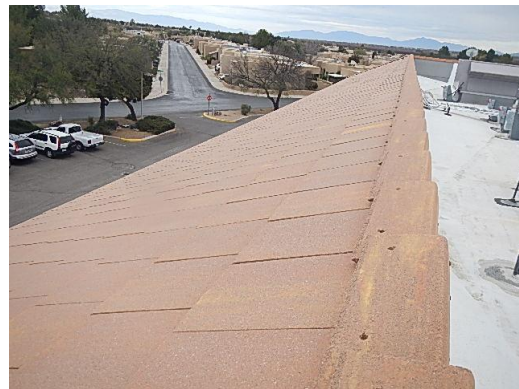
606 - Pitched: Tile 84 Squares- Building Roof	Useful Life 30 Remaining Life 10 Quantity 84 Unit of Measure Squares Cost /Sqrs \$600 % Included 100.00% Total Cost/Study \$50,400 Replacement Year 2026 Future Cost \$64,516
Summary

This is to replace the tile roofing system. Tile roofs should be regularly inspected and repaired as indicated to ensure maximum life.

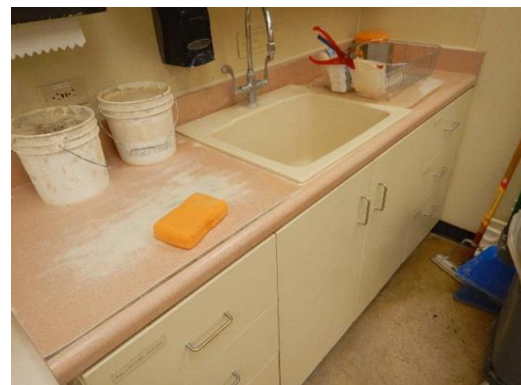
472 - Cabinets 2 Art & Clay Counters & Cabinets	Useful Life 20 Quantity 2 Cost /Rm \$8,625 % Included 100.00%	Remaining Life 1 Unit of Measure Room Total Cost/Study \$17,250
Summary	Replacement Year 2017	Future Cost \$17,681

This is for replacing the cabinets per existing. Replacement costs will depend on the scope of work at replacement.

In 2016, the counter tops are very worn.

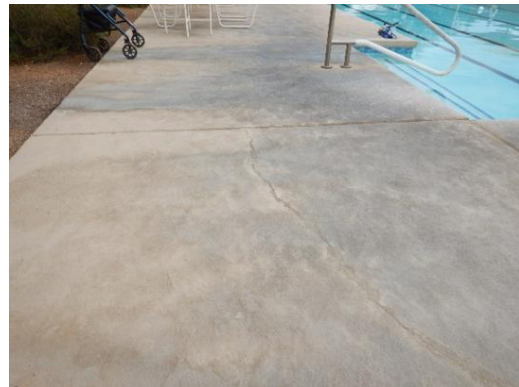
630 - Deck: Re-Surface	Useful Life 15	Remaining Life 3
5,975 Sq. Ft. Pool Area Decking	Quantity 5,975	Unit of Measure Square Feet
	Cost /SqFt \$7.50	
	% Included 100.00%	Total Cost/Study \$44,813
Summary	Replacement Year 2019	Future Cost \$48,258

This is to prepare and resurface the coated deck with Kool Deck or similar product.

In 2016, the deck was stained and exhibited some chipped areas.

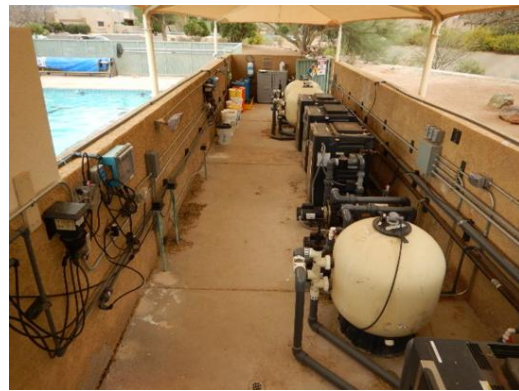
730 - Equipment: Replacement	Useful Life 5	Remaining Life 2	
Pool & Spa Equipment (50%)	Quantity 1	Unit of Measure Lump Sum	
	Cost /LS \$35,760	Qty * \$/LS \$35,760	
	% Included 50.00%	Total Cost/Study \$17,880	
Summary	Replacement Year 2018	Future Cost \$18,785

This is to replace the pool equipment. Since not all equipment will fail simultaneously, this component provides for one half replacement every five years.

- 3- Pentair Triton II Commercial filters
- 3- Pentair Intelliflo Variable Speed pumps
- 2- additional spa pumps
- 4- Raypak Professional heaters (3- pool, 1- spa)
- 2- Aquasol chemical control systems
- Assorted- pipes, fittings, controls, lights, etc
- Carbon dioxide tank is not provided for within reserves.

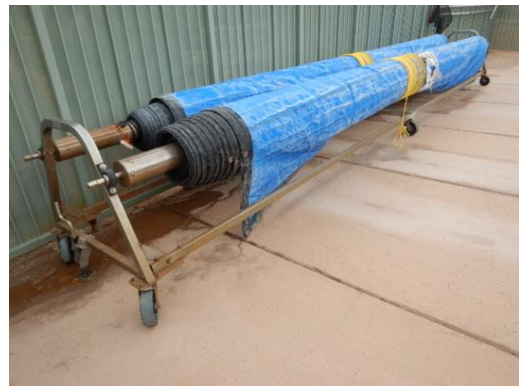
824 - Cover	Useful Life 6	Remaining Life 2	
3,600 Sq. Ft. Pool Cover	Quantity 3,600	Unit of Measure Square Feet	
	Cost /SqFt \$1.65		
	% Included 100.00%	Total Cost/Study \$5,940	
Summary	Replacement Year 2018	Future Cost \$6,241

This is to replace the pool cover. The cover should be properly cleaned and stored during non-use to ensure maximum life.

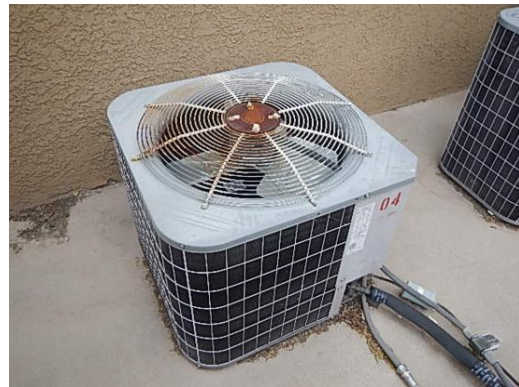
344 - HVAC	Useful Life 15	Remaining Life 3
2 Carrier Units- 2004	Quantity 2	Unit of Measure Items
	Cost /Itm \$4,900	
	% Included 100.00%	Total Cost/Study \$9,800
Summary	Replacement Year 2019	Future Cost \$10,554

This is to replace the Carrier HVAC systems. It is possible that sub-components of these systems can be replaced or rebuilt to extend their lives.

Unit 4- Hand Studio- Carrier- 3T  
 Unit 9- Fitness- Carrier- 5T

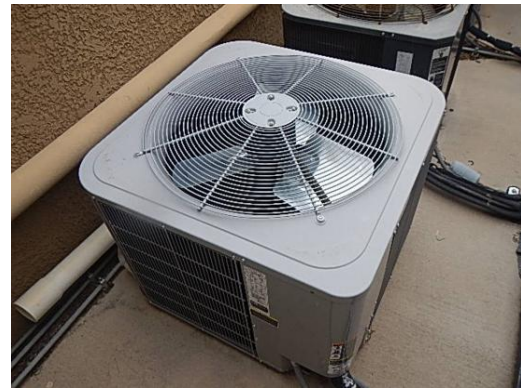
368 - HVAC	Useful Life 15	Remaining Life 11
2 Carrier Units- 2012	Quantity 2	Unit of Measure Items
	Cost /Itm \$5,800	
	% Included 100.00%	Total Cost/Study \$11,600
Summary	Replacement Year 2027	Future Cost \$15,220

This is to replace the Carrier HVAC systems. It is possible that sub-components of these systems can be replaced or rebuilt to extend their lives.

Unit 5- Fiesta Room- Carrier- 5T  
 Unit 24- Art Room- Carrier- 5T

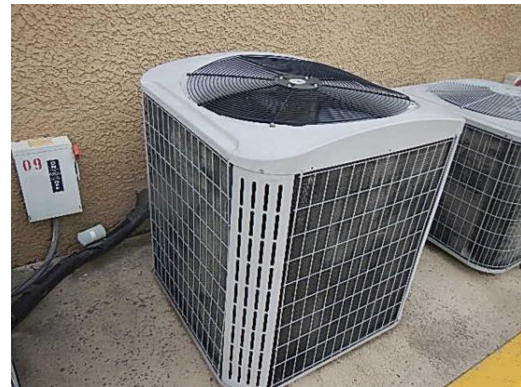
392 - HVAC	Useful Life 15	Remaining Life 2
2 Carrier Units- 2003	Quantity 2	Unit of Measure Items
	Cost /Itm \$3,650	
	% Included 100.00%	Total Cost/Study \$7,300
Summary	Replacement Year 2018	Future Cost \$7,670

This is to replace the Carrier HVAC systems. It is possible that sub-components of these systems can be replaced or rebuilt to extend their lives.

Unit 6- Clay Studio- Carrier- 2.5T  
 Unit 14- Kitchen- Carrier- 2.5T

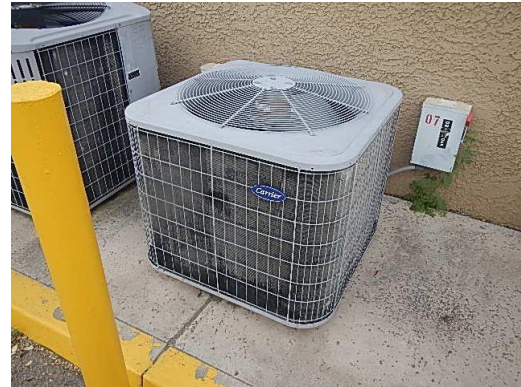
416 - HVAC	Useful Life 15	Remaining Life 7	
Carrier Unit- 2008	Quantity 1	Unit of Measure	Items
	Cost /Itm \$5,800		
	% Included 100.00%	Total Cost/Study	\$5,800
Summary	Replacement Year 2023	Future Cost	\$6,894

This is to replace the Carrier HVAC system. It is possible that sub-components of this system can be replaced or rebuilt to extend it's life.

Unit 7- Fitness- Carrier- 5T

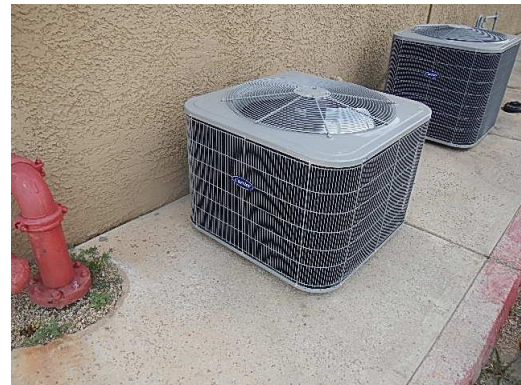
436 - HVAC	Useful Life 15	Remaining Life 13	
Carrier Unit- 2014	Quantity 1	Unit of Measure	Items
	Cost /Itm \$5,800		
	% Included 100.00%	Total Cost/Study	\$5,800
Summary	Replacement Year 2029	Future Cost	\$7,995

This is to replace the Carrier HVAC system. It is possible that sub-components of this system can be replaced or rebuilt to extend it's life.

Unit 11- Locker Room- Carrier- 5T

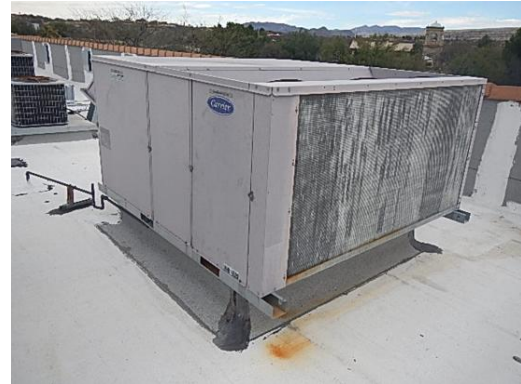
448 - HVAC	Useful Life 15	Remaining Life 1	
8 Carrier Units- 2001	Quantity 8	Unit of Measure	Items
	Cost /Itm \$7,200		
	% Included 100.00%	Total Cost/Study	\$57,600
Summary	Replacement Year 2017	Future Cost	\$59,040

This is to replace the Carrier HVAC systems. It is possible that sub-components of these systems can be replaced or rebuilt to extend their lives.

- Unit 15- Comp Pecan Room- Carrier- 3T
- Unit 17- Comp Lobby- Carrier- 3T
- Unit 18- Comp Ed Hall- Carrier- 5T
- Unit 19- Comp Multi Room- Carrier- 5T
- Unit 20- Comp General- Carrier- 4T
- Unit 21- Comp Laptop Room- Carrier- 3T
- Unit 22- Anza Building- Carrier- 12.5T
- Unit 23- Anza Building- Carrier- 12.5T

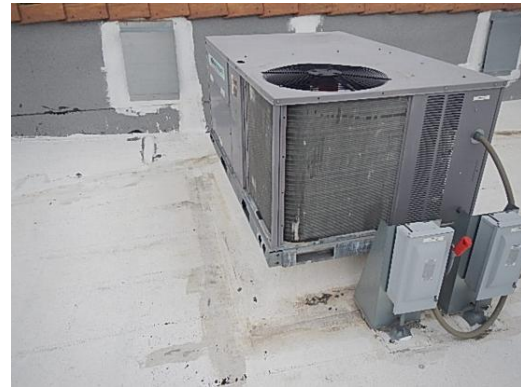
452 - HVAC	Useful Life 15	Remaining Life 6
2 Carrier Units- 2007	Quantity 2	Unit of Measure Items
	Cost /Itm \$7,150	
	% Included 100.00%	Total Cost/Study \$14,300
Summary	Replacement Year 2022	Future Cost \$16,584

This is to replace the Carrier HVAC systems. It is possible that sub-components of these systems can be replaced or rebuilt to extend their lives.

- Unit 25- Photo Room- Carrier- 7T
- Unit 26- Photo Room- Carrier- 5T

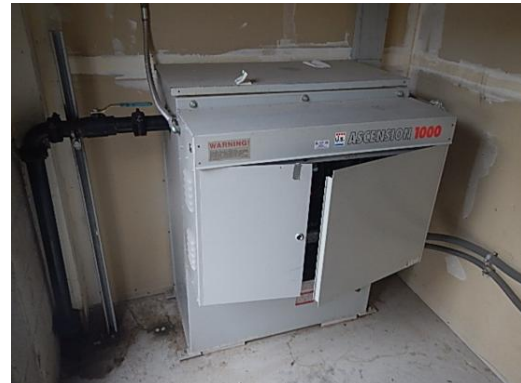
200 - Modernize/Overhaul	Useful Life 25	Remaining Life 5
Anza Building Elevator	Quantity 1	Unit of Measure Items
	Cost /Itm \$44,800	
	% Included 100.00%	Total Cost/Study \$44,800
Summary	Replacement Year 2021	Future Cost \$50,687

This is to modernize or overhaul the elevator system.

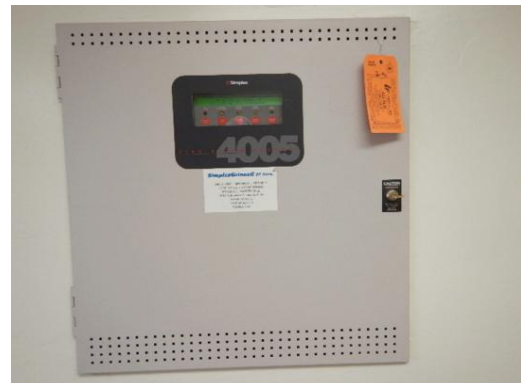
240 - Fire Control Misc	Useful Life 20	Remaining Life 4	
Fire Alarm System	Quantity 1	Unit of Measure	Lump Sum
	Cost /LS	\$28,150	
	% Included	100.00%	Total Cost/Study \$28,150
Summary	Replacement Year	2020	Future Cost \$31,072

This is to repair and replace the fire alarm control panel, fire suppression system, alarms, sensors, pull stations, etc.

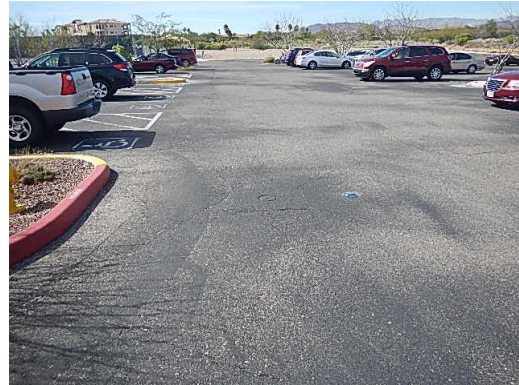
148 - Asphalt: Sealing 64,068 Sq. Ft. Drives & Parking	Useful Life 5    Remaining Life 1 Quantity 64,068    Unit of Measure Square Feet Cost /SqFt \$0.200 % Included 100.00%    Total Cost/Study \$12,814 Replacement Year 2017    Future Cost \$13,134
Summary

This is to prepare the surface, apply a single coat asphalt emulsion product and restripe to match the existing layout. If a second coat is desired the cost is generally 10% to 20% higher.

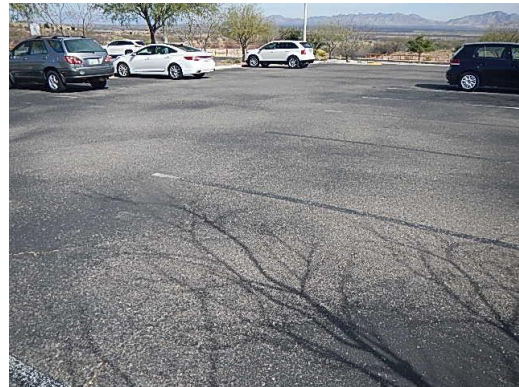
248 - Asphalt: Ongoing Repairs 64,068 Sq. Ft. Drives & Parking (3%)	Useful Life 5    Remaining Life 1 Quantity 64,068    Unit of Measure Square Feet Cost /SqFt \$3.25    Qty * \$/SqFt \$208,221 % Included 2.50%    Total Cost/Study \$5,206 Replacement Year 2017    Future Cost \$5,336
Summary

This is for miscellaneous repairs including crack fill, skin patching and minor dig out & fill. Cracks 1/4" or wider should be filled when observed.

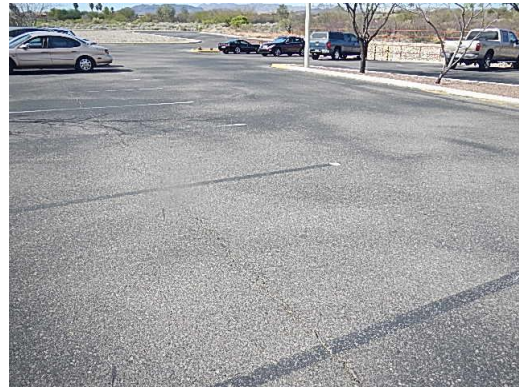
342 - Asphalt: Overlay w/ Interlayer 64,068 Sq. Ft. Drives & Parking	Useful Life 25 Remaining Life 17 Quantity 64,068 Unit of Measure Square Feet Cost /SqFt \$1.60 % Included 100.00% Total Cost/Study \$102,509 Replacement Year 2033 Future Cost \$155,979
Summary

This is to apply a paving fabric interlayer to the existing asphalt surface and overlay with a minimum of 1.5" of new hot mix asphalt. Generally this includes edge grinding and utility box extensions.

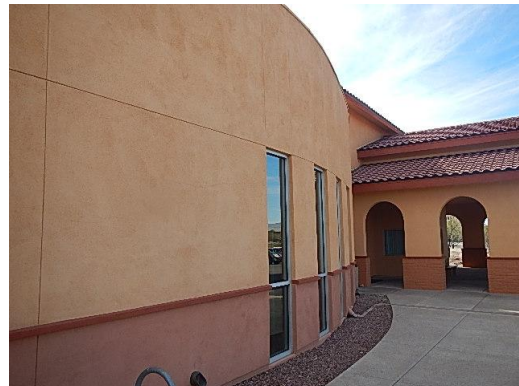
142 - Stucco 14,760 Sq. Ft. Building Exterior Surfaces	Useful Life 10 Remaining Life 2 Quantity 14,760 Unit of Measure Square Feet Cost /SqFt \$1.00 % Included 100.00% Total Cost/Study \$14,760 Replacement Year 2018 Future Cost \$15,507
Summary

This is to prepare, power wash, sand, scrape, caulk and paint the stucco surfaces with a premium paint.

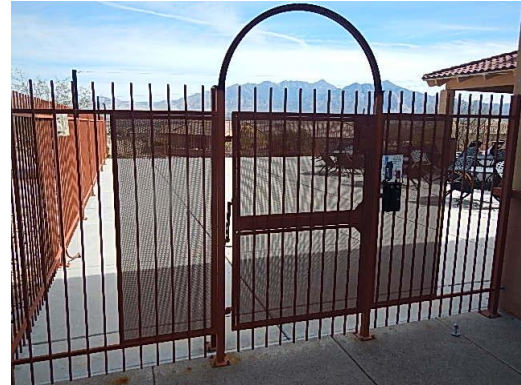
406 - Wrought Iron	Useful Life 4	Remaining Life 1
614 Lin. Ft. Metal Fencing & Railings	Quantity 614	Unit of Measure Linear Feet
	Cost /l.f. \$9.00	
	% Included 100.00%	Total Cost/Study \$5,526
Summary	Replacement Year 2017	Future Cost \$5,664

This is to prepare, power wash, sand, scrape, spot prime and paint the wrought iron.

- 300 lf- 4' metal rail, north side parking lot @ ditch
- 264 lf- 6' wrought iron fencing @ patio perimeter
- 50 lf- metal hand rail @pickleball courts walkway

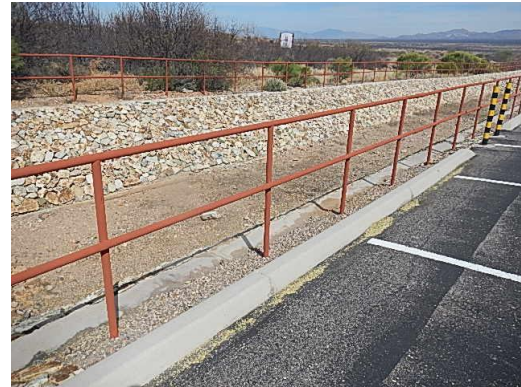
606 - Metal Railings	Useful Life	20	Remaining Life	12
350 Lin. Ft. Parking & Pickleball	Quantity	350	Unit of Measure	Linear Feet
	Cost /l.f.	\$25.00		
	% Included	100.00%	Total Cost/Study	\$8,750
Summary	Replacement Year	2028	Future Cost	\$11,768

This is to replace the metal railings.

300 lf- north side parking lot @ ditch  
 50 lf- at pickleball courts walkway

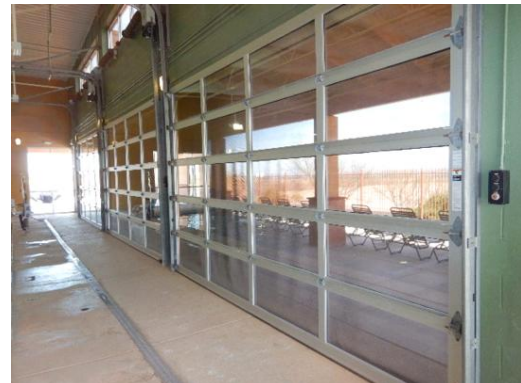
912 - Doors	Useful Life	20	Remaining Life	12
3 Pool East Patio Doors	Quantity	3	Unit of Measure	Items
	Cost /Itm	\$16,000		
	% Included	100.00%	Total Cost/Study	\$48,000
Summary	Replacement Year	2028	Future Cost	\$64,555

This is to repair, replace and maintain the 5-panel glass doors, operators and hardware.

3- 10'x16.5' glass doors  
 3- LiftMaster operators

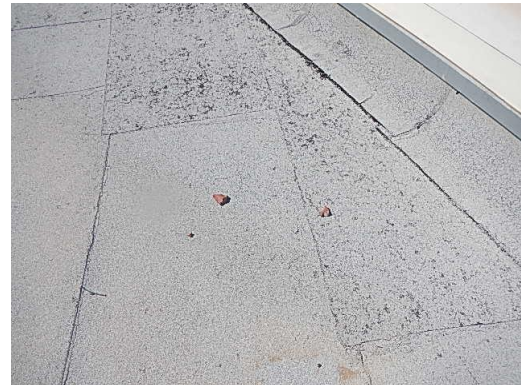
200 - Low Slope: BUR 133 Squares- Building Roof	Useful Life 20    Remaining Life 12 Quantity 133                      Unit of Measure Squares Cost /Sqrs \$300 % Included 100.00%            Total Cost/Study \$39,900 Replacement Year 2028                      Future Cost \$53,661
Summary

This is to replace the built-up roofing. All roofs should be regularly inspected and repaired as indicated to ensure maximum life.

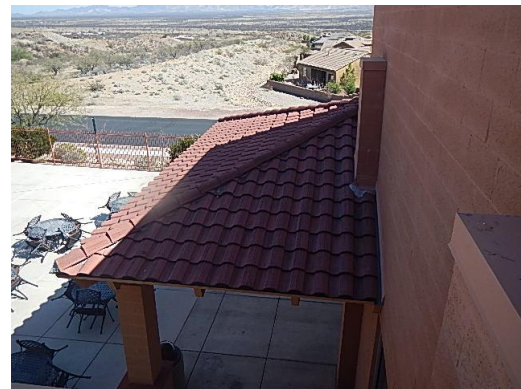
612 - Pitched: Tile 45 Squares- Building Roof	Useful Life 30    Remaining Life 22 Quantity 45                      Unit of Measure Squares Cost /Sqrs \$600 % Included 100.00%            Total Cost/Study \$27,000 Replacement Year 2038                      Future Cost \$46,482
Summary

This is to replace the tile roofing system. Tile roofs should be regularly inspected and repaired as indicated to ensure maximum life.

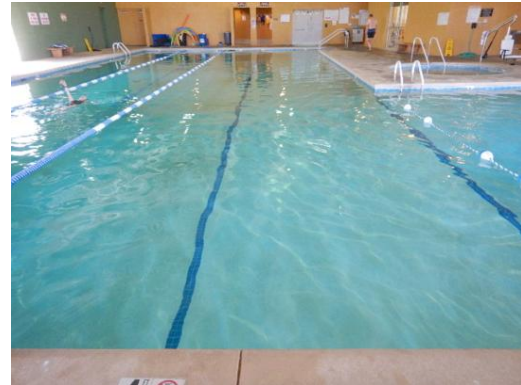
136 - Resurface	Useful Life 12	Remaining Life 4
256 Lin. Ft. Pool	Quantity 256	Unit of Measure Linear Feet
	Cost /l.f. \$140	
	% Included 100.00%	Total Cost/Study \$35,840
Summary	Replacement Year 2020	Future Cost \$39,561

This is to resurface the pool including start-up costs.

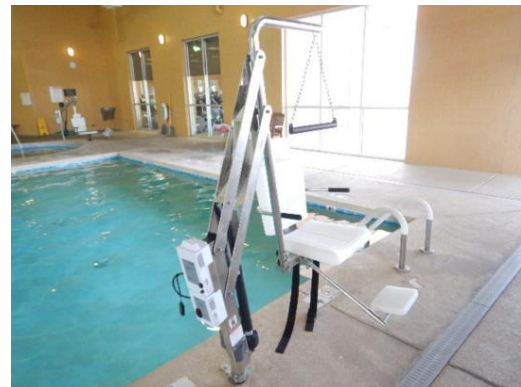
Spectrum Products Traveler II

412 - ADA Chair Lift	Useful Life 10	Remaining Life 4
2 Pool & Spa ADA Chairs	Quantity 2	Unit of Measure Items
	Cost /Itm \$8,400	
	% Included 100.00%	Total Cost/Study \$16,800
Summary	Replacement Year 2020	Future Cost \$18,544

This is to replace the pool and spa ADA compliant chair lifts.

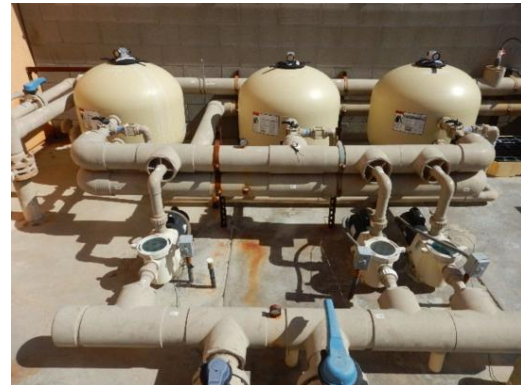
This is to replace the pool equipment. Since not all equipment will fail simultaneously, this component provides for one half replacement every five years.

- 4- Pentair Triton II Commercial filters
- 3- Pentair Intelliflo Variable Speed pumps
- 2- additional spa pumps
- 3- Raypak Professional heaters (2- pool, 1- spa)
- 2- Aquasol chemical control systems
- Assorted- pipes, fittings, controls, lights, etc
- Carbon dioxide tank is not provided for within reserves.

2015- Equipment including filters were replaced.

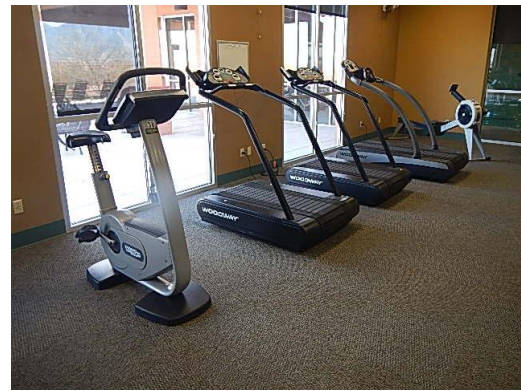
250 - Exercise: Cardio Equipment	Useful Life 1	Remaining Life 1
13 Fitness Center Cardio Machines (20%)	Quantity 13	Unit of Measure Items
	Cost /Itm \$6,000	Qty * \$/Itm \$78,000
	% Included 20.00%	Total Cost/Study \$15,600
Summary	Replacement Year 2017	Future Cost \$15,990

This is for as needed periodic replacement of the cardio equipment machines. Strength machines are provided for in another component.

Rower (1)- Concept-2

Treadmills (3)- Woodway

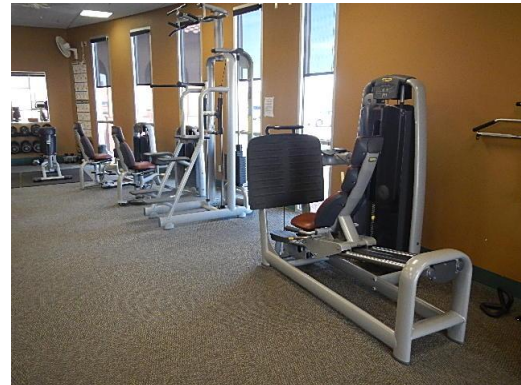
350 - Exercise: Strength Equipment	Useful Life 1	Remaining Life 1
19 Fitness Center Strength Machines (10%)	Quantity 19	Unit of Measure Items
	Cost /Itm \$4,000	Qty * \$/Itm \$76,000
	% Included 10.00%	Total Cost/Study \$7,600
Summary	Replacement Year 2017	Future Cost \$7,790

This is for as needed periodic replacement of the strength equipment machines. Cardio machines are provided for in another component.

Radiant (1)- Pulley Machine

Techno Gym (16)- Anterior Flexibility, Posterior Flexibility, Shoulder Press, Arm Extension, Arm Curl, Rotary Torso, Abdominal Crunch, Lower Back, Leg Extension, Leg Curl, Chest Incline, Abductor, Adductor, Pull-up Climber, Leg Press, Low Row

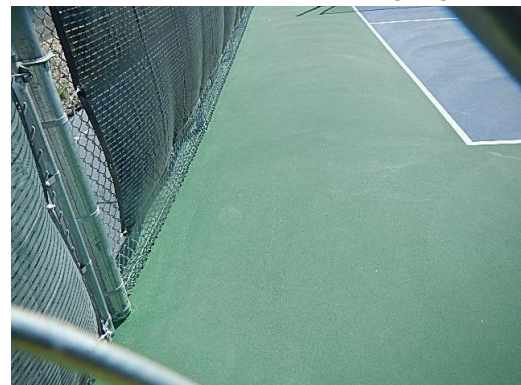
220 - Seal & Striping	Useful Life 7	Remaining Life 2
11,204 Sq. Ft. Pickleball & Basketball Courts	Quantity 11,204	Unit of Measure Square Feet
	Cost /SqFt \$0.900	
	% Included 100.00%	Total Cost/Study \$10,084
Summary	Replacement Year 2018	Future Cost \$10,594

This is to seal, repair and re-stripe the pickleball courts and basketball court surfaces on an ongoing basis.

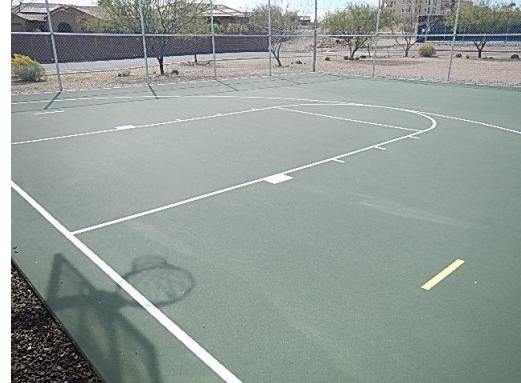
420 - Overlay	Useful Life 21	Remaining Life 16
11,204 Sq. Ft. Pickleball & Basketball Courts	Quantity 11,204	Unit of Measure Square Feet
	Cost /SqFt \$2.75	
	% Included 100.00%	Total Cost/Study \$30,811
Summary	Replacement Year 2032	Future Cost \$45,739

This is to overlay the surface with new hot asphalt.

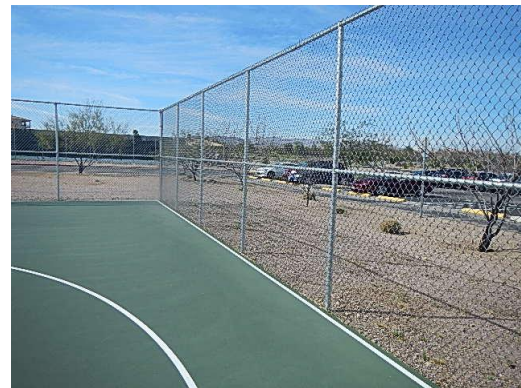
100 - Chain Link	Useful Life 30	Remaining Life 24
788 Lin. Ft. Pickleball & Basketball Courts	Quantity 788	Unit of Measure Linear Feet
	Cost /l.f. \$30.00	
	% Included 100.00%	Total Cost/Study \$23,640
Summary	Replacement Year 2040	Future Cost \$42,758

This is to replace the chain link fencing.

- 200 lf- 10' chain link fence @ basketball court
- 460 lf- 10' chain link fence @ pickleball courts
- 128 lf- 4' chain link fence @ pickleball courts

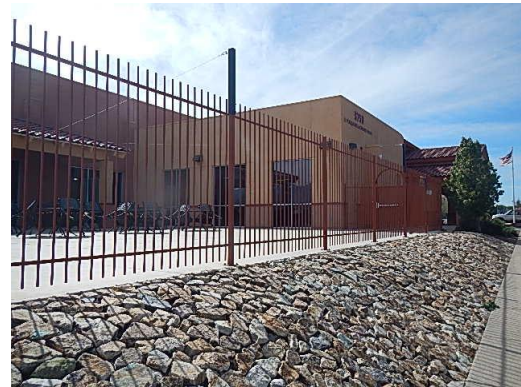
230 - Wrought Iron: 6' 264 Lin. Ft. Patio Perimeter	Useful Life 30 Quantity 264 Cost /l.f. \$36.00 % Included 100.00%	Remaining Life 22 Unit of Measure Linear Feet Total Cost/Study \$9,504 Replacement Year 2038 Future Cost \$16,362
Summary

This is to replace the 6' wrought iron fencing. With aggressive paint maintenance, this component's life may be extended. Painting is provided for within another component.

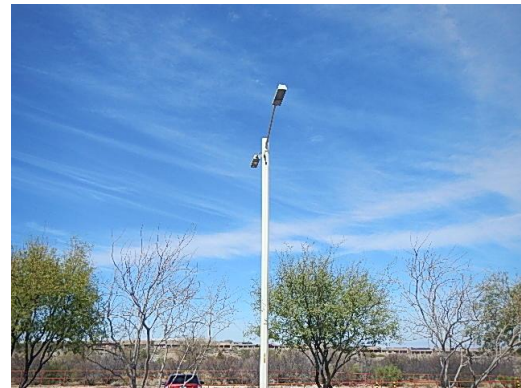
540 - Parking Lot 4 Parking Lot Lights	Useful Life 25 Quantity 4 Cost /itm \$2,500 % Included 100.00%	Remaining Life 17 Unit of Measure Items Total Cost/Study \$10,000 Replacement Year 2033 Future Cost \$15,216
Summary

This is to replace the parking lot lights.

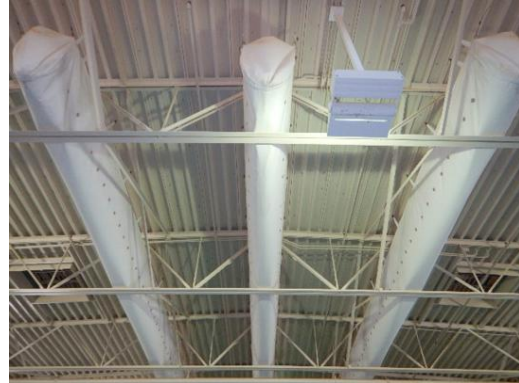
100 - HVAC	Useful Life 18	Remaining Life 10
435 Lin. Ft. [5] Pool Area Fabric Ducts	Quantity 435	Unit of Measure Linear Feet
	Cost /l.f. \$35.00	
	% Included 100.00%	Total Cost/Study \$15,225
Summary	Replacement Year 2026	Future Cost \$19,489

This is to replace the pool area fabric ducts. Fabric ducts require regular cleaning.

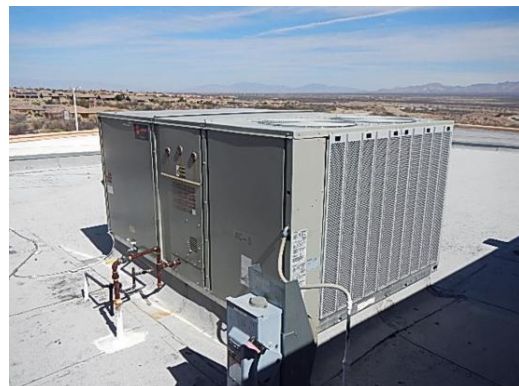
236 - HVAC	Useful Life 15	Remaining Life 7
5 Rooftop HVAC Units- 2008	Quantity 5	Unit of Measure Items
	Cost /Itm \$8,120	
	% Included 100.00%	Total Cost/Study \$40,600
Summary	Replacement Year 2023	Future Cost \$48,261

This is to replace the HVAC system. It is possible that sub-components of this system can be replaced or rebuilt to extend its life.

- Unit 1- Lobby- Trane- 5T
- Unit 2- Multi Room- Trane- 12T
- Unit 3- Women's- Aaon- 6T
- Unit 4- Men's- Aaon- 6T
- Unit 5- Fitness- Trane- 5T

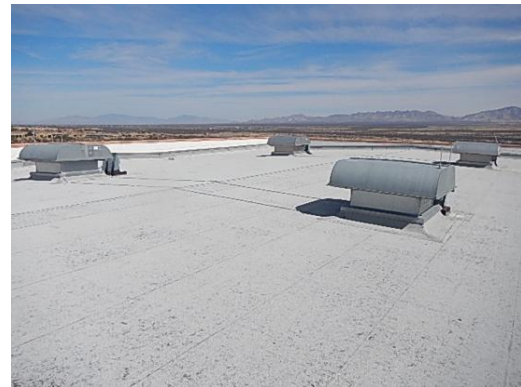
508 - Swamp Cooler	Useful Life 15	Remaining Life 7	
5 Rooftop Evaporative Coolers- 2008	Quantity 5	Unit of Measure	Items
	Cost /Itm \$3,000		
	% Included 100.00%	Total Cost/Study	\$15,000
Summary	Replacement Year 2023	Future Cost	\$17,830

This is to replace the swamp coolers.

- Unit EC- Pool- Aerocool- Evaporative Cooler
- Unit EC- Pool- Aerocool- Evaporative Cooler
- Unit EC- Pool- Aerocool- Evaporative Cooler
- Unit ECH1- Pool- Trane- Evaporative Cooler
- Unit ECH1- Pool- Trane- Evaporative Cooler

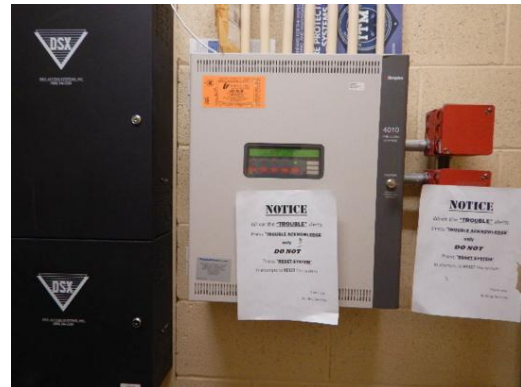
250 - Fire Control Misc	Useful Life 20	Remaining Life 12	
Fire Alarm System	Quantity 1	Unit of Measure	Lump Sum
	Cost /LS \$16,000		
	% Included 100.00%	Total Cost/Study	\$16,000
Summary	Replacement Year 2028	Future Cost	\$21,518

This is to repair and replace the fire alarm control panel, fire suppression system, alarms, sensors, pull stations, etc.

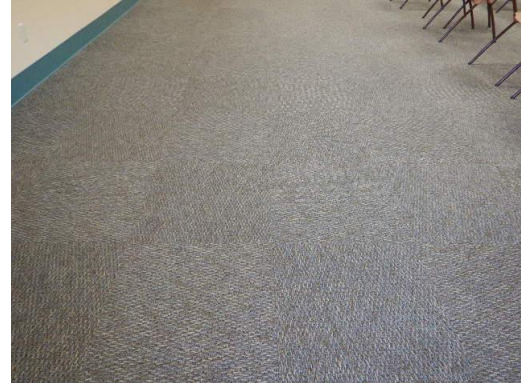
270 - Carpeting 660 Sq. Yds. All Spaces	Useful Life 10    Remaining Life 2 Quantity 660            Unit of Measure Square Yard Cost /SqYd \$32.00 % Included 100.00%    Total Cost/Study \$21,120 Replacement Year 2018            Future Cost \$22,189
--------------------------------------------	-----------------------------------------------------------------------------------------------------------------------------------------------------------------------------------------------------------------------------

This is to replace the carpeting.
