**RESERVE STUDY**

Full Study

**Green Valley Recreation Inc**

Published - June 28, 2016

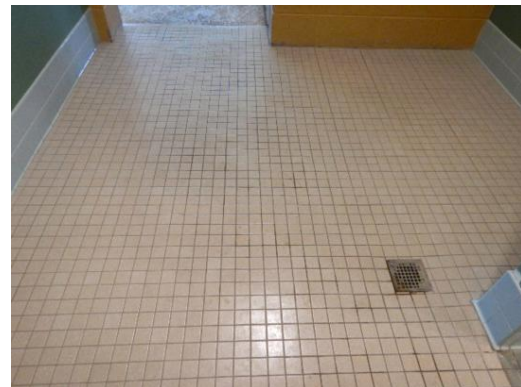
470 - Tile 1,575 Sq. Ft. Clubhouse Walls & Floors	Useful Life 20    Remaining Life 5 Quantity 1,575            Unit of Measure Square Feet Cost /SqFt \$10.00 % Included 100.00%    Total Cost/Study \$15,750 Replacement Year 2021            Future Cost \$17,820
------------------------------------------------------	-------------------------------------------------------------------------------------------------------------------------------------------------------------------------------------------------------------------------------

This is to replace the wall and floor tile.

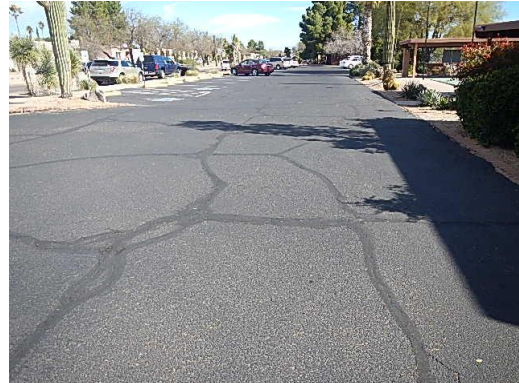
254 - Asphalt: Ongoing Repairs	Useful Life 5	Remaining Life 3
18,768 Sq. Ft. Seal/Crack Fill/Stripe	Quantity 18,768	Unit of Measure Square Feet
	Cost /SqFt \$0.350	
	% Included 100.00%	Total Cost/Study \$6,569
Summary	Replacement Year 2019	Future Cost \$7,074

This is for miscellaneous repairs including emulsion sealing, crack fill, skin patching, minor dig out & fill, and re-striping to match the existing layout. Cracks 1/4" or wider should be filled when observed.

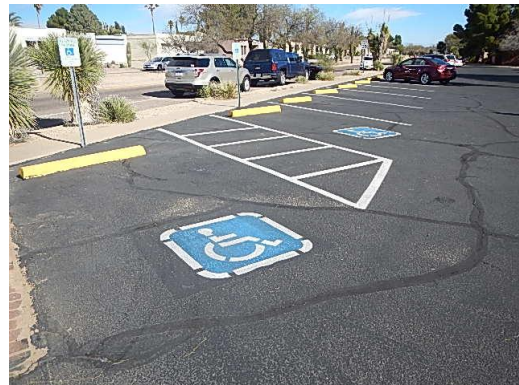
400 - Asphalt: Major Repairs	Useful Life 25	Remaining Life 8
18,768 Sq. Ft. Parking Lot	Quantity 18,768	Unit of Measure Square Feet
	Cost /SqFt \$5.00	
	% Included 100.00%	Total Cost/Study \$93,840
Summary	Replacement Year 2024	Future Cost \$114,335

This is for major excavation, recompaction and installation of new hot mix asphalt to selected areas.

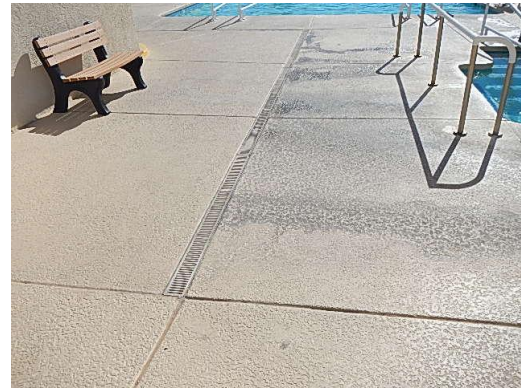
442 - Pool Deck	Useful Life 5	Remaining Life 3	
5,565 Sq. Ft. Pool Area Concrete (5%)	Quantity 5,565	Unit of Measure Square Feet	
	Cost /SqFt \$20.00	Qty * \$/SqFt \$111,300	
	% Included 5.00%	Total Cost/Study \$5,565	
Summary	Replacement Year 2019	Future Cost \$5,993

This is to repair and replace deck drains and concrete pool deck to remove abrupt elevation changes and maintain functionality. Since the concrete useful life exceeds the scope of this study, this component provides for repair only and not full replacement.

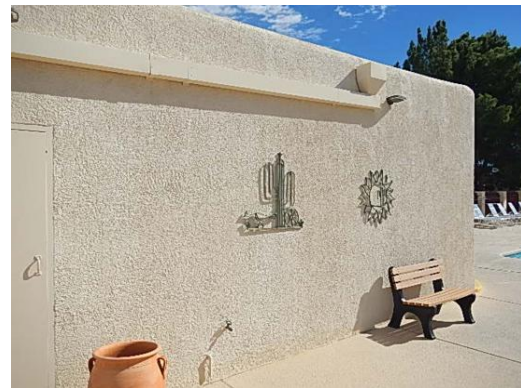
200 - Surface Restoration	Useful Life 10	Remaining Life 5	
7,191 Sq. Ft. Exterior Surfaces	Quantity 7,191	Unit of Measure Square Feet	
	Cost /SqFt \$1.00		
	% Included 100.00%	Total Cost/Study \$7,191	
Summary	Replacement Year 2021	Future Cost \$8,136

This is to prepare, power wash, sand, scrape, caulk and paint with a 100% premium acrylic paint.

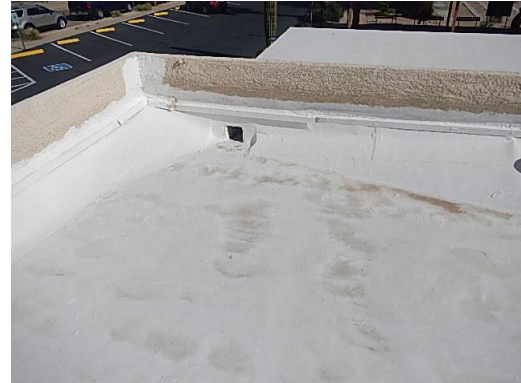
372 - Low Slope: Vinyl 49 Squares- Pool Building Roofs	Useful Life 20 Quantity 49 Cost /Sqrs \$500 % Included 100.00%	Remaining Life 15 Unit of Measure Squares Total Cost/Study \$24,500
Summary	Replacement Year 2031	Future Cost \$35,483

This is to replace the low slope single-ply vinyl roofing system. All roofs should be regularly inspected and repaired as indicated to ensure maximum life.

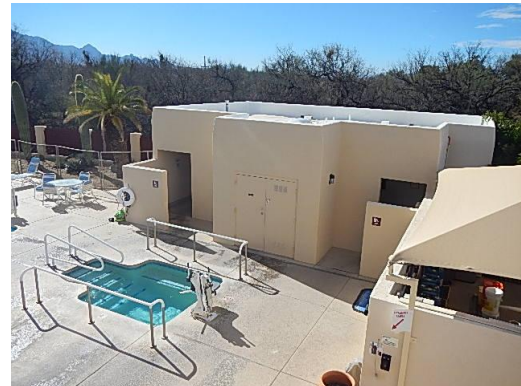
236 - Bathrooms 2 Locker Rooms	Useful Life 20 Quantity 2 Cost /Rm \$8,500 % Included 100.00%	Remaining Life 10 Unit of Measure Room Total Cost/Study \$17,000
Summary	Replacement Year 2026	Future Cost \$21,761

This is to rehab and redecorate the bathrooms including items such as partitions, fixtures, lighting, tile, etc. Client input will further define this component.

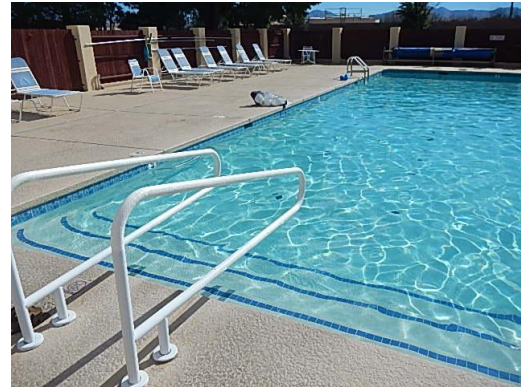
140 - Resurface	Useful Life 12	Remaining Life 10	
170 Lin. Ft. Pool	Quantity 170	Unit of Measure Linear Feet	
	Cost /l.f. \$120		
	% Included 100.00%	Total Cost/Study \$20,400	
Summary	Replacement Year 2026	Future Cost \$26,114

This is to resurface the pool including start-up costs.

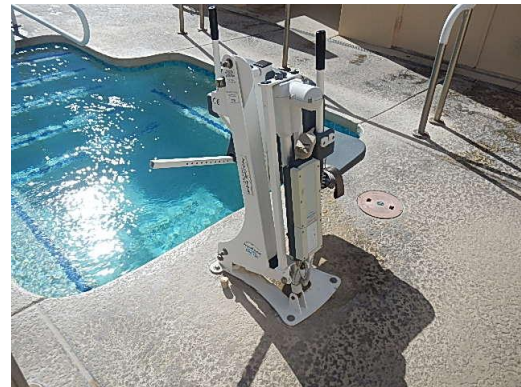
418 - ADA Chair Lift	Useful Life 10	Remaining Life 5	
2 Pool & Spa ADA Chairs	Quantity 2	Unit of Measure Items	
	Cost /Itm \$4,400		
	% Included 100.00%	Total Cost/Study \$8,800	
Summary	Replacement Year 2021	Future Cost \$9,956

This is to replace the pool and spa ADA compliant chair lifts.

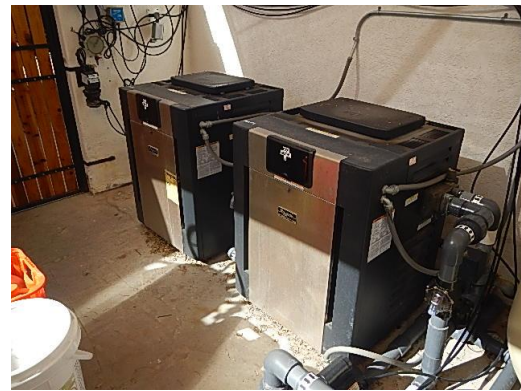
742 - Equipment: Replacement	Useful Life 5	Remaining Life 3	
Pool & Spa Equipment (50%)	Quantity 1	Unit of Measure Lump Sum	
	Cost /LS \$28,560	Qty * \$/LS \$28,560	
	% Included 50.00%	Total Cost/Study \$14,280	
Summary	Replacement Year 2019	Future Cost \$15,378

This is to replace the pool equipment. Since not all equipment will fail simultaneously, this component provides for one half replacement every five years.

- 3- Raypak Professional Heaters
- 2- Triton II commercial filters
- 2- Pentair Intelliflow variable speed pumps
- 1- spa air blower pump
- 1- Century spa jet pump
- Assorted- pipes, fittings, controls, lights, etc
- Carbon dioxide tank is not provided for within reserves.

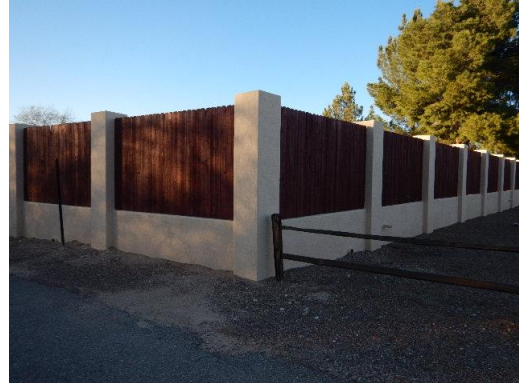
900 - Miscellaneous	Useful Life 20	Remaining Life 15
258 Lin. Ft. Pool Perimeter Wall/Fence	Quantity 258	Unit of Measure Linear Feet
	Cost /l.f. \$25.00	
	% Included 100.00%	Total Cost/Study \$6,450
Summary	Replacement Year 2031	Future Cost \$9,342

This is for miscellaneous repairs and replacement to the pool perimeter fencing, walls and pedestrian gates.

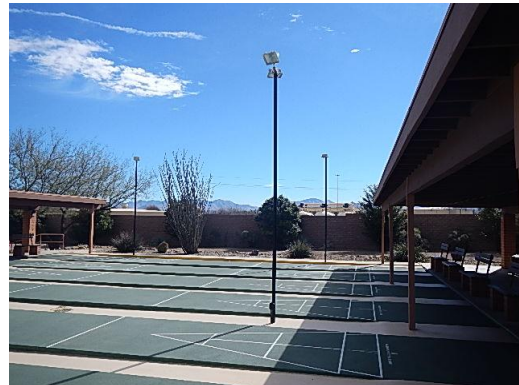
240 - Pole Lights	Useful Life 20	Remaining Life 10
8 Shuffleboard Lights	Quantity 8	Unit of Measure Items
	Cost /Itm \$1,200	
	% Included 100.00%	Total Cost/Study \$9,600
Summary	Replacement Year 2026	Future Cost \$12,289

This is to replace the shuffleboard pole lights reusing the existing wiring and conduits.

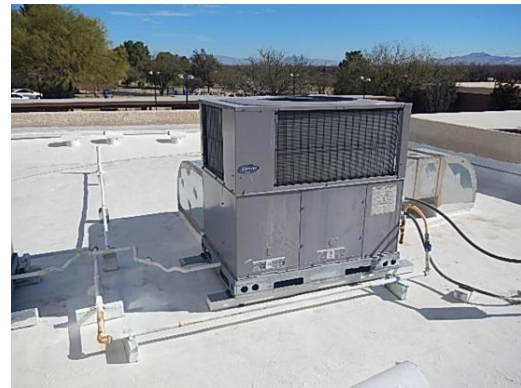
240 - HVAC	Useful Life 15	Remaining Life 10
2 Rooftop Carrier Units- 2011	Quantity 2	Unit of Measure Items
	Cost /Itm \$5,000	
	% Included 100.00%	Total Cost/Study \$10,000
Summary	Replacement Year 2026	Future Cost \$12,801

This is to replace the Carrier 4T HVAC systems. It is possible that sub-components of these systems can be replaced or rebuilt to extend its life.

- Unit 1- West Lobby- Carrier- 4T
- Unit 2- East Lobby/Restrooms- Carrier- 4T

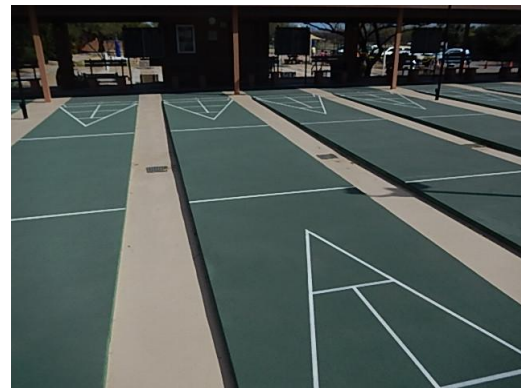
900 - Miscellaneous	Useful Life 8	Remaining Life 4
3,744 Sq. Ft. [12] Shuffleboard Courts	Quantity 3,744	Unit of Measure Square Feet
	Cost /SqFt \$2.25	
	% Included 100.00%	Total Cost/Study \$8,424
Summary	Replacement Year 2020	Future Cost \$9,299

This is to resurface the shuffleboard courts.

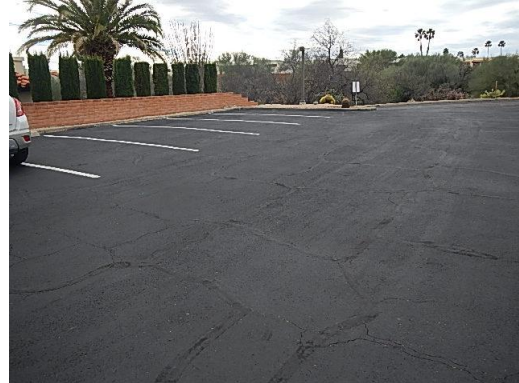
406 - Asphalt: Major Repairs	Useful Life 25	Remaining Life 9	
6,726 Sq. Ft. Parking Lot	Quantity 6,726	Unit of Measure Square Feet	
	Cost /SqFt \$5.00		
	% Included 100.00%	Total Cost/Study \$33,630	
Summary	Replacement Year 2025	Future Cost \$41,999

This is for major excavation, recompaction and installation of new hot mix asphalt to selected areas.

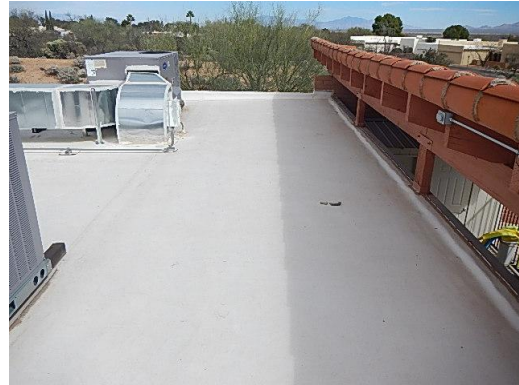
342 - Low Slope: Vinyl 20 Squares- Pool Building Roof	Useful Life 20 Quantity 20 Cost /Sqrs \$500 % Included 100.00%	Remaining Life 10 Unit of Measure Squares Total Cost/Study \$10,000 Replacement Year 2026 Future Cost \$12,801
Summary

This is to replace the low slope single-ply vinyl roofing system. All roofs should be regularly inspected and repaired as indicated to ensure maximum life.

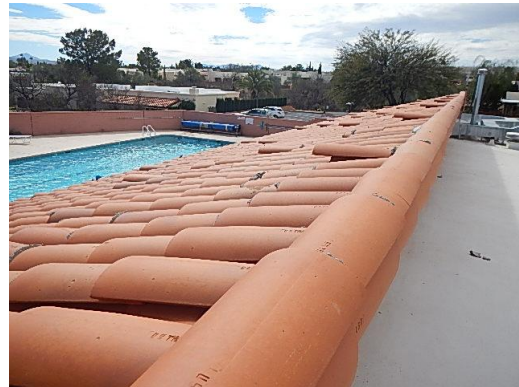
618 - Pitched: Tile 13 Squares- Pool Building Roof	Useful Life 30 Quantity 13 Cost /Sqrs \$600 % Included 100.00%	Remaining Life 5 Unit of Measure Squares Total Cost/Study \$7,800 Replacement Year 2021 Future Cost \$8,825
Summary

This is to replace the tile roofing system. Tile roofs should be regularly inspected and repaired as indicated to ensure maximum life.

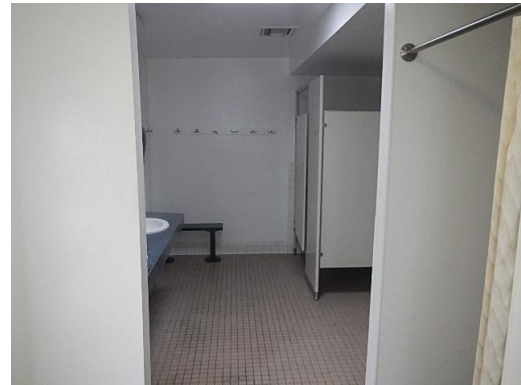
242 - Bathrooms	Useful Life 20	Remaining Life 10
2 Locker Rooms	Quantity 2	Unit of Measure Room
	Cost /Rm \$8,500	
	% Included 100.00%	Total Cost/Study \$17,000
Summary	Replacement Year 2026	Future Cost \$21,761

This is to rehab and redecorate the bathrooms including items such as partitions, fixtures, lighting, tile, etc. Client input will further define this component.

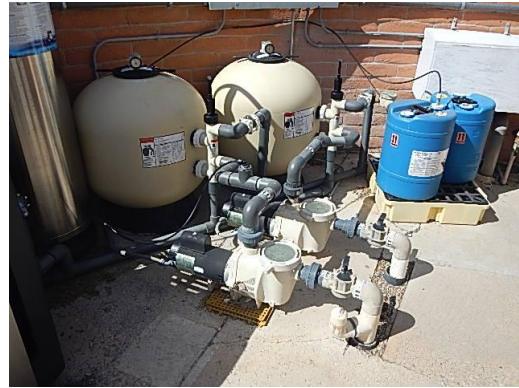
748 - Equipment: Replacement	Useful Life 5	Remaining Life 2	
Pool & Spa Equipment (50%)	Quantity 1	Unit of Measure	Lump Sum
	Cost /LS \$30,360	Qty * \$/LS	\$30,360
	% Included 50.00%	Total Cost/Study	\$15,180
Summary	Replacement Year 2018	Future Cost	\$15,948

This is to replace the pool equipment. Since not all equipment will fail simultaneously, this component provides for one half replacement every five years.

- 3- Pentair Triton II Commercial filters
- 3- Pentair Intelliflo Variable Speed pumps
- 1- additional spa pumps
- 2- Raypak Professional heaters (1- pool, 1- spa)
- 2- Aquasol chemical control systems
- Assorted- pipes, fittings, controls, lights, etc
- Carbon dioxide tank is not provided for within reserves.

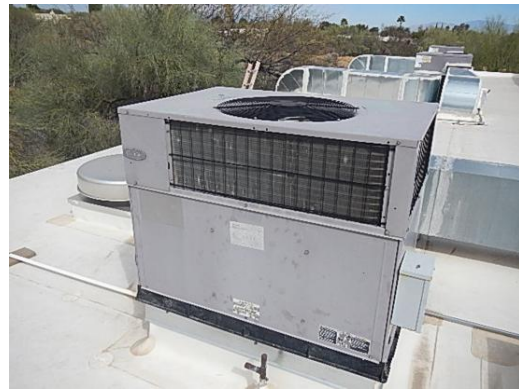
Unit 3- Wash Room- Carrier- 5T

244 - HVAC	Useful Life 15	Remaining Life 3
Rooftop Carrier Unit- 2004	Quantity 1	Unit of Measure Items
	Cost /Itm \$5,800	
	% Included 100.00%	Total Cost/Study \$5,800
Summary	Replacement Year 2019	Future Cost \$6,246

This is to replace the Carrier HVAC system. It is possible that sub-components of this system can be replaced or rebuilt to extend its life.

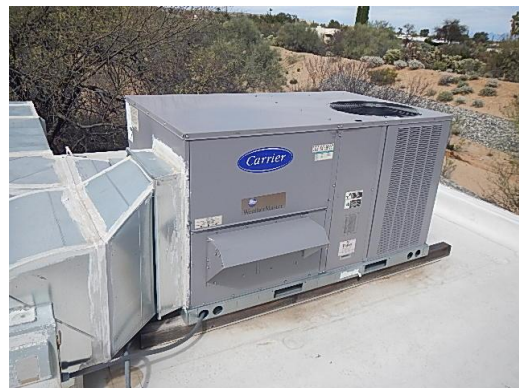
Unit 1- Building Roof- Carrier- 5T  
 Unit 2- Building Roof- Carrier- 5T

248 - HVAC	Useful Life 15	Remaining Life 12
2 Rooftop Carrier Units- 2013	Quantity 2	Unit of Measure Items
	Cost /Itm \$5,800	
	% Included 100.00%	Total Cost/Study \$11,600
Summary	Replacement Year 2028	Future Cost \$15,601

This is to replace the Carrier HVAC systems. It is possible that sub-components of these systems can be replaced or rebuilt to extend their lives.

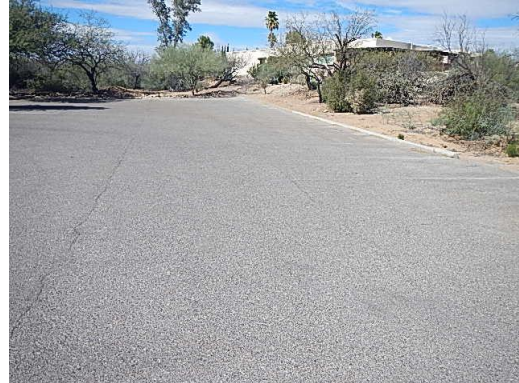
412 - Asphalt: Major Repairs 9,772 Sq. Ft. Parking Lot	Useful Life 25    Remaining Life 16 Quantity 9,772    Unit of Measure Square Feet Cost /SqFt \$5.00 % Included 100.00%    Total Cost/Study \$48,860 Replacement Year 2032    Future Cost \$72,533
Summary

This is for major excavation, recompaction and installation of new hot mix asphalt to selected areas.

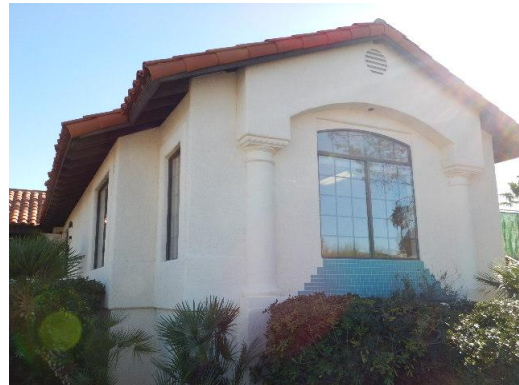
206 - Surface Restoration 4,020 Sq. Ft. Exterior Surfaces	Useful Life 10    Remaining Life 5 Quantity 4,020    Unit of Measure Square Feet Cost /SqFt \$1.50 % Included 100.00%    Total Cost/Study \$6,030 Replacement Year 2021    Future Cost \$6,822
Summary

This is to prepare, power wash, sand, scrape, caulk and paint with a 100% premium acrylic paint.

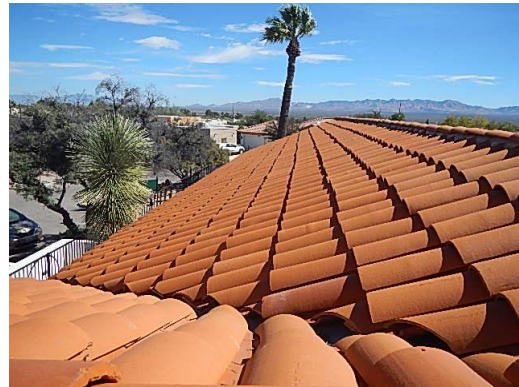
624 - Pitched: Tile 39 Squares- Pool Building Roof	Useful Life 30 Quantity 39 Cost /Sqrs \$600 % Included 100.00%	Remaining Life 5 Unit of Measure Squares Total Cost/Study \$23,400 Future Cost \$26,475
Summary	Replacement Year 2021

This is to replace the tile roofing system. Tile roofs should be regularly inspected and repaired as indicated to ensure maximum life.

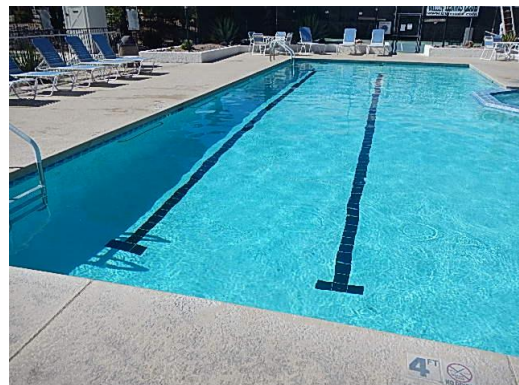
154 - Resurface 156 Lin. Ft. Pool	Useful Life 12 Quantity 156 Cost /l.f. \$120 % Included 100.00%	Remaining Life 6 Unit of Measure Linear Feet Total Cost/Study \$18,720 Future Cost \$21,709
Summary	Replacement Year 2022

This is to resurface the pool including start-up costs.

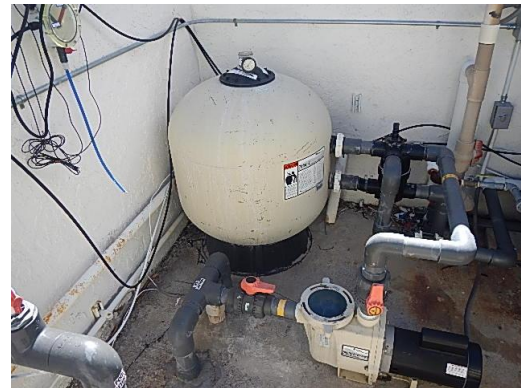
754 - Equipment: Replacement Pool & Spa Equipment (50%)	Useful Life 5    Remaining Life 3 Quantity 1 Cost /LS \$21,960 % Included 50.00%	Unit of Measure Lump Sum Qty * \$/LS \$21,960 Total Cost/Study \$10,980
Summary	Replacement Year 2019	Future Cost \$11,824

This is to replace the pool equipment. Since not all equipment will fail simultaneously, this component provides for one half replacement every five years.

- 2- Pentair Triton II Commercial filters
- 2- Pentair Intelliflo Variable Speed pumps
- 2- Raypak Professional heaters (1- pool, 1- spa)
- 2- Aquasol chemical control systems
- Assorted- pipes, fittings, controls, lights, etc
- Carbon dioxide tank is not provided for within reserves.

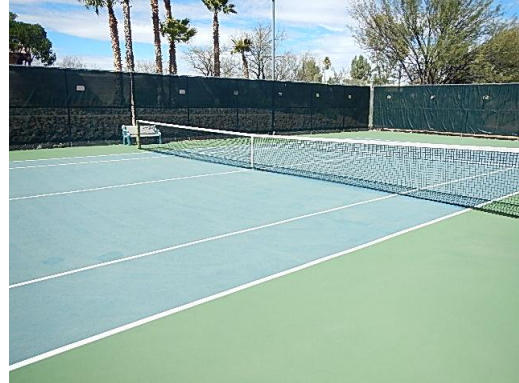
540 - Resurface	Useful Life 21	Remaining Life 7	
7,200 Sq. Ft. Tennis Court	Quantity 7,200	Unit of Measure Square Feet	
	Cost /SqFt \$2.75		
	% Included 100.00%	Total Cost/Study \$19,800	
Summary	Replacement Year 2023	Future Cost \$23,536

This is to resurface the tennis courts utilizing an overlay, color coat and striping.

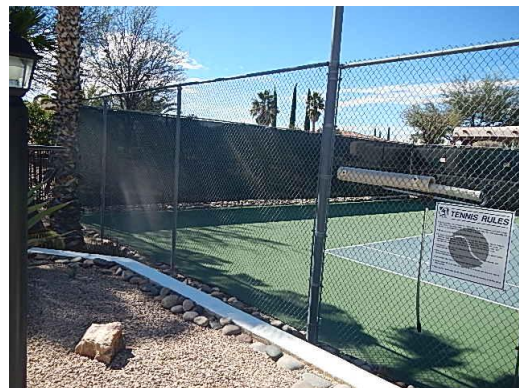
170 - Chain Link: 10'	Useful Life 30	Remaining Life 15	
360 Lin. Ft. Tennis Court Fence	Quantity 360	Unit of Measure Linear Feet	
	Cost /l.f. \$18.00		
	% Included 100.00%	Total Cost/Study \$6,480	
Summary	Replacement Year 2031	Future Cost \$9,385

This is to replace the 10' chain link fencing.

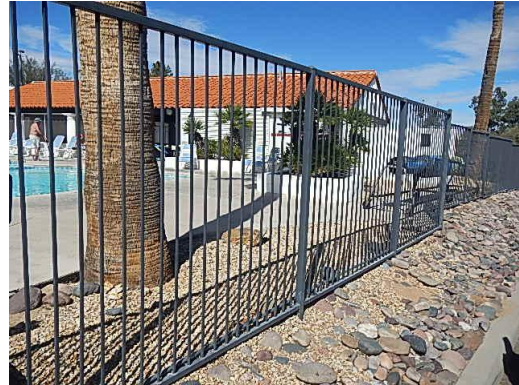
240 - Wrought Iron: 6'	Useful Life 30	Remaining Life 10
380 Lin. Ft. Pool Perimeter Fence	Quantity 380	Unit of Measure Linear Feet
	Cost /l.f. \$36.00	
	% Included 100.00%	Total Cost/Study \$13,680
Summary	Replacement Year 2026	Future Cost \$17,512

This is to replace the 6' wrought iron fencing. With aggressive paint maintenance, this component's life may be extended. Painting is provided for within another component.

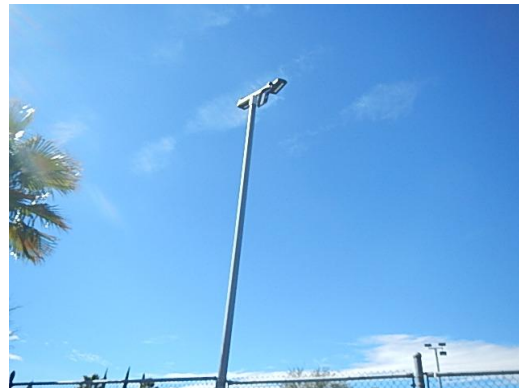
250 - Pole Lights	Useful Life 20	Remaining Life 10
4 Tennis Court Lights	Quantity 4	Unit of Measure Items
	Cost /itm \$1,500	
	% Included 100.00%	Total Cost/Study \$6,000
Summary	Replacement Year 2026	Future Cost \$7,681

This is to replace the pole lights reusing the existing wiring and conduits.

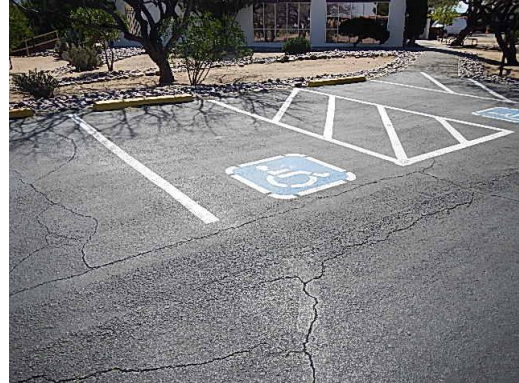
418 - Asphalt: Major Repairs 7,128 Sq. Ft. Parking Areas	Useful Life 25    Remaining Life 6 Quantity 7,128    Unit of Measure Square Feet Cost /SqFt \$5.00
	% Included 100.00%    Total Cost/Study \$35,640
Summary	Replacement Year 2022    Future Cost \$41,331

This is for major excavation, recompaction and installation of new hot mix asphalt to selected areas.

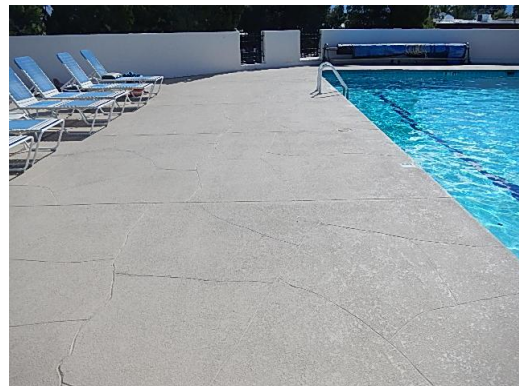
460 - Pool Deck 6,128 Sq. Ft. Pool Area Concrete (6%)	Useful Life 5    Remaining Life 3 Quantity 6,128    Unit of Measure Square Feet Cost /SqFt \$20.00    Qty * \$/SqFt \$122,560
	% Included 6.00%    Total Cost/Study \$7,354
Summary	Replacement Year 2019    Future Cost \$7,919

This is to repair and replace concrete pool deck to remove abrupt elevation changes and maintain functionality. Since the concrete useful life exceeds the scope of this study, this component provides for repair only and not full replacement.

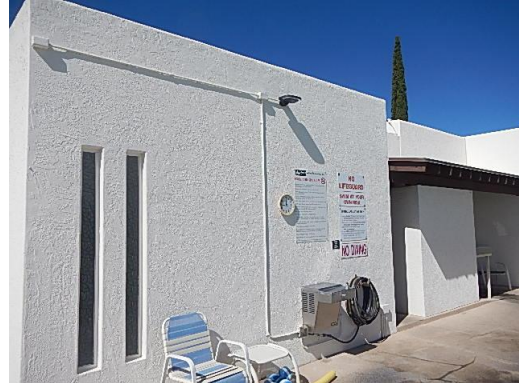
212 - Surface Restoration 7,470 Sq. Ft. Exterior Surfaces	Useful Life 10 Remaining Life 6 Quantity 7,470 Unit of Measure Square Feet Cost /SqFt \$1.00 % Included 100.00% Total Cost/Study \$7,470 Replacement Year 2022 Future Cost \$8,663
Summary

This is to prepare, power wash, sand, scrape, caulk and paint with a 100% premium acrylic paint.

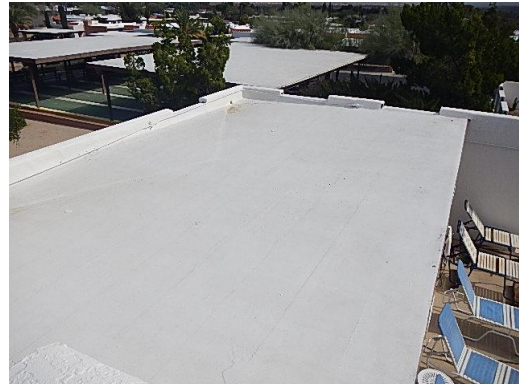
348 - Low Slope: Vinyl 61 Squares- Pool Building Roofs	Useful Life 20 Remaining Life 2 Quantity 61 Unit of Measure Squares Cost /Sqrs \$500 % Included 100.00% Total Cost/Study \$30,500 Replacement Year 2018 Future Cost \$32,044
Summary

This is to replace the low slope single-ply vinyl roofing system. All roofs should be regularly inspected and repaired as indicated to ensure maximum life.

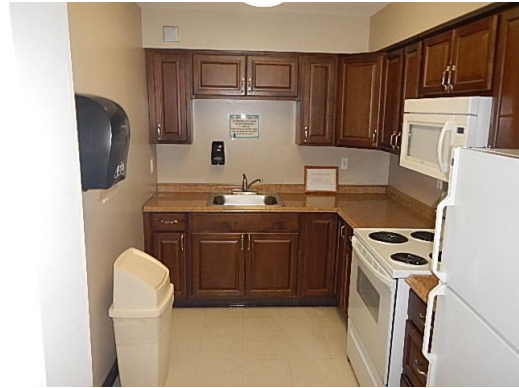
418 - Kitchen	Useful Life 20	Remaining Life 15
Clubhouse Kitchen	Quantity 1	Unit of Measure Room
	Cost /Rm \$6,500	
	% Included 100.00%	Total Cost/Study \$6,500
Summary	Replacement Year 2031	Future Cost \$9,414

This is to rehab and redecorate the kitchen including items such as cabinets, countertops, fixtures, lighting, etc. Client input will further define this component.

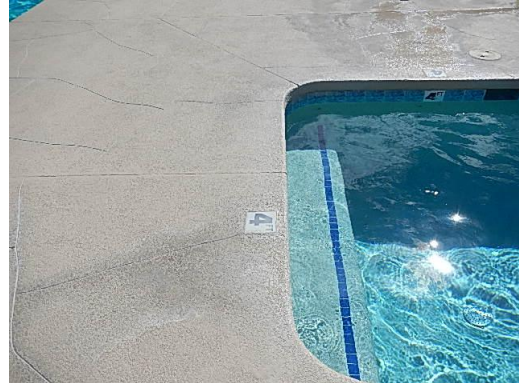
660 - Deck: Re-Surface	Useful Life 15	Remaining Life 12	
6,128 Sq. Ft. Pool Area Decking	Quantity 6,128	Unit of Measure Square Feet	
	Cost /SqFt \$7.50		
	% Included 100.00%	Total Cost/Study \$45,960	
Summary	Replacement Year 2028	Future Cost \$61,811

This is to prepare and resurface the coated deck with Kool Deck or similar product.

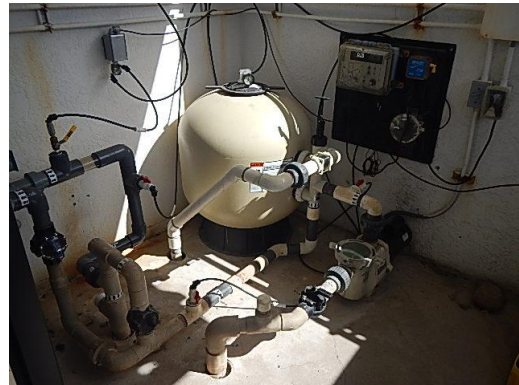
760 - Equipment: Replacement	Useful Life 5	Remaining Life 3	
Pool & Spa Equipment (50%)	Quantity 1	Unit of Measure Lump Sum	
	Cost /LS \$29,160	Qty * \$/LS \$29,160	
	% Included 50.00%	Total Cost/Study \$14,580	
Summary	Replacement Year 2019	Future Cost \$15,701

This is to replace the pool equipment. Since not all equipment will fail simultaneously, this component provides for one half replacement every five years.

- 3- Pentair Triton II Commercial filters
- 3- Pentair Intelliflo Variable Speed pumps
- 3- Raypak Professional heaters (2- pool, 1- spa)
- 2- Aquasol chemical control systems
- Assorted- pipes, fittings, controls, lights, etc
- Carbon dioxide tank is not provided for within reserves.

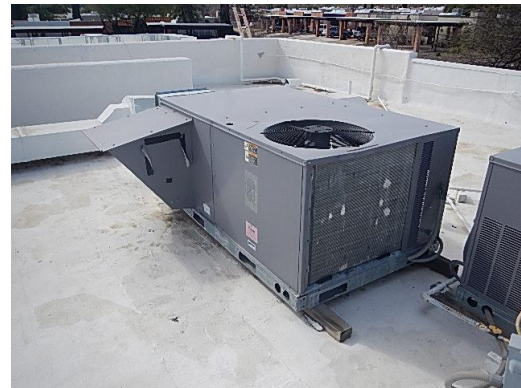
256 - HVAC	Useful Life 15	Remaining Life 10	
2 Rooftop Carrier Units- 2011	Quantity 2	Unit of Measure Items	
	Cost /Itm \$4,000		
	% Included 100.00%	Total Cost/Study \$8,000	
Summary	Replacement Year 2026	Future Cost \$10,241

This is to replace the Carrier HVAC systems. It is possible that sub-components of these systems can be replaced or rebuilt to extend their lives.

- Unit 1- Building Roof (N)- Carrier- 3T
- Unit 2- Building Roof (S)- Carrier- 3T

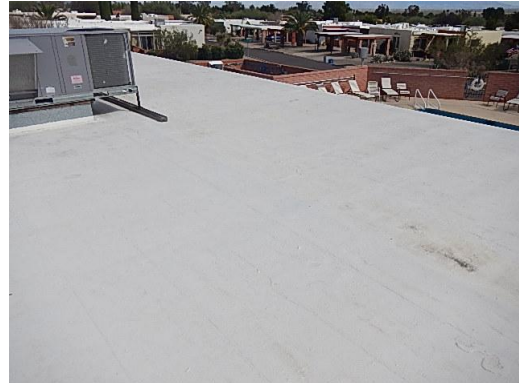
354 - Low Slope: Vinyl	Useful Life 20	Remaining Life 5
53 Squares- Pool Building Roofs	Quantity 53	Unit of Measure Squares
	Cost /Sqrs \$500	
	% Included 100.00%	Total Cost/Study \$26,500
Summary	Replacement Year 2021	Future Cost \$29,982

This is to replace the low slope single-ply vinyl roofing system. All roofs should be regularly inspected and repaired as indicated to ensure maximum life.

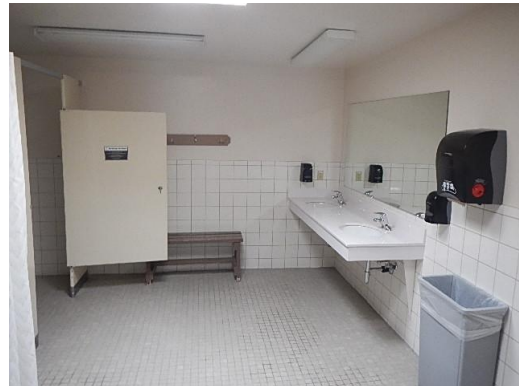
260 - Bathrooms	Useful Life 20	Remaining Life 8
2 Locker Rooms	Quantity 2	Unit of Measure Room
	Cost /Rm \$8,500	
	% Included 100.00%	Total Cost/Study \$17,000
Summary	Replacement Year 2024	Future Cost \$20,713

This is to rehab and redecorate the bathrooms including items such as partitions, fixtures, lighting, tile, etc. Client input will further define this component.

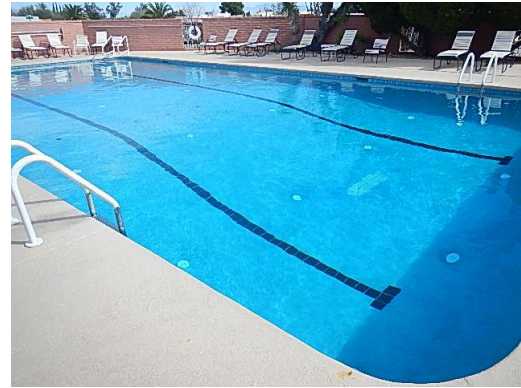
166 - Resurface	Useful Life 12	Remaining Life 6	
180 Lin. Ft. Pool	Quantity 180	Unit of Measure Linear Feet	
	Cost /l.f. \$120		
	% Included 100.00%	Total Cost/Study \$21,600	
Summary	Replacement Year 2022	Future Cost \$25,049

This is to resurface the pool including start-up costs.

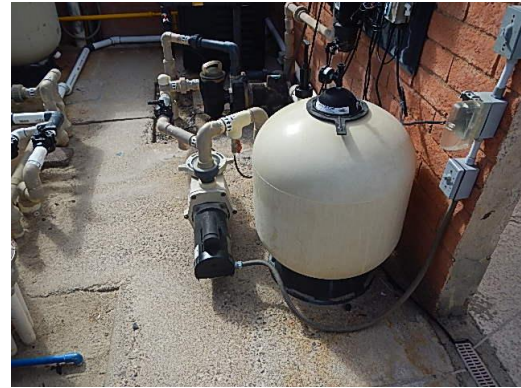
766 - Equipment: Replacement	Useful Life 5	Remaining Life 3	
Pool & Spa Equipment (50%)	Quantity 1	Unit of Measure Lump Sum	
	Cost /LS \$30,360	Qty * \$/LS \$30,360	
	% Included 50.00%	Total Cost/Study \$15,180	
Summary	Replacement Year 2019	Future Cost \$16,347

This is to replace the pool equipment. Since not all equipment will fail simultaneously, this component provides for one half replacement every five years.

- 3- Pentair Triton II Commercial filters
- 3- Pentair Intelliflo Variable Speed pumps
- 1- additional spa pumps
- 3- Raypak Professional heaters (2- pool, 1- spa)
- 2- Aquasol chemical control systems
- Assorted- pipes, fittings, controls, lights, etc
- Carbon dioxide tank is not provided for within reserves.

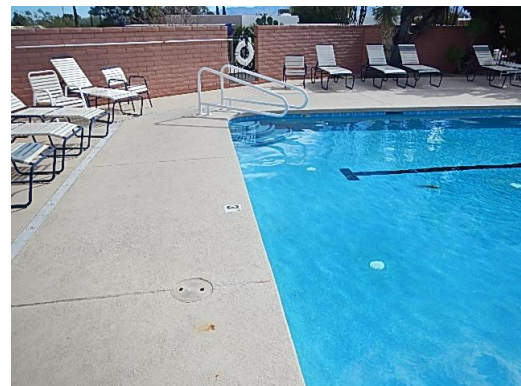
960 - Furniture: Misc	Useful Life 6	Remaining Life 3	
Pool Area Furnishings	Quantity 1	Unit of Measure Lump Sum	
	Cost /LS \$6,500		
	% Included 100.00%	Total Cost/Study \$6,500	
Summary	Replacement Year 2019	Future Cost \$7,000

This is to replace miscellaneous pool furniture.

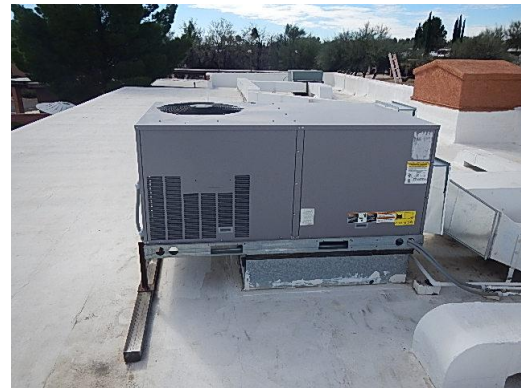
272 - HVAC	Useful Life 15	Remaining Life 10	
2 Rooftop Carrier Units- 2011	Quantity 2	Unit of Measure	Items
	Cost /Itm \$4,000		
	% Included 100.00%	Total Cost/Study	\$8,000
Summary	Replacement Year 2026	Future Cost	\$10,241

This is to replace the Carrier HVAC systems. It is possible that sub-components of these systems can be replaced or rebuilt to extend their lives.

Unit 1- Building Roof- Carrier- 3T  
 Unit 2- Building Roof- Carrier- 3T

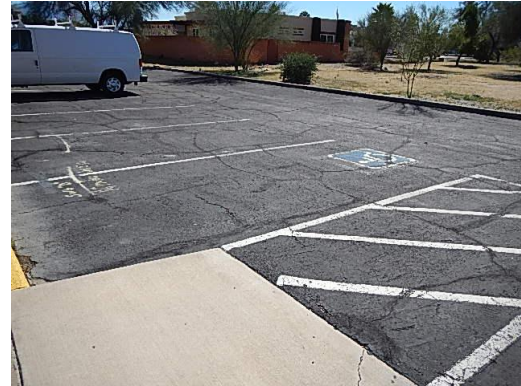
430 - Asphalt: Major Repairs 6,455 Sq. Ft. Parking Area	Useful Life 25    Remaining Life 7 Quantity 6,455    Unit of Measure Square Feet Cost /SqFt \$5.00 % Included 100.00%    Total Cost/Study \$32,275 Replacement Year 2023    Future Cost \$38,365
------------------------------------------------------------	--------------------------------------------------------------------------------------------------------------------------------------------------------------------------------------------------------------

This is for major excavation, re-compaction and installation of new hot mix asphalt to selected areas.

1997- overlay work performed

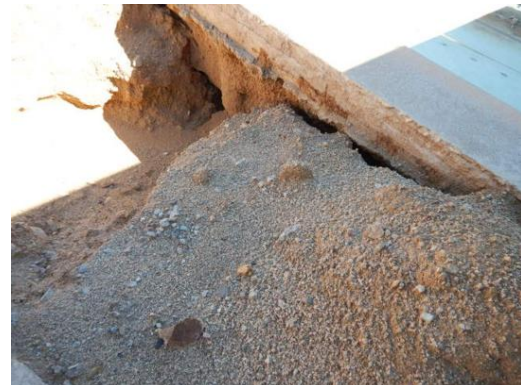
472 - Pool Deck 4,523 Sq. Ft. Pool Area Concrete (6%)	Useful Life 5    Remaining Life 0 Quantity 4,523    Unit of Measure Square Feet Cost /SqFt \$20.00    Qty * \$/SqFt \$90,460 % Included 6.00%    Total Cost/Study \$5,428 Replacement Year 2016    Future Cost \$5,428
----------------------------------------------------------	------------------------------------------------------------------------------------------------------------------------------------------------------------------------------------------------------------------------------------

This is to repair and replace concrete pool deck to remove abrupt elevation changes and maintain functionality. Since the concrete useful life exceeds the scope of this study, this component provides for repair only and not full replacement. Pool Deck resurfacing is provided for in another component.

In 2016, total pool replacement was in progress at the time of the reserve site visit. This component provides for repairs and not the total replacement.

Deck area excavation.

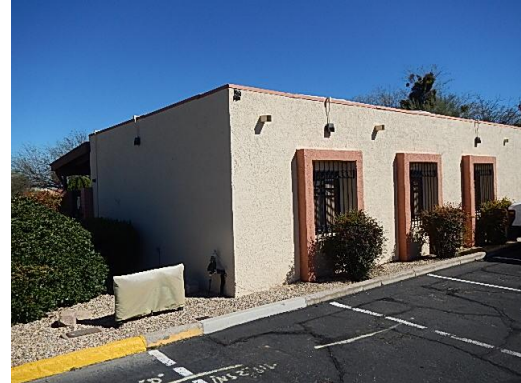
218 - Surface Restoration	Useful Life 10	Remaining Life 5
5,892 Sq. Ft. Exterior Surfaces	Quantity 5,892	Unit of Measure Square Feet
	Cost /SqFt \$1.00	
	% Included 100.00%	Total Cost/Study \$5,892
Summary	Replacement Year 2021	Future Cost \$6,666

This is to prepare, power wash, sand, scrape, caulk and paint with a 100% premium acrylic paint.

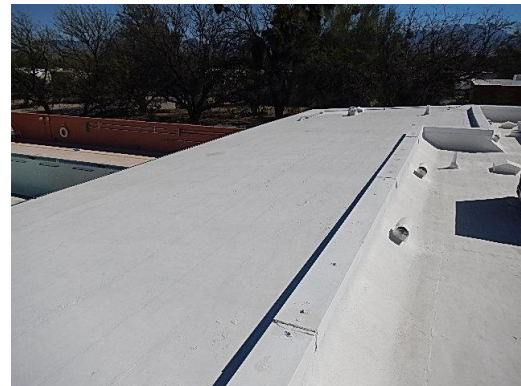
360 - Low Slope: Vinyl	Useful Life 20	Remaining Life 10
21 Squares- Pool Building Roof	Quantity 21	Unit of Measure Squares
	Cost /Sqrs \$500	
	% Included 100.00%	Total Cost/Study \$10,500
Summary	Replacement Year 2026	Future Cost \$13,441

This is to replace the low slope single-ply vinyl roofing system. All roofs should be regularly inspected and repaired as indicated to ensure maximum life.

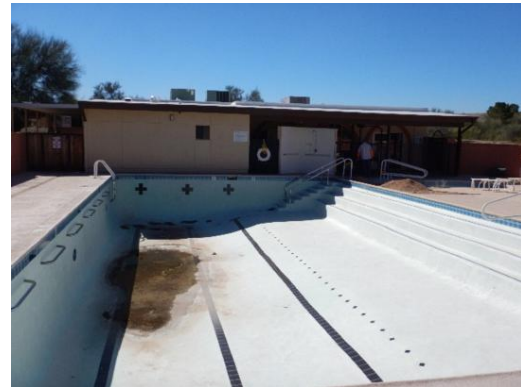
172 - Resurface	Useful Life 12	Remaining Life 12
180 Lin. Ft. Pool	Quantity 180	Unit of Measure Linear Feet
	Cost /l.f. \$120	
	% Included 100.00%	Total Cost/Study \$21,600
Summary	Replacement Year 2028	Future Cost \$29,050

In 2016, total pool replacement was in progress at the time of the reserve site visit. This component provides for resurfacing and not the total replacement.

2016- Per client 4/21/2016, \$464,000 total is anticipated to replace the pool in 2016.

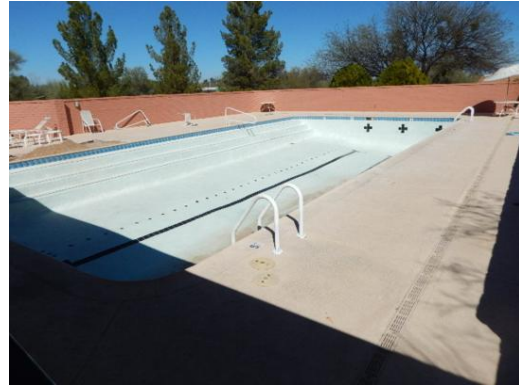
173 - Miscellaneous	Useful Life 1	Remaining Life 0	Treatment [nr:1]
Pool Replace (2016 Only)	Quantity 1	Unit of Measure Lump Sum	
	Cost /LS \$464,000		
	% Included 100.00%	Total Cost/Study \$464,000	
Summary	Replacement Year 2016	Future Cost \$464,000

This is to replace the pool in 2016.

In 2016, total pool replacement was in progress at the time of the reserve site visit.

2016- Per client 4/21/2016, \$464,000 total is anticipated to replace the pool in 2016.

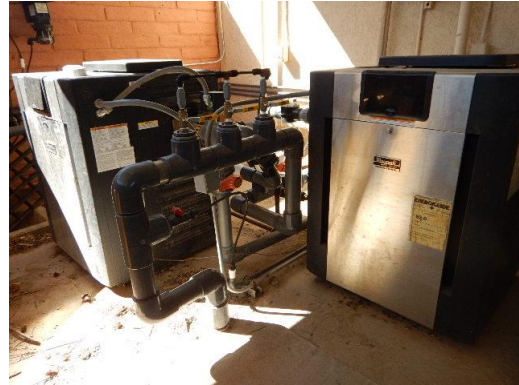
772 - Equipment: Replacement	Useful Life 5	Remaining Life 5	
Pool & Spa Equipment (50%)	Quantity 1	Unit of Measure	Lump Sum
	Cost /LS \$30,360	Qty * \$/LS	\$30,360
	% Included 50.00%	Total Cost/Study	\$15,180
Summary	Replacement Year 2021	Future Cost	\$17,175

This is to replace the pool equipment. Since not all equipment will fail simultaneously, this component provides for one half replacement every five years.

- 3- Pentair Triton II Commercial filters
- 3- Pentair Intelliflo Variable Speed pumps
- 1- additional spa pumps
- 3- Raypak Professional heaters (2- pool, 1- spa)
- 2- Aquasol chemical control systems
- Assorted- pipes, fittings, controls, lights, etc
- Carbon dioxide tank is not provided for within reserves.

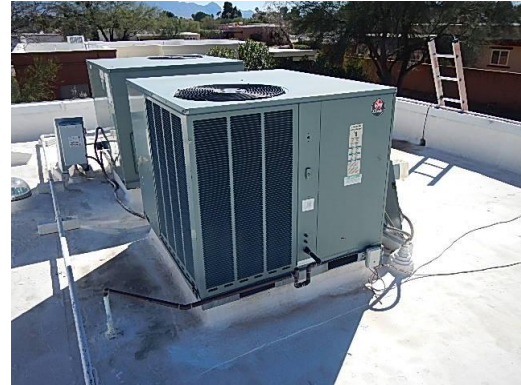
400 - HVAC	Useful Life 15	Remaining Life 6	
2 Rooftop Rheem Units- 2007	Quantity 2	Unit of Measure	Items
	Cost /Itm \$3,650		
	% Included 100.00%	Total Cost/Study	\$7,300
Summary	Replacement Year 2022	Future Cost	\$8,466

This is to replace the Rheem HVAC systems. It is possible that sub-components of this system can be replaced or rebuilt to extend its life.

Unit 2- Women's- Rheem- 2.5T  
 Unit 3- Men's- Rheem- 2.5T

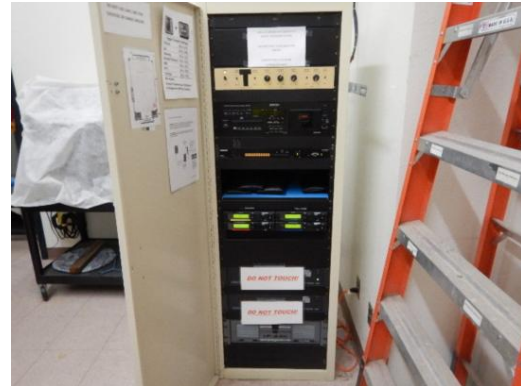
260 - Entertainment System	Useful Life 10	Remaining Life 10
5 Various Locations	Quantity 5	Unit of Measure Building
	Cost /Bldg \$3,000	
	% Included 100.00%	Total Cost/Study \$15,000
Summary	Replacement Year 2026	Future Cost \$19,201

This is to periodically replace various audio visual and lighting systems. Not all items will be replaced at one time. West Center items are provided for within a West Center component. Several meeting rooms have smaller video projectors and screens.

EC, CH, LC, CH and SRS auditoriums sound systems generally consist of the rack mounted following items:

- Induction loop driver(s)
- Audio amplifiers
- Wireless microphone receivers
- Tape/CD/DVD decks
- Mixer/controller
- Speakers
- Video projectors
- Projection screens
- Equipment racks
- Lighting controls
- assorted connectors

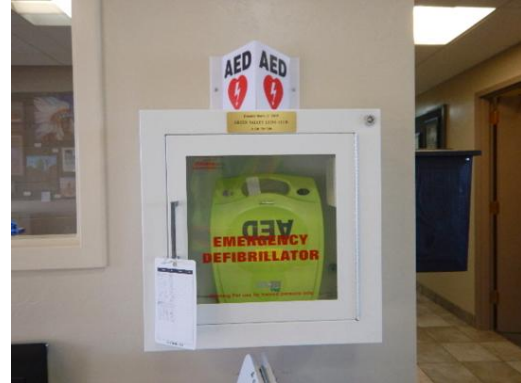
350 - Defibrillators	Useful Life 10	Remaining Life 5	
8 Various Locations	Quantity 8	Unit of Measure	Items
	Cost /Itm \$2,900		
	% Included 100.00%	Total Cost/Study	\$23,200
Summary	Replacement Year 2021	Future Cost	\$26,249

This is to replace the (AED) automated external defibrillator units.

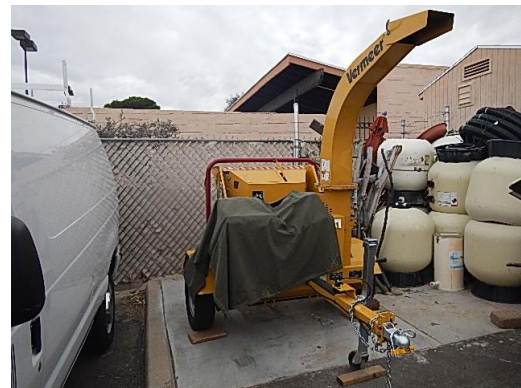
200 - Maintenance Equipment	Useful Life 20	Remaining Life 10	
Vermeer Chipper	Quantity 1	Unit of Measure	Items
	Cost /Itm \$7,500		
	% Included 100.00%	Total Cost/Study	\$7,500
Summary	Replacement Year 2026	Future Cost	\$9,601

This is to replace Vermeer chipper.

Model #- BC700XL  
 VIN/PIN- 1VRC101V9F10 00862

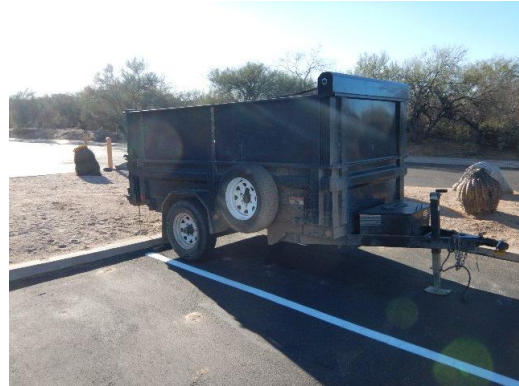
700 - Trailer	Useful Life 15	Remaining Life 5	
Utility Trailer	Quantity 1	Unit of Measure	Items
	Cost /Itm \$5,000		
	% Included 100.00%	Total Cost/Study	\$5,000
Summary	Replacement Year 2021	Future Cost	\$5,657

This is to replace the Load Trail utility trailer.

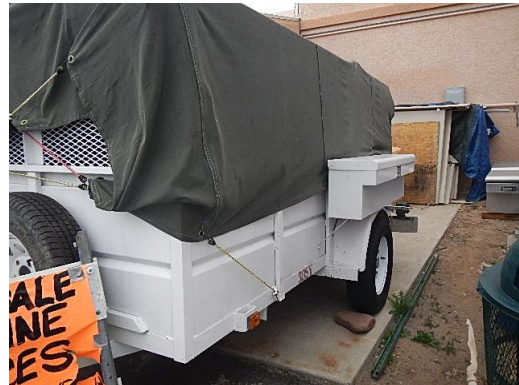
710 - Trailer	Useful Life 15	Remaining Life 6	
Landscaping Trailer	Quantity 1	Unit of Measure	Items
	Cost /Itm \$5,000		
	% Included 100.00%	Total Cost/Study	\$5,000
Summary	Replacement Year 2022	Future Cost	\$5,798

This is to replace the Big Tex landscaping trailer.

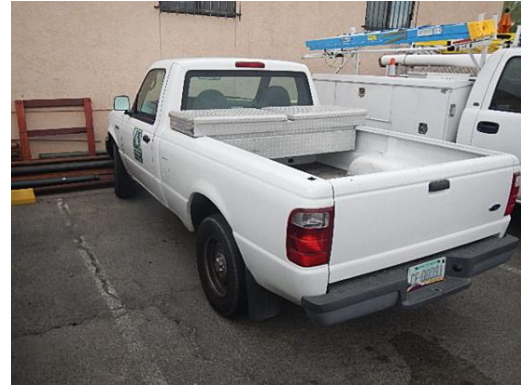
800 - Vehicle	Useful Life 10	Remaining Life 1	
Vehicle 01- 2003 Ford Ranger	Quantity 1	Unit of Measure	Items
	Cost /Itm \$15,000		
	% Included 100.00%	Total Cost/Study	\$15,000
Summary	Replacement Year 2017	Future Cost	\$15,375

This is to replace the 2003 Ford Ranger pickup truck.

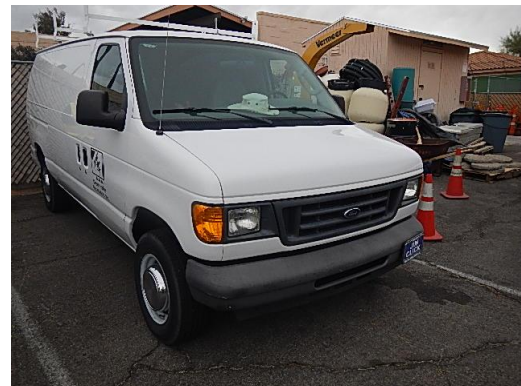
804 - Vehicle	Useful Life 10	Remaining Life 1	
Vehicle 10- 2005 Ford E250 Van	Quantity 1	Unit of Measure	Items
	Cost /Itm \$32,500		
	% Included 100.00%	Total Cost/Study	\$32,500
Summary	Replacement Year 2017	Future Cost	\$33,313

This is to replace the 2005 Ford E250 van.

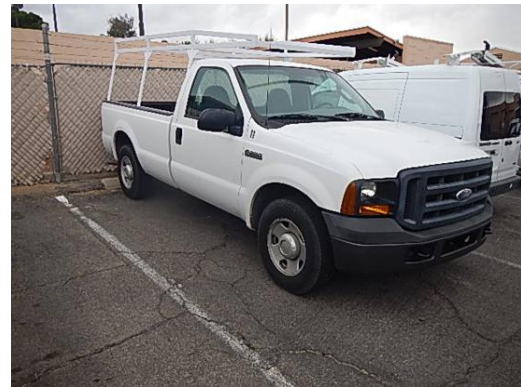
808 - Vehicle	Useful Life 10	Remaining Life 1	
Vehicle 11- 2006 Ford F250 Pickup	Quantity 1	Unit of Measure	Items
	Cost /Itm \$35,000		
	% Included 100.00%	Total Cost/Study	\$35,000
Summary	Replacement Year 2017	Future Cost	\$35,875

This is to replace the 2006 Ford F250 pickup truck.

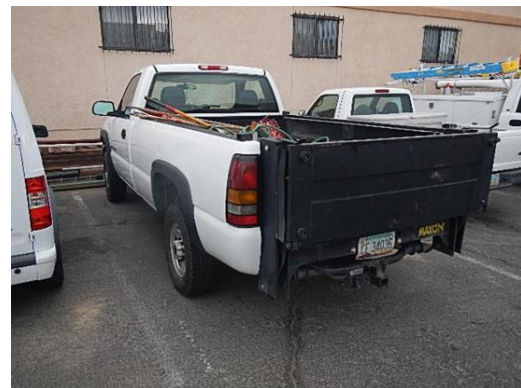
812 - Vehicle	Useful Life 10	Remaining Life 1	
Vehicle 12- 2007 GMC 2500 Pickup	Quantity 1	Unit of Measure	Items
	Cost /Itm \$32,500		
	% Included 100.00%	Total Cost/Study	\$32,500
Summary	Replacement Year 2017	Future Cost	\$33,313

This is to replace the 2006 Ford F250 pickup truck.

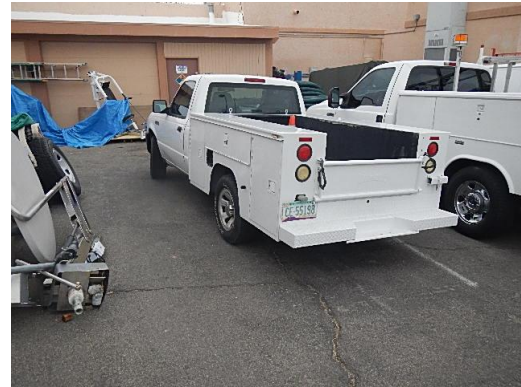
816 - Vehicle	Useful Life 10	Remaining Life 1	
Vehicle 16- 2007 Ford Ranger Pickup	Quantity 1	Unit of Measure	Items
	Cost /Itm \$25,000		
	% Included 100.00%	Total Cost/Study	\$25,000
Summary	Replacement Year 2017	Future Cost	\$25,625

This is to replace the 2007 Ford Ranger pickup truck.

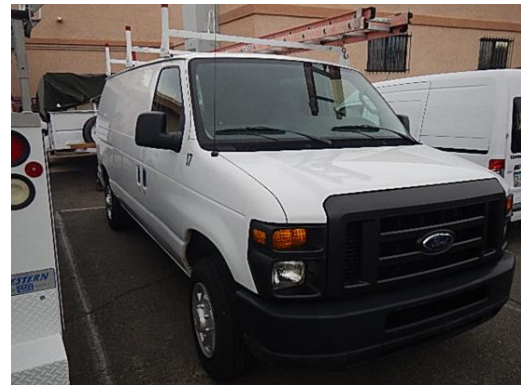
820 - Vehicle	Useful Life 10	Remaining Life 3	
Vehicle 17- 2009 Ford E150 Van	Quantity 1	Unit of Measure	Items
	Cost /Itm \$27,500		
	% Included 100.00%	Total Cost/Study	\$27,500
Summary	Replacement Year 2019	Future Cost	\$29,614

This is to replace the 2009 Ford E150 van.

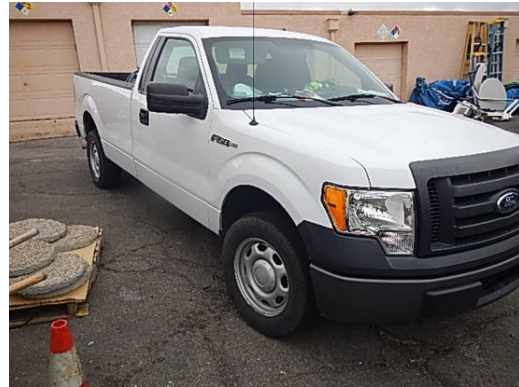
824 - Vehicle	Useful Life 10	Remaining Life 5	
Vehicle 18- 2011 Ford F150 Pickup	Quantity 1	Unit of Measure	Items
	Cost /Itm \$30,000		
	% Included 100.00%	Total Cost/Study	\$30,000
Summary	Replacement Year 2021	Future Cost	\$33,942

This is to replace the 2011 Ford F150 pickup truck.

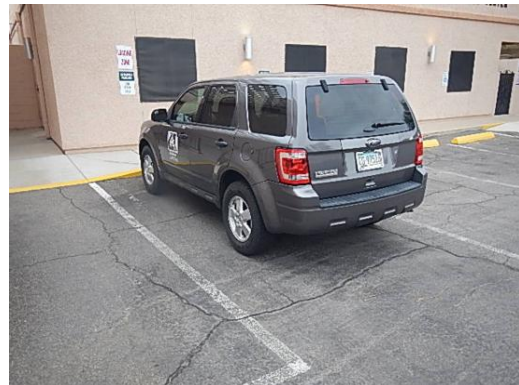
828 - Vehicle	Useful Life 10	Remaining Life 6	
Vehicle 19- 2012 Ford Escape	Quantity 1	Unit of Measure	Items
	Cost /Itm \$25,000		
	% Included 100.00%	Total Cost/Study	\$25,000
Summary	Replacement Year 2022	Future Cost	\$28,992

This is to replace the 2012 Ford Escape SUV.

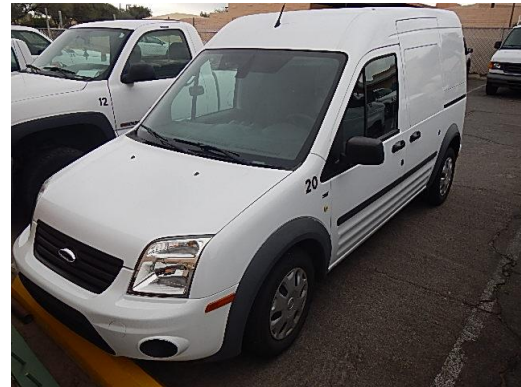
832 - Vehicle	Useful Life 10	Remaining Life 7	
4 Vehicles 20-23- Ford Transit Connects	Quantity 4	Unit of Measure	Items
	Cost /Itm \$25,000		
	% Included 100.00%	Total Cost/Study	\$100,000
Summary	Replacement Year 2023	Future Cost	\$118,869

This is to replace the 2013 Ford Transit Connect XLTs and XL's.

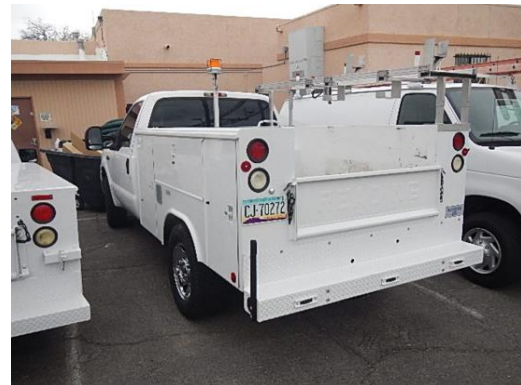
836 - Vehicle	Useful Life 10	Remaining Life 1	
Vehicle 24- 2005 Ford F250 Pickup	Quantity 1	Unit of Measure	Items
	Cost /Itm \$35,000		
	% Included 100.00%	Total Cost/Study	\$35,000
Summary	Replacement Year 2017	Future Cost	\$35,875

This is to replace the 2005 Ford F250 Utility Bed pickup truck.

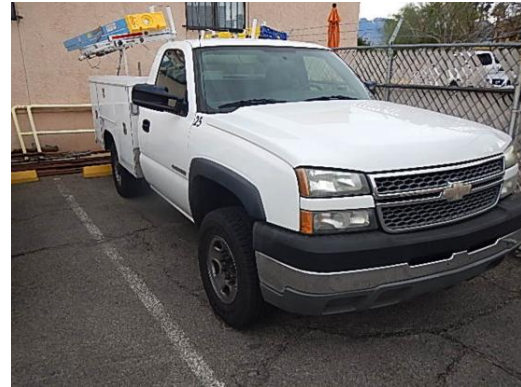
840 - Vehicle	Useful Life 10	Remaining Life 1	
Vehicle 25- 2005 Chevy Silverado 2500 HD	Quantity 1	Unit of Measure	Items
	Cost /Itm \$35,000		
	% Included 100.00%	Total Cost/Study	\$35,000
Summary	Replacement Year 2017	Future Cost	\$35,875

This is to replace the 2005 Chevy Silverado Utility Bed pickup truck.
